Phnom Bakheng Progress Report August 2009

Since the last progress report submitted in May 2009 site mobilization measures have been completed, the tower crane has been successfully installed, and the first phase of restoration work has commenced at the lower terrace of the northern half of the East Elevation. Archaeological excavation in front of the East Elevation –South side and detailed condition surveys have continued. Some additional emergency stabilization and protection measures for surrounding brick shrine structures are being planned and will be executed in due course.

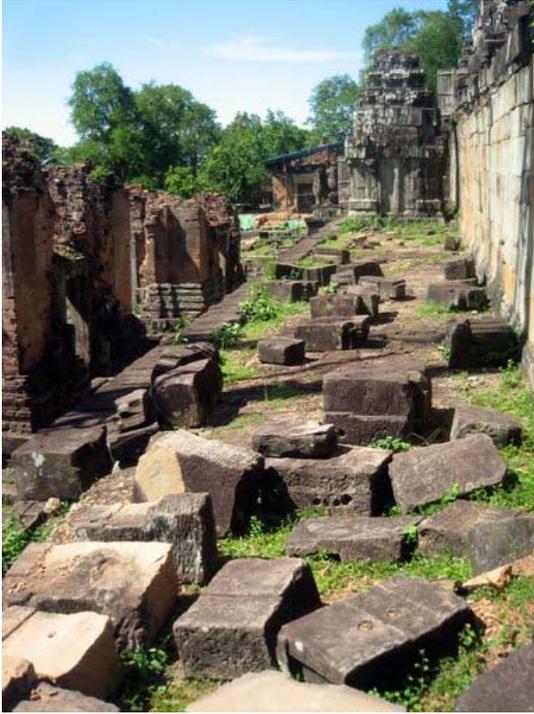
Fig 22: North East terrace of level F

After detailed documentation of site conditions, plans for disassembly including a stone numbering system and storage locations were established. The terrace of the lower level (level F) was cleared and stones were removed to a safe location.

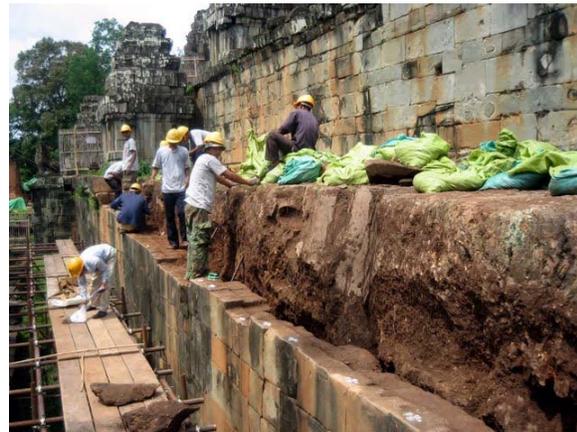
Fig 25: disassembly of North side of East Elevation

The team then began dismantling pavers and stone blocks from unstable areas in the first section of the work area on the NE corner.

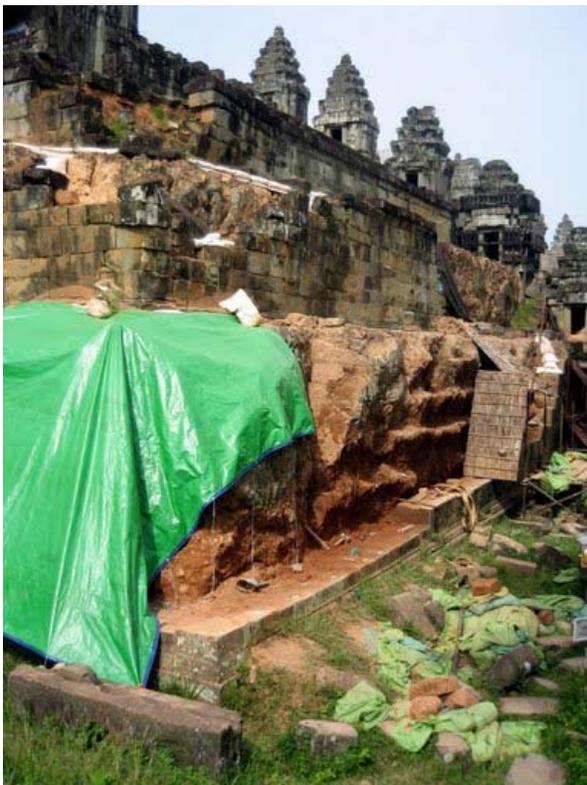
To date all stone blocks in the defined area of the North East corner have been removed and the exposed bedrock has been cleaned of soil, vegetation, and remains of deteriorated laterite. The documentation team is currently preparing detailed drawings of the condition of the bedrock to determine required repairs for this section.

Fig 28: North side of level F after disassembly

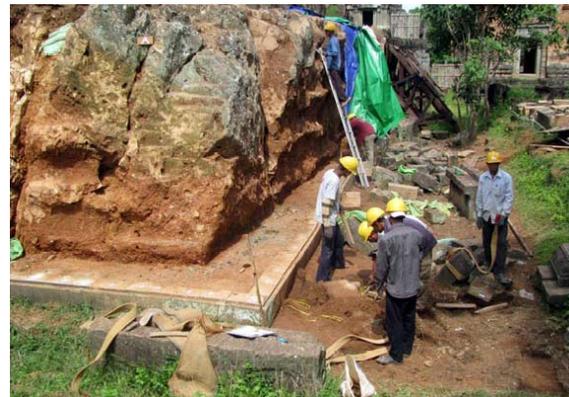
Fig 29: North East corner - exposed bedrock

Since this is the initial work area and the lowest of the corners, thus the most vulnerable, it was decided that almost all stones are to be removed to enable good observation of the bedrock condition. Information obtained from this first examination is expected to aid planning for disassembly required in other areas.

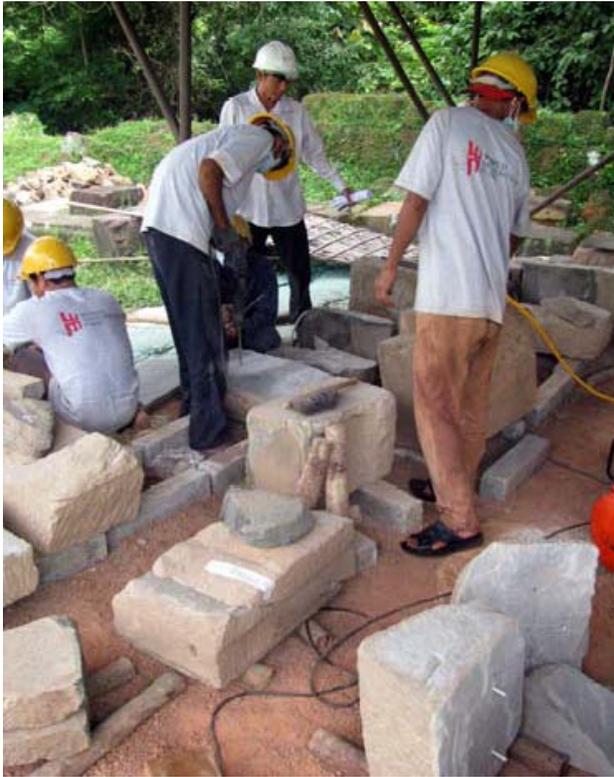
Fig 32: preparation of stone to insert stainless steel pins

The conservation of damaged stone blocks has commenced. The team is using stainless steel pins and fiber glass dowels of different sizes, and an epoxy based adhesive, to reattach broken stone fragments. This measure serves to stabilize stone blocks to be reused in the repaired wall section.

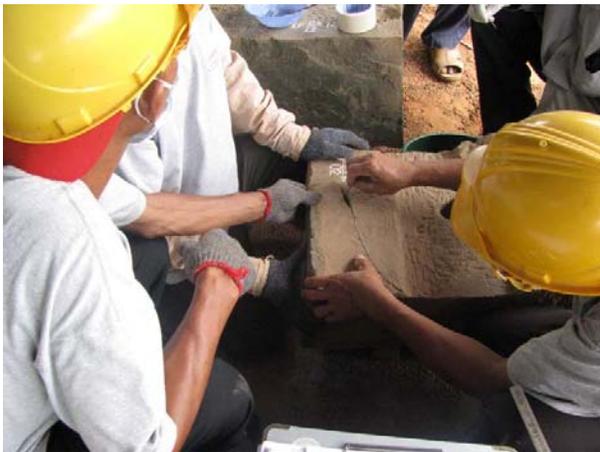
Fig 33: reattaching stone fragment using epoxy based adhesive

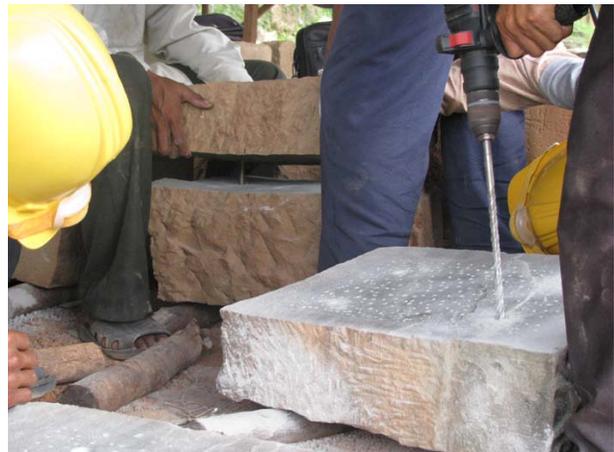
Fig 34: structural consolidation of stone block by insertion of stainless steel pins and epoxy adhesive

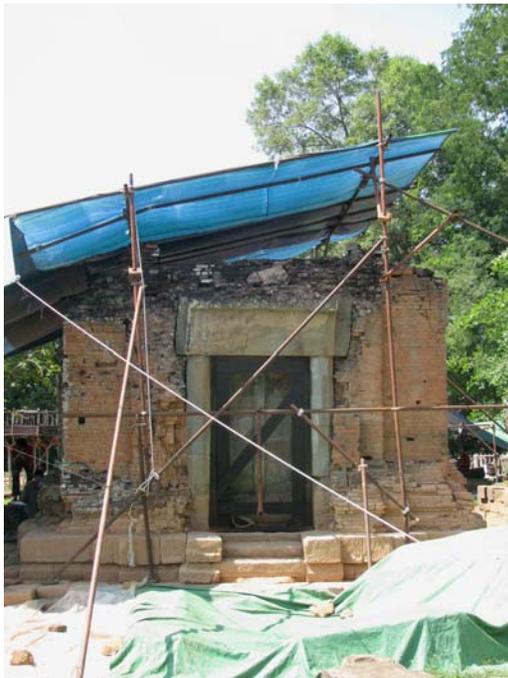
Fig 37: Shoring brick shrine G4- North side

Wooden shoring has been installed in the door frames of the exposed brick shrine to ensure structural stability during the excavation.

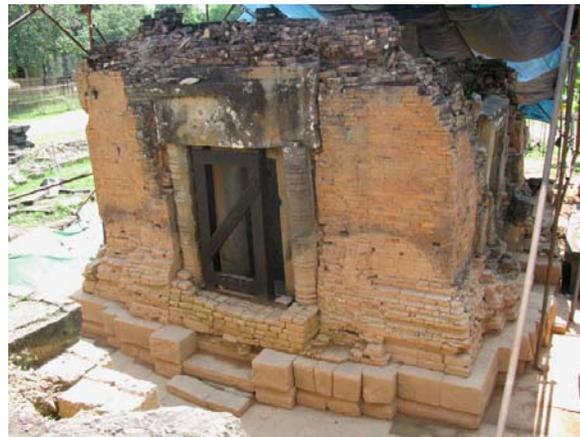
Fig 38: Shoring brick shrine G4 – South side

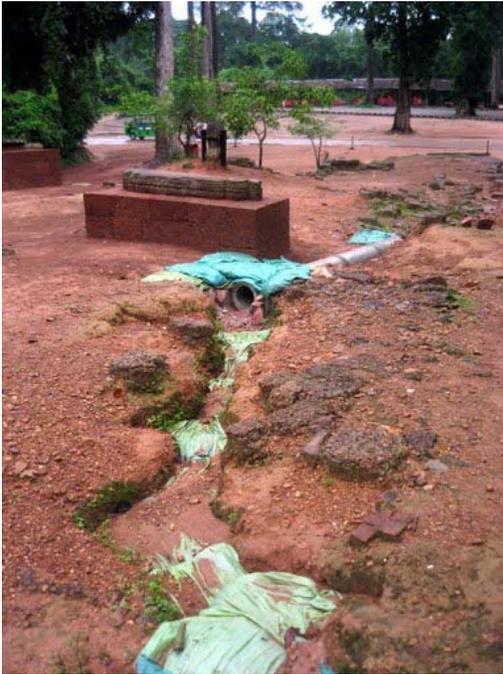
Fig 42: drainage pipes

During the rainy season intensive maintenance of the repaired pathway leading up to Phnom Bakheng is required. The work crew is checking the condition and performance of the repairs with regard to structural stability and drainage, and undertakes small repairs if required every week. At the bottom of the hill additional drainage pipes were installed to direct water run-off and limit erosion of the natural hill.
