Attachment C. Examples of Condition Survey - format and photography

**EMBASSY MAIN RESIDENCE
BUENOS AIRES, ARGENTINA**

CONSERVATION CONDITION SURVEY
COLLECTION OF FURNITURE AND OBJECTS D'ART

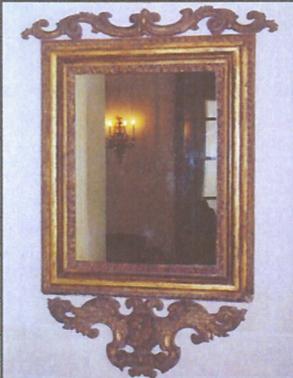
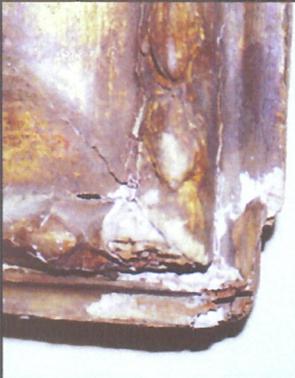
23843	19300	G39 - Elevator Lobby					
OBJECT NAME							
Mirror							
GENERIC CLASSIFICATION							
Decorative Object							
SIZE							
h: 185cm / w: 127cm.							
ORIGIN- SIGNATURES / MARKS			PHOTO N°	DETAIL N°			
			1030	1033			
COMPONENTS AND TECHNIQUES			VALUATION	\$ 8,000			
Carved giltwood. Mirror.							
DESCRIPTION							
Antique Italian style mirror frame with wood carved ornamentation, including an eagle pendant and foliage cresting.							
CONSERVATION CONDITION							
<input checked="" type="checkbox"/>	SUPERFICIAL DIRT	<input checked="" type="checkbox"/>	LOSS	<input type="checkbox"/>	LACK OF ADHESIVENESS	<input type="checkbox"/>	DENTS / KNOCKS
<input checked="" type="checkbox"/>	EMBEDDED DIRT	<input type="checkbox"/>	EMBRITTLEMENT	<input checked="" type="checkbox"/>	CHIPPING	<input checked="" type="checkbox"/>	STAINS
<input type="checkbox"/>	FADING	<input type="checkbox"/>	FLAKING	<input checked="" type="checkbox"/>	ABRASION	<input checked="" type="checkbox"/>	SIGNS OF INFESTATION

<input checked="" type="checkbox"/>	DETACHMENT	<input type="checkbox"/>	CRACKING	<input type="checkbox"/>	MARKS	<input checked="" type="checkbox"/>	OTHER
OBSERVATIONS							
Superficial and embedded dirt. Abrasion. Loss of gold leaf exposing the wood. The most affected areas show the wooden substrate. Residues of cleaning products. Signs of old, severe infestations.							
PROBABLE DETERIORATION CAUSE / CAUSES							
Inadequate cleaning techniques and frequency. Aging. Knocks.							
Lack of professional restoration and maintenance work.							
PREVIOUS INTERVENTIONS							
<input checked="" type="checkbox"/>	NONE	<input type="checkbox"/>	AMATEUR	<input type="checkbox"/>	PROFESSIONAL		
SURVEYORS				DATE			
Astesiano-Mallol.				August, 2003			
RESPONSIBLE

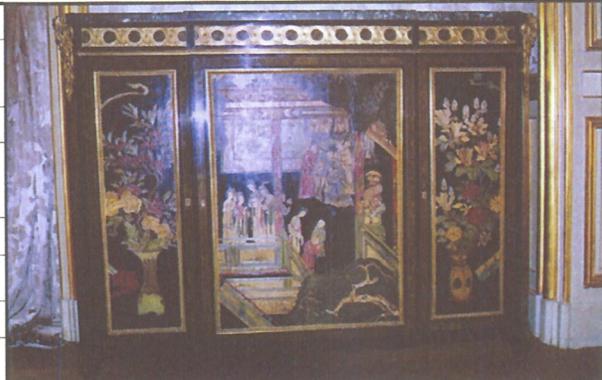
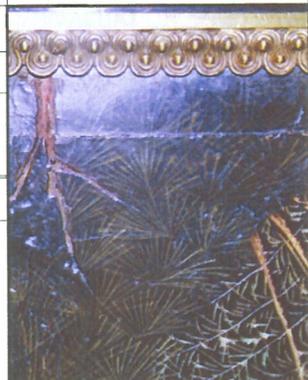
PHOTO N° 8009

OBSERVATIONS
Superficial dirt. Chipping, superficial stains, losses.

PROBABLE DETERIORATION CAUSE / CAUSES
Inadequate cleaning frequency and repair work. Lack of professional periodic maintenance work.

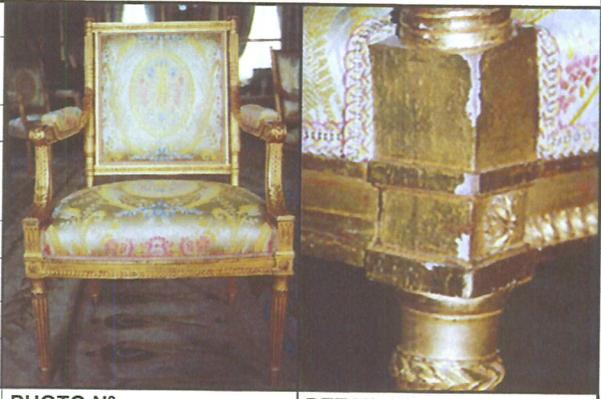
OBSERVATIONS
Exposed surfaces of arms, legs and borders show abrasion, knocks and loss of gold leaf exposing the underlying white bold. The most affected areas show the bare wood. Shows progressive loss of gold leaf.

PROBABLE DETERIORATION CAUSE / CAUSES
Incorrect handling and temporary storage.
Inadequate cleaning frequency.
Lack of, or inadequate protection of devices and attachments used during daily cleaning in order to prevent accidental knocks.
Abrupt and wide environmental fluctuations -relative humidity and temperature-.

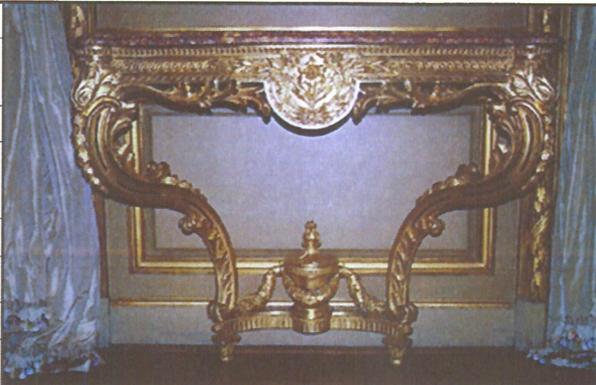
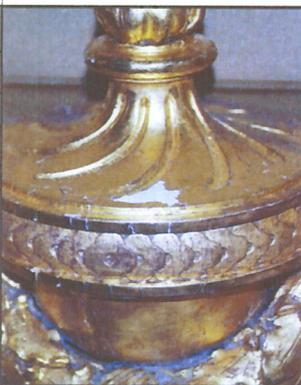
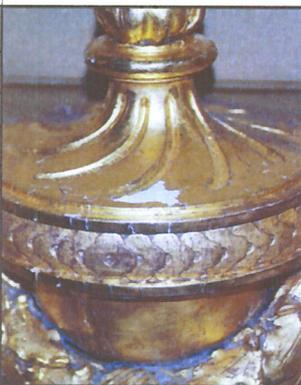
FADING	<input checked="" type="checkbox"/>	FLAKING	<input type="checkbox"/>	ABRASION	<input checked="" type="checkbox"/>	SIGNS OF INFESTATION
	DETACHMENT	<input checked="" type="checkbox"/>	CRACKING	<input type="checkbox"/>	MARKS	<input type="checkbox"/>	OTHER
OBSERVATIONS							
High percentage of superficial dirt. Embrittlement, chipping, cracking and lack of adhesiveness to the substrate. Progressive loss of gold leaf.							
PROBABLE DETERIORATION CAUSE / CAUSES							
Inadequate cleaning frequency. Knocks. Lack of periodic professional maintenance work.							
PREVIOUS INTERVENTIONS							
<input type="checkbox"/> NONE		<input type="checkbox"/> AMATEUR		<input checked="" type="checkbox"/> PROFESSIONAL			
SURVEYORS				DATE			
Astesiano- Mallol				August, 2003			
RESPONSIBLE

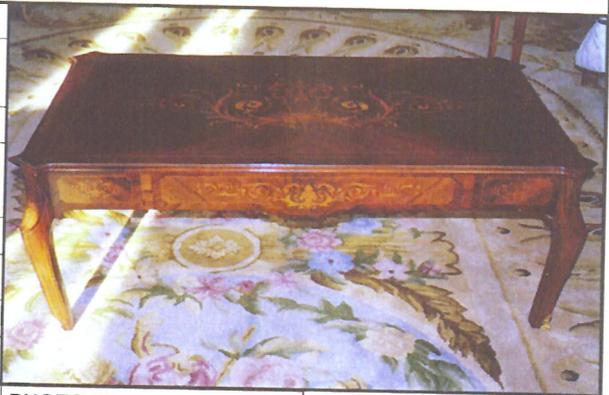
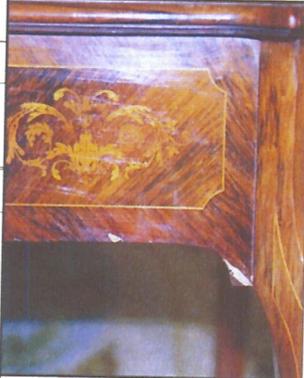
PHOTO N° 11032

Superficial dirt, lifting veneer and minor losses.

Veneered wood is vulnerable to knocks and careless handling and abrupt fluctuations of temperature and RH.

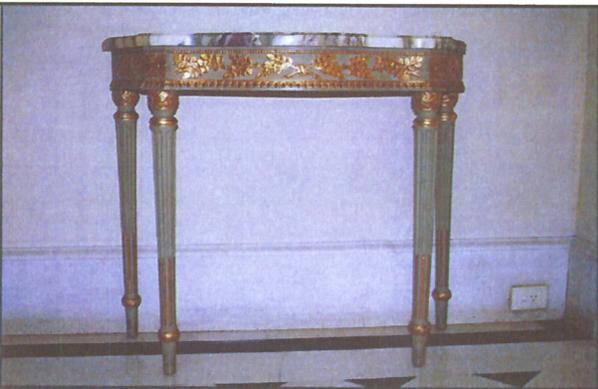
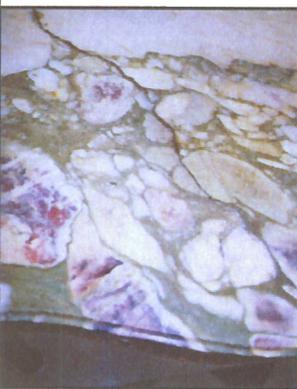
<input type="checkbox"/>	FADING	<input type="checkbox"/>	FLAKING	<input type="checkbox"/>	ABRASION	<input type="checkbox"/>	SIGNS OF INFESTATION
<input type="checkbox"/>	DETACHMENT	<input checked="" type="checkbox"/>	CRACKING	<input checked="" type="checkbox"/>	MARKS	<input checked="" type="checkbox"/>	OTHER
OBSERVATIONS							
Superficial and embedded dirt. Chipping. Marks and stains on the marble top. Cracking.							
PROBABLE DETERIORATION CAUSE / CAUSES							
Inadequate cleaning frequency. Careless handling. Knocks. Misuse.							
PREVIOUS INTERVENTIONS							
<input type="checkbox"/>	NONE	<input checked="" type="checkbox"/>	AMATEUR	<input checked="" type="checkbox"/>	PROFESSIONAL		
SURVEYORS				DATE			
Astesiano-Mallol.				August, 2003			
RESPONSIBLE

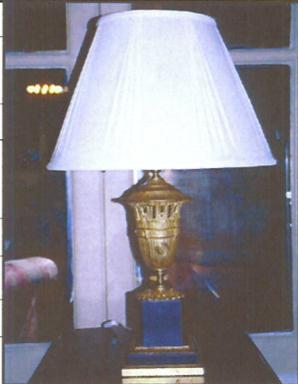
Good conservation condition.							
PROBABLE DETERIORATION CAUSE / CAUSES							
PREVIOUS INTERVENTIONS							
<input checked="" type="checkbox"/>	NONE		<input type="checkbox"/>	AMATEUR		<input type="checkbox"/>	PROFESSIONAL
SURVEYORS					DATE		
Astesiano- Malloj					December, 2003		
RESPONSIBLE

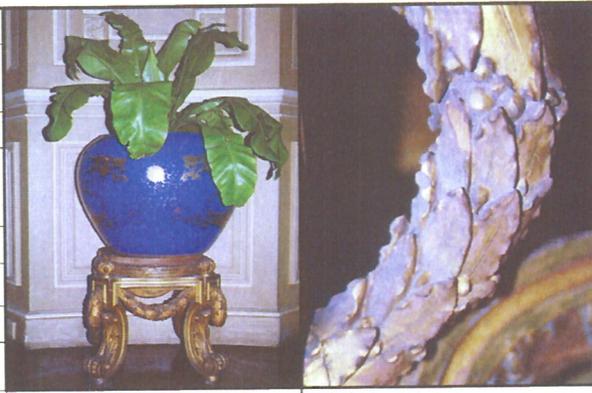
PHOTO N°	DETAIL N°
13010	13012

OBSERVATIONS
Superficial and embedded dirt. Cracking, abrasion, minor chipping and losses on the giltwood base.

PROBABLE DETERIORATION CAUSE / CAUSES
Inadequate maintenance work.

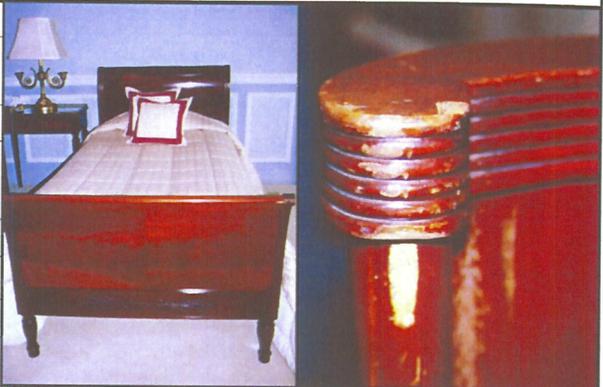
<input type="checkbox"/>	DETACHMENT	<input type="checkbox"/>	CRACKING	<input checked="" type="checkbox"/>	MARKS	<input type="checkbox"/>	OTHER
OBSERVATIONS							
Embedded dirt. Scratches and dents on legs and borders. Abrasion on protruding areas of head and footboards (see detail).							
PROBABLE DETERIORATION CAUSE / CAUSES							
Careless cleaning and handling.							
PREVIOUS INTERVENTIONS							
<input checked="" type="checkbox"/>	NONE	<input type="checkbox"/>	AMATEUR	<input type="checkbox"/>	PROFESSIONAL		
SURVEYORS				DATE			
Astesiano- Mallol				December, 2003			
RESPONSIBLE
