1.0 GENERAL

The purpose of this report is to evaluate the existing retaining walls of the DCR Facility and to recommend rehabilitation measures. Rehabilitation will include the reinforcing and replacement of the existing retaining walls

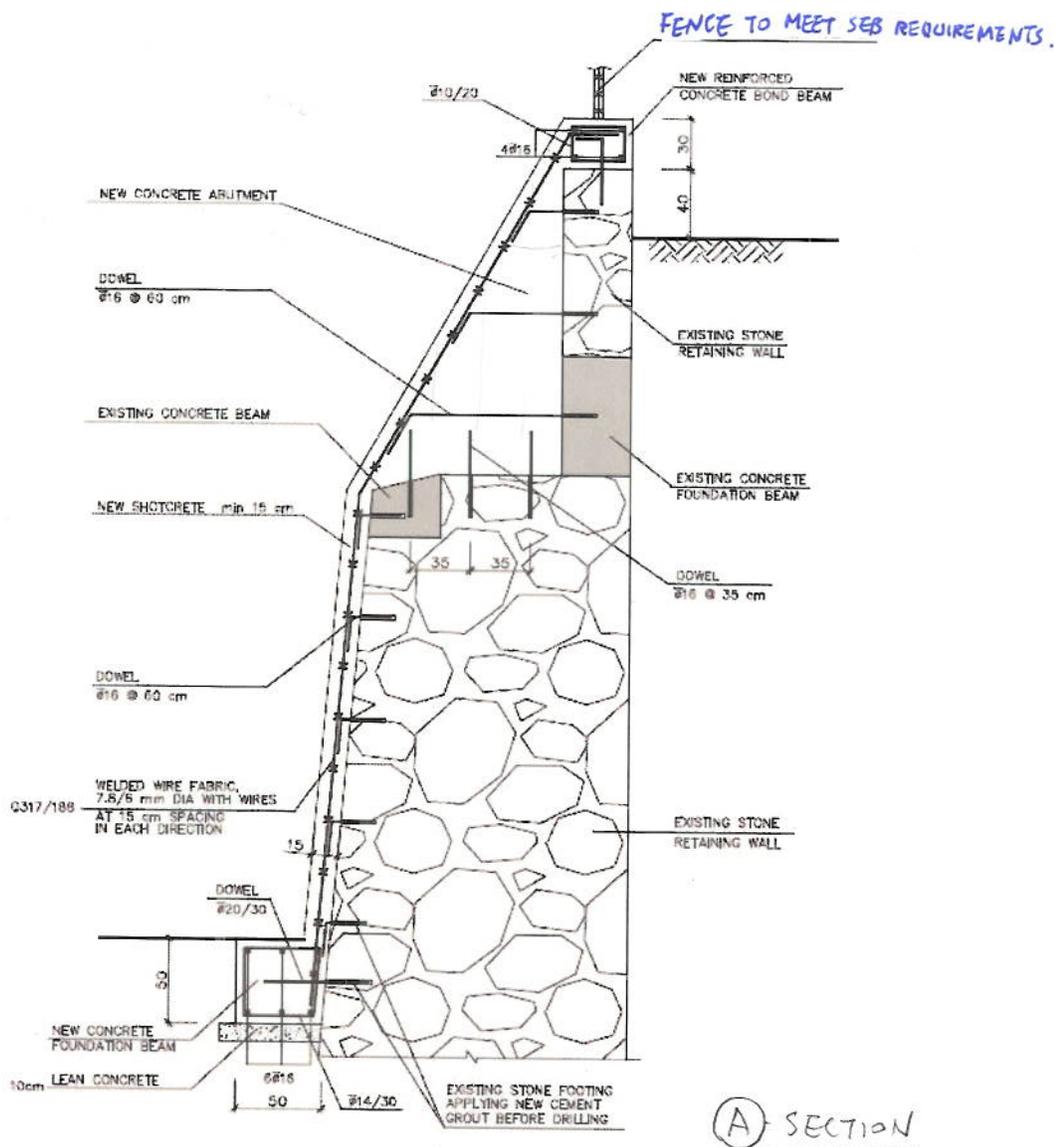
2.2 North Section of West Retaining Wall

Surface rehabilitation is recommended for the lower part,

- The surface damages, loose mortar and deteriorated stone particles will be removed.
- A 50x50 cm foundation beam will be constructed and minimum 15 cm thick shotcrete with wire mesh reinforcement and dowels will be applied to the exterior face.

The upper part will be strengthened by adding a concrete abutment wall on the top of the lower part as detailed below.

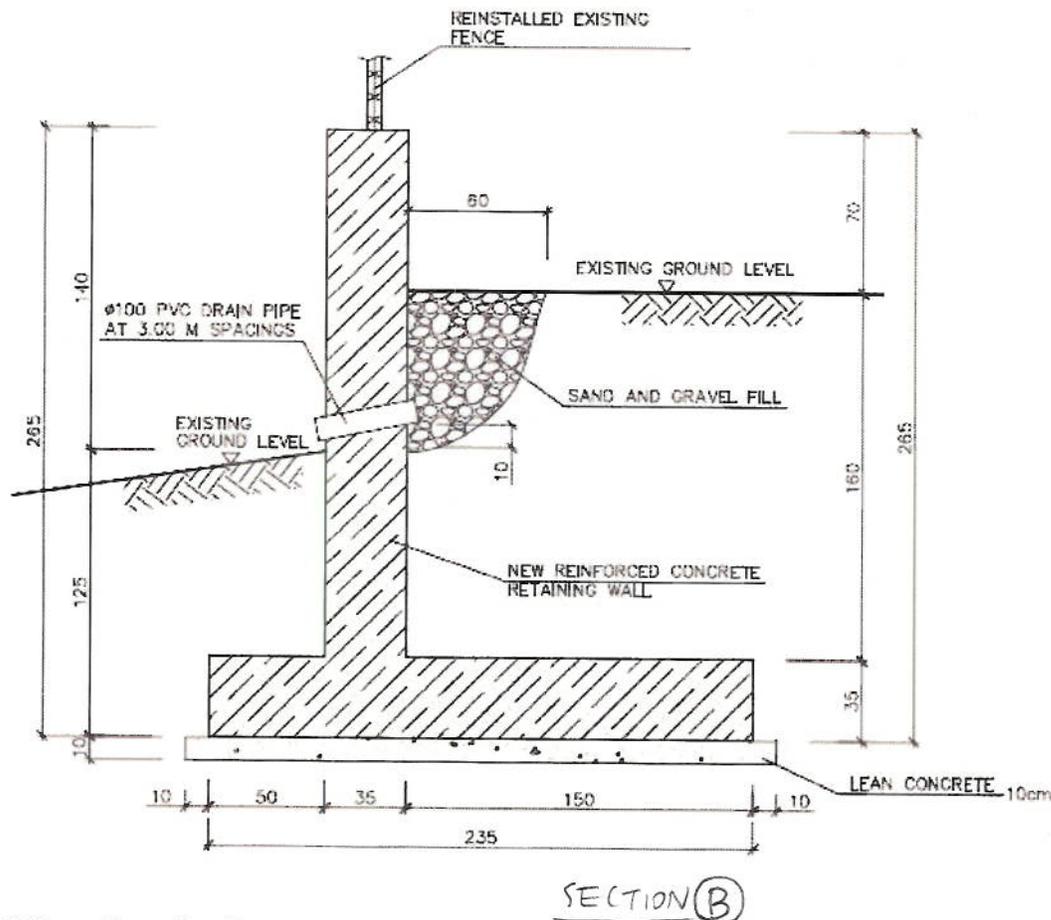
2.3 South Section of West Retaining Wall

This section has considerable damages and deformations and the replacement of existing retaining wall is recommended.

Existing stone wall at this section will be removed and a new reinforced concrete retaining wall will be constructed. The detail design for the new reinforced concrete retaining wall is given in Appendix A. The section of new retaining wall is shown below.

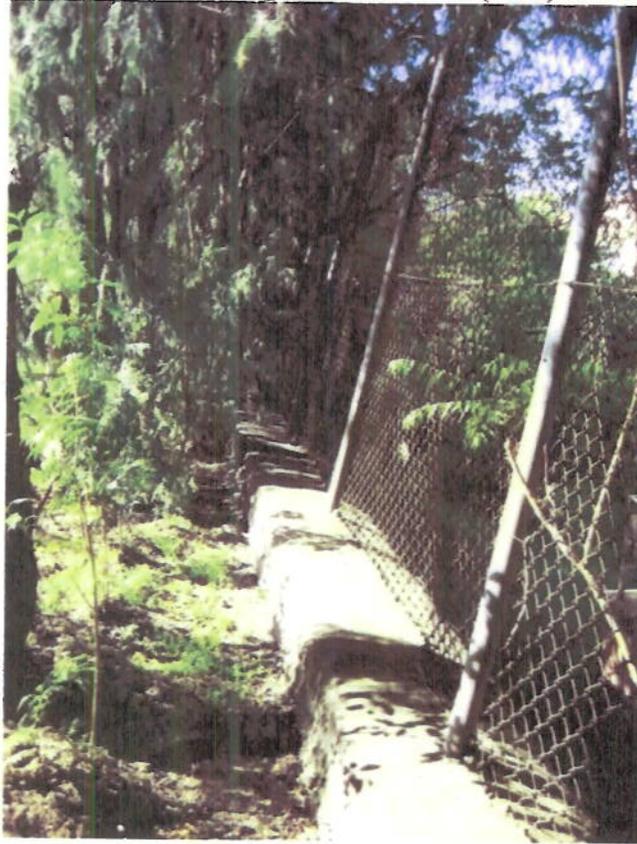
Photo 6 – Tilted Existing Perimeter Wall (west) at DCMR

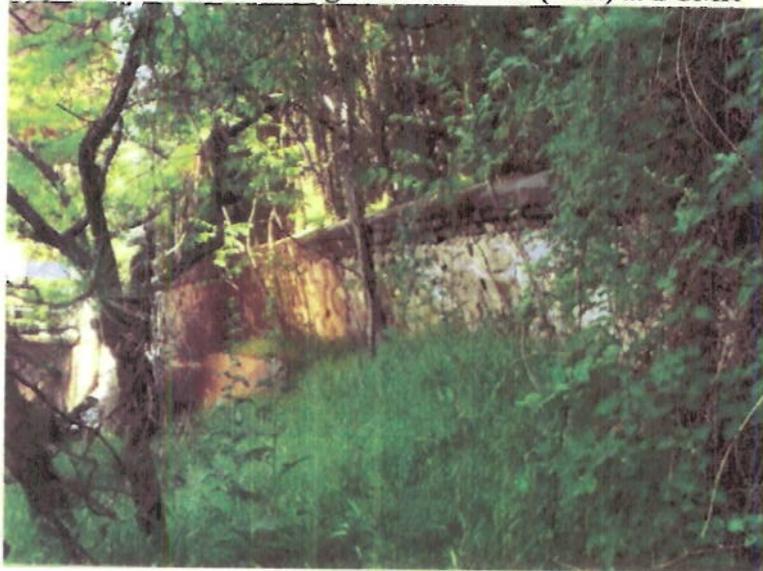
Photo 7 – Tilted Existing Perimeter Wall (west) at DCMR

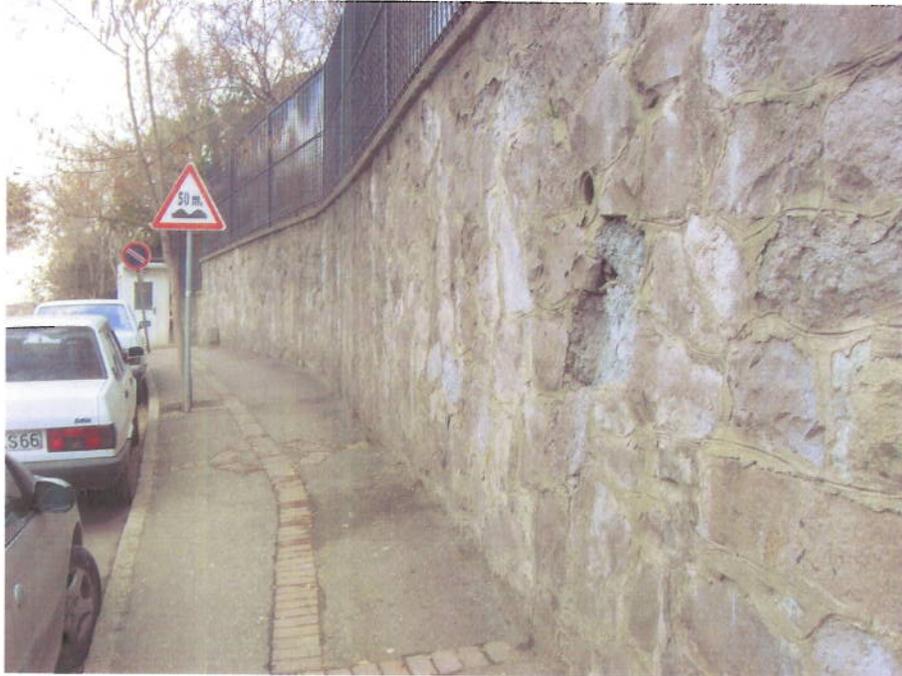
2.00 to 4.00 m height North Retaining Wall is in a good condition; only small surface damages were observed.

General View of North Retaining Wall

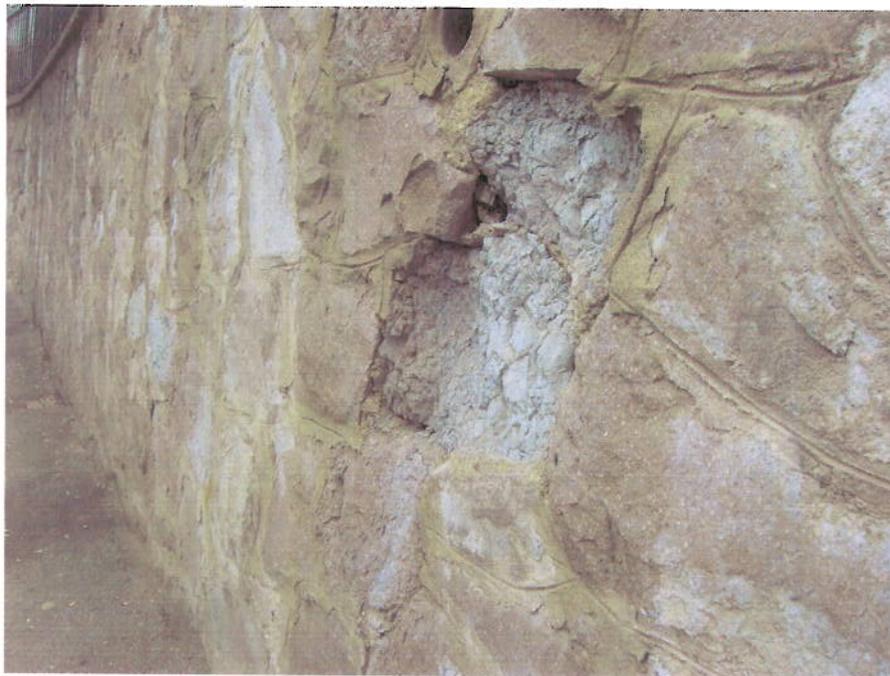
Surface Damages at North Retaining Wall
