Akhaldaba Landslide (Photo courtesy of GeoGraphics GIS and Remote Sensing Consulting Center)

Tbilisi Flood 2015

Initial Findings and Response Actions

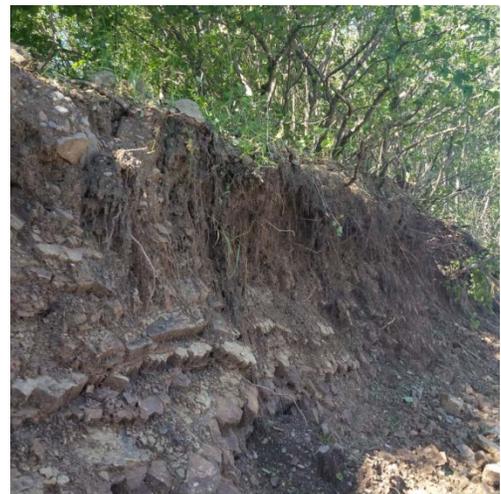
Figure 2: Interbedded layers of sandstone, siltstone and claystone are weak, easily decomposed and eroded.

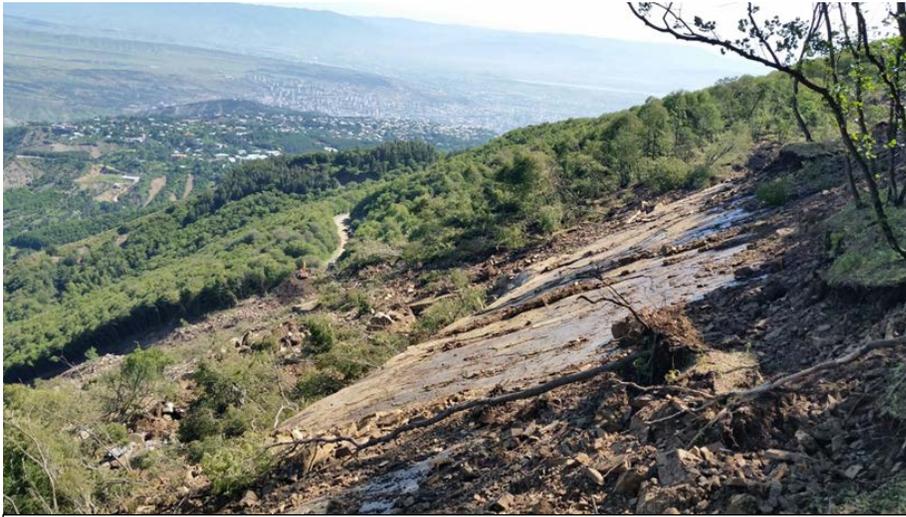
north (Figure 3). Therefore, along the south side of the Vere watershed, the slope of the land is directly parallel to the layers of the bedrock. Like a tilted stack of cards that can easily slip past one another.

Figure 3: Bedrock layer dipping toward the north parallel to slope is prone to landslides.

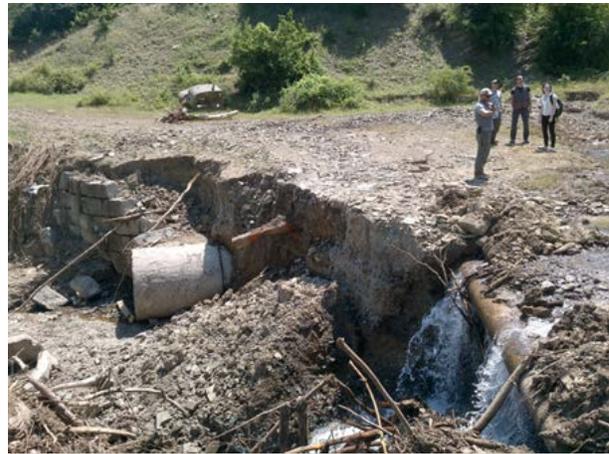
Figure 9: This blocked culvert in Ukhankhevi River is acting as a stream level control point.

the streambed elevation lowers, then additional undercutting of the toe of landslide areas would occur, causing increased landslide activity. Multiple natural control points were observed where resistant bedrock created nickpoints in the mainstem of the Vere River. In the Ukhankhevi River watershed (Figure 9), an unnatural control point has been created at a road-stream crossing, resulting from a blocked culvert and severe erosion of the stream downstream of the culvert. If this control point were removed, it would result in headward cutting of the stream until it regains its original stream gradient. Lowering of the stream bed at this location could activate additional landslides in the watershed upstream of the electrical substation, further threatening the function and integrity of this substation. Due to the unstable nature of the landscape above this point, that headward erosion should be controlled.

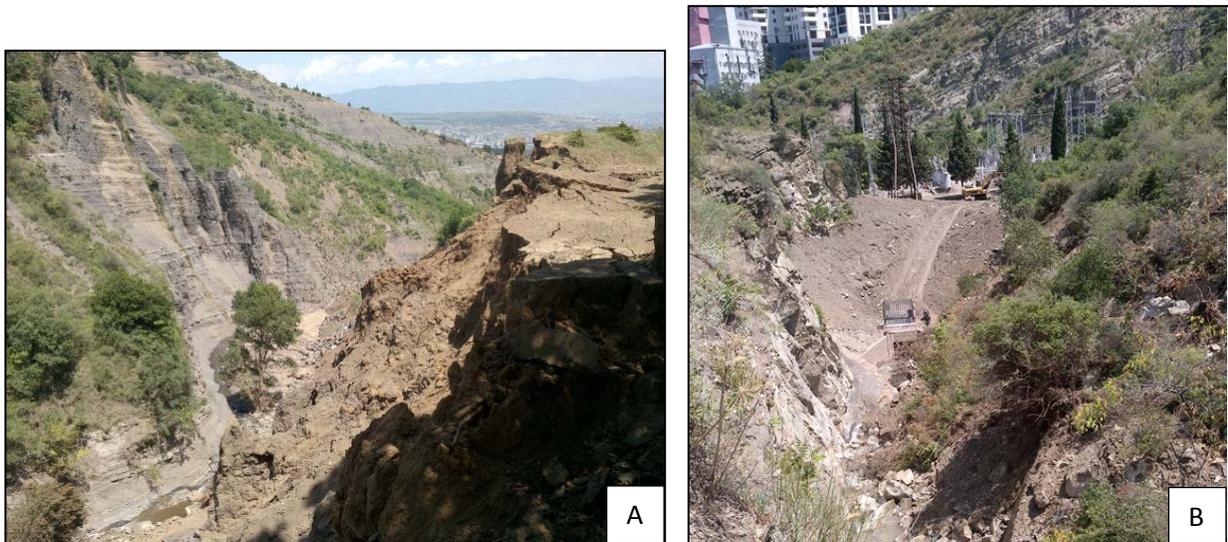
Figure 10: Earthflow (A) and rockfall (B) areas are active in the lower Ukankhevi River that meets the Vere River just above Tbilisi. These geo-hazards are perched just upstream of the electricity sub-station and water supply systems that serve the city of Tbilisi. Those utilities are built over the stream channel at a point where three streams come together and are threatened by these hazards.

Remove the rockfall in Ukhankhevi River above electricity sub-station:

The slide area just upstream of the Electrical Plant poses another very difficult problem due to the narrow ravine for access. Evaluate the engineering feasibility of removing the rock slide and building a buttress at the toe with rock. It appears to be feasible to bring a road in from the top by the power lines to first topple and then remove the rock slide material until the bankfull width of the stream channel is attained and the slide is buttressed and stable. A stable storage area for the rock that is removed will need to be found. If the rock is suitable for construction projects, it could be sold.

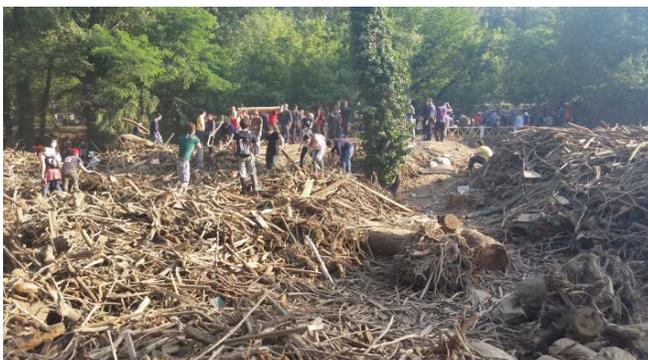
Due to bulking of the flood flow carrying not only a significant amount of water but also the added volume of sediment and debris from all the landslides, a debris dam was created when it hit the first tunnel. This slowed the flow and backed up the stream. As it slowed, much of the sediment and debris dropped out but as the level of inundation rose much of the debris floated. When the pressure of water overcame the blockage, the water rushed into the culvert in a manner described as dam breach hydrology. The force of the flow now accelerated, due both to the head of water now created and the small constriction of tunnel #1. This enormous flow exited the first tunnel with such force that it eroded approximately 30 meters of the streambank at the culvert outlet and undermined houses (Figure 12). The flow continued down the Vere River through the City, constricting and backing up at each culvert/tunnel and accelerated as the head breached the constriction. In Mziuri Park, above the zoo, the stream was finally allowed to occupy its historic floodplain (Figure 11) and that is where the majority of

Figure 11: Area of Mziuri Park where the stream occupied its historic floodplain and dropped much sediment and debris

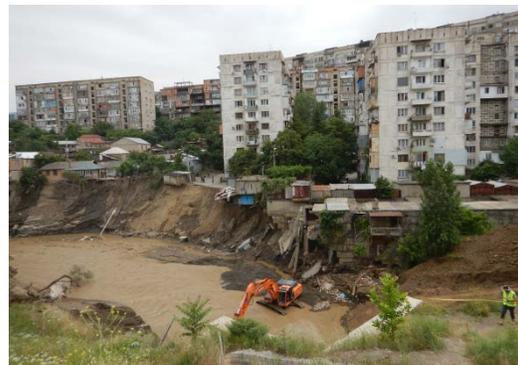
Figure 12: Downstream outlet of tunnel #1 showing area of streambank that was eroded 30 meters back and undercutting houses.

Figure 19: Designs for a well constructed retaining wall at the site of the outlet of the first tunnel. Rapid implementation of this project may limit options for stream restoration in the future.

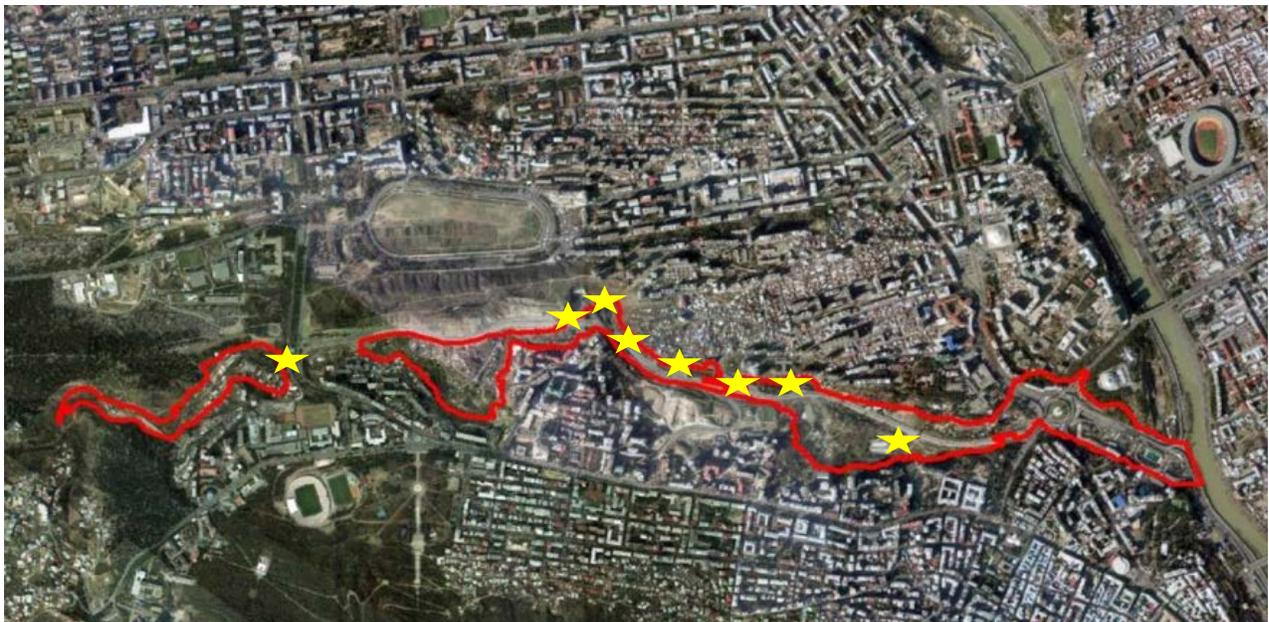
Figure 13: Approximate locations of the ponded areas that occurred during the Vere flood the night of June 13 and morning of June 14, 2015. There were only two zones where the natural channel was allowed to occupy its flood plain. The eight tunnel/culvert sections (starred) first ponded and then accelerated streamflow. (Source: GeoGraphics , GIS and Remote Sensing Consulting Center)

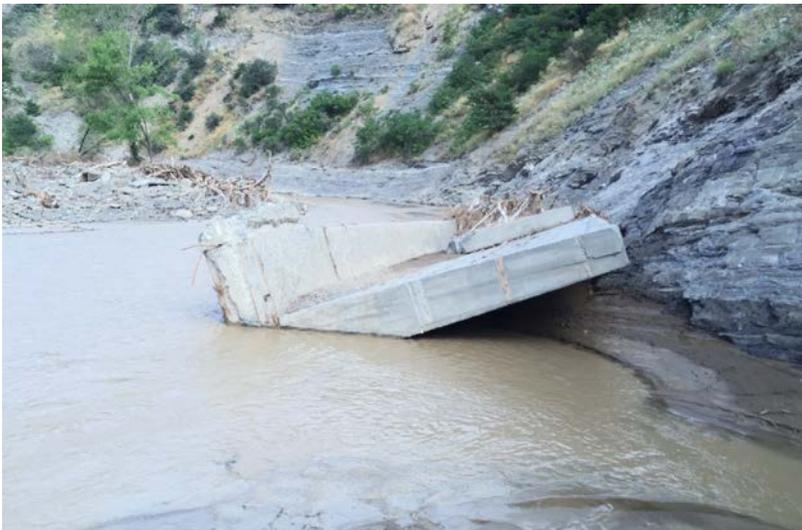
SMZ regulation should also control the types of structures allowed within the SMZ. An example of poor construction was found just upstream of the first tunnel where the Vere River was channelized adjacent to some buildings. The concrete retaining wall did not appear to be tied to either the Vere River insitu rock sidewalls nor embedded into the undying stream-bed. This allowed the wall to be scoured and float up in the stormwater event (Figure 17). Engineered hardened features placed into the stream channel are prone to failure.

Figure 17: Flood caused this poorly constructed concrete retaining wall to float during the flood.
