CAIRO I ELEVATOR REPAIR

STATEMENT OF WORK

Date: Dec 10, 2015

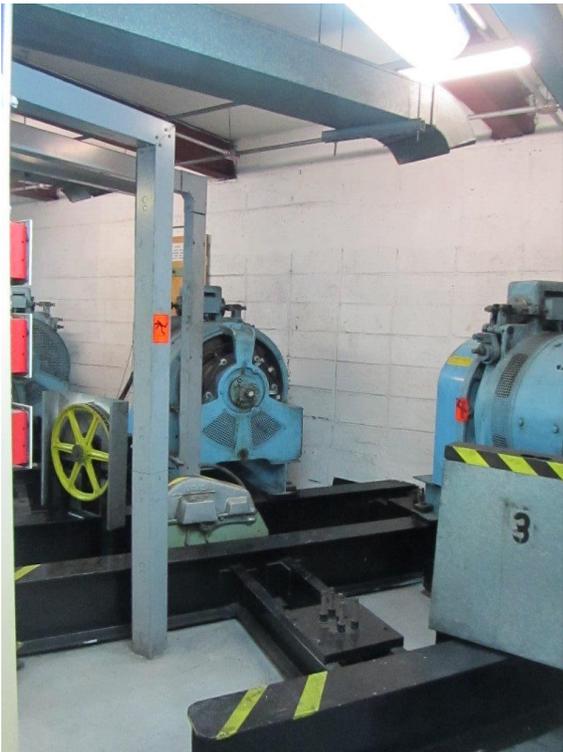
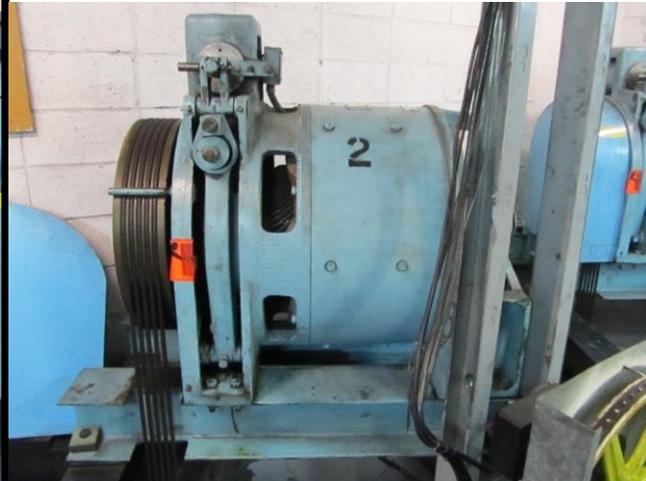
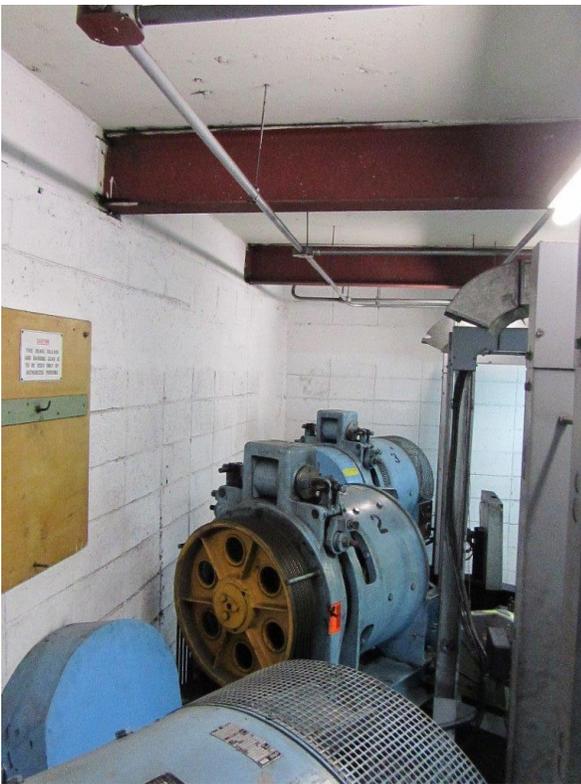
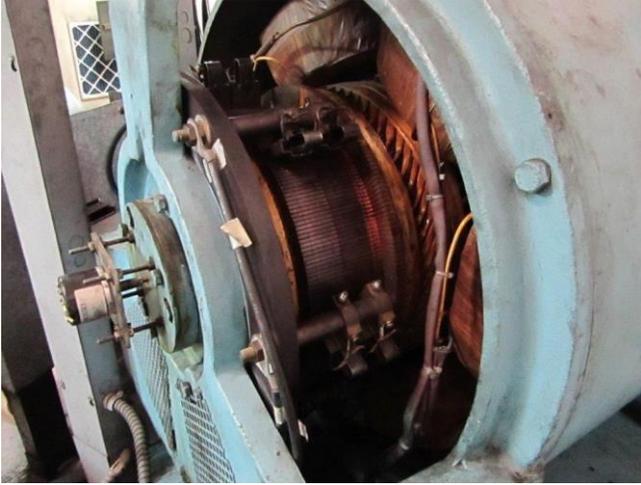
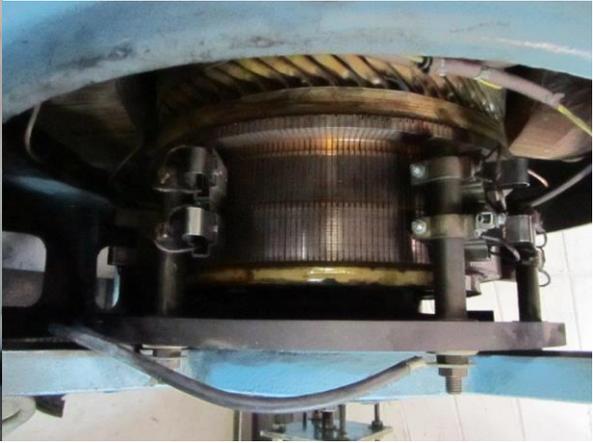
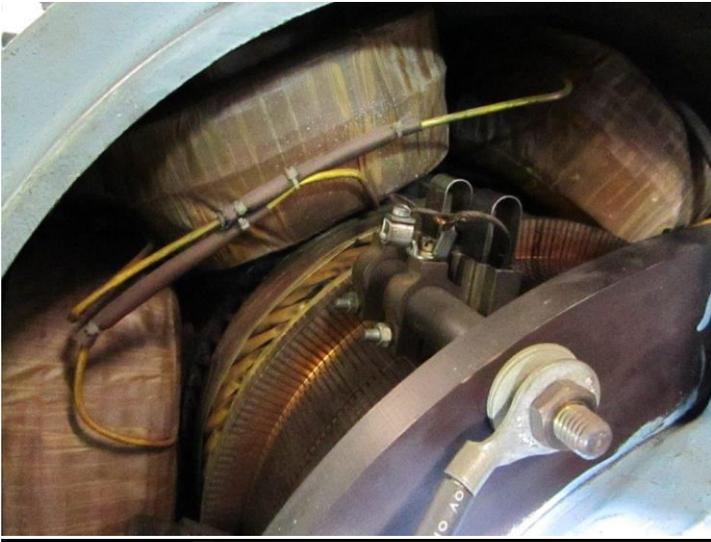
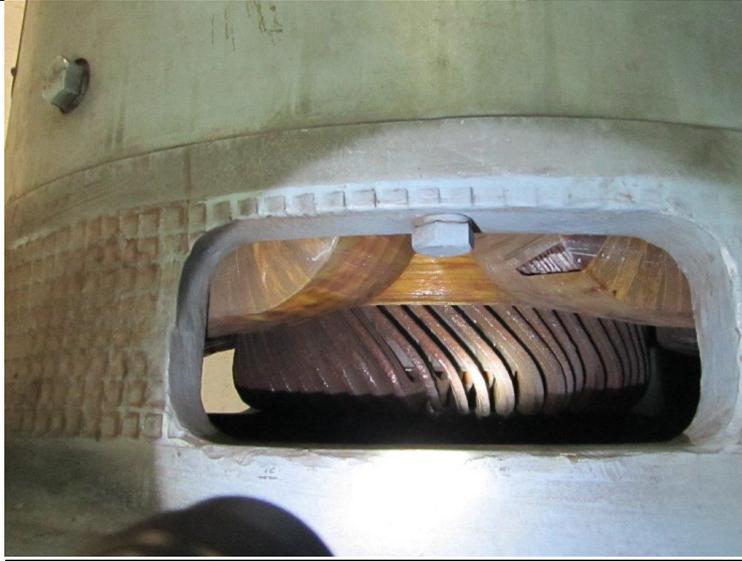
Attachment #1--- Picture for existing conditions

On October 15th, 2015 the nearly 5,000 pound elevator motor of elevator #2 failed. This motor lifts one of three passenger elevators serving the Cairo I tower (15 story office building). The Elevator is an “Otis” brand, the motor is original, dates to the mid-1980s, and was installed in 1988 in the mechanical room at the 16th floor of the Cairo I building.

Pictures showing the existing conditions in the mechanical room are shown as an attachment to this document.
