Scope of Work
Trim and removal of trees
away from security fence and
alongside Barker Road

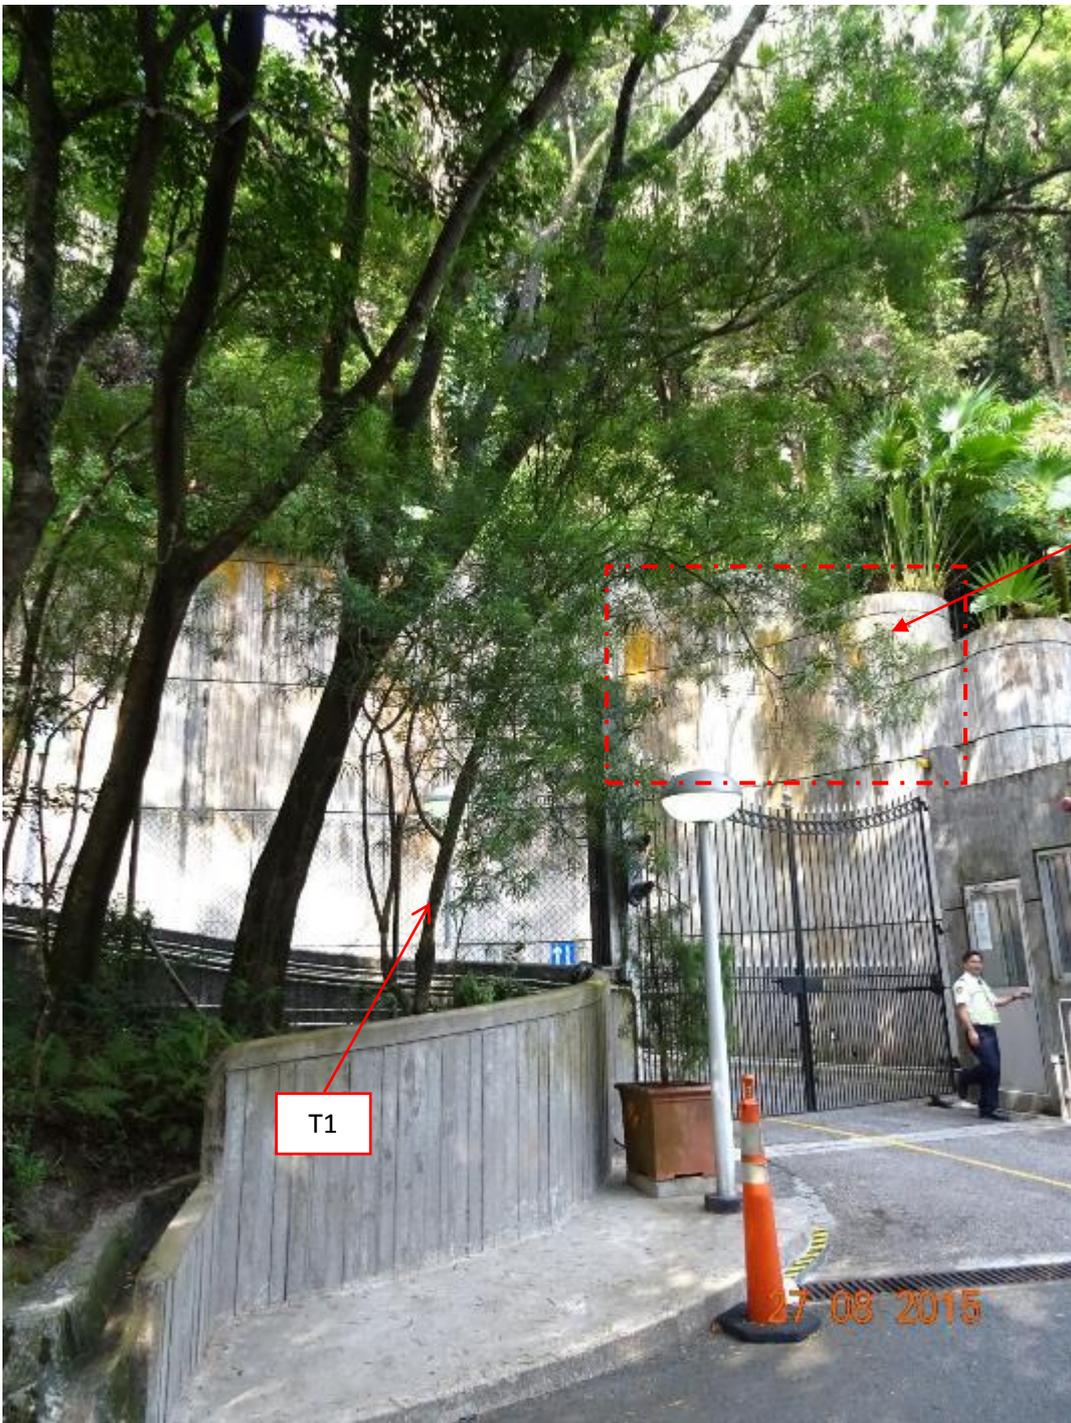
Overview of the subject tree T1. Crown raising to add clearance of the entrance can be considered.

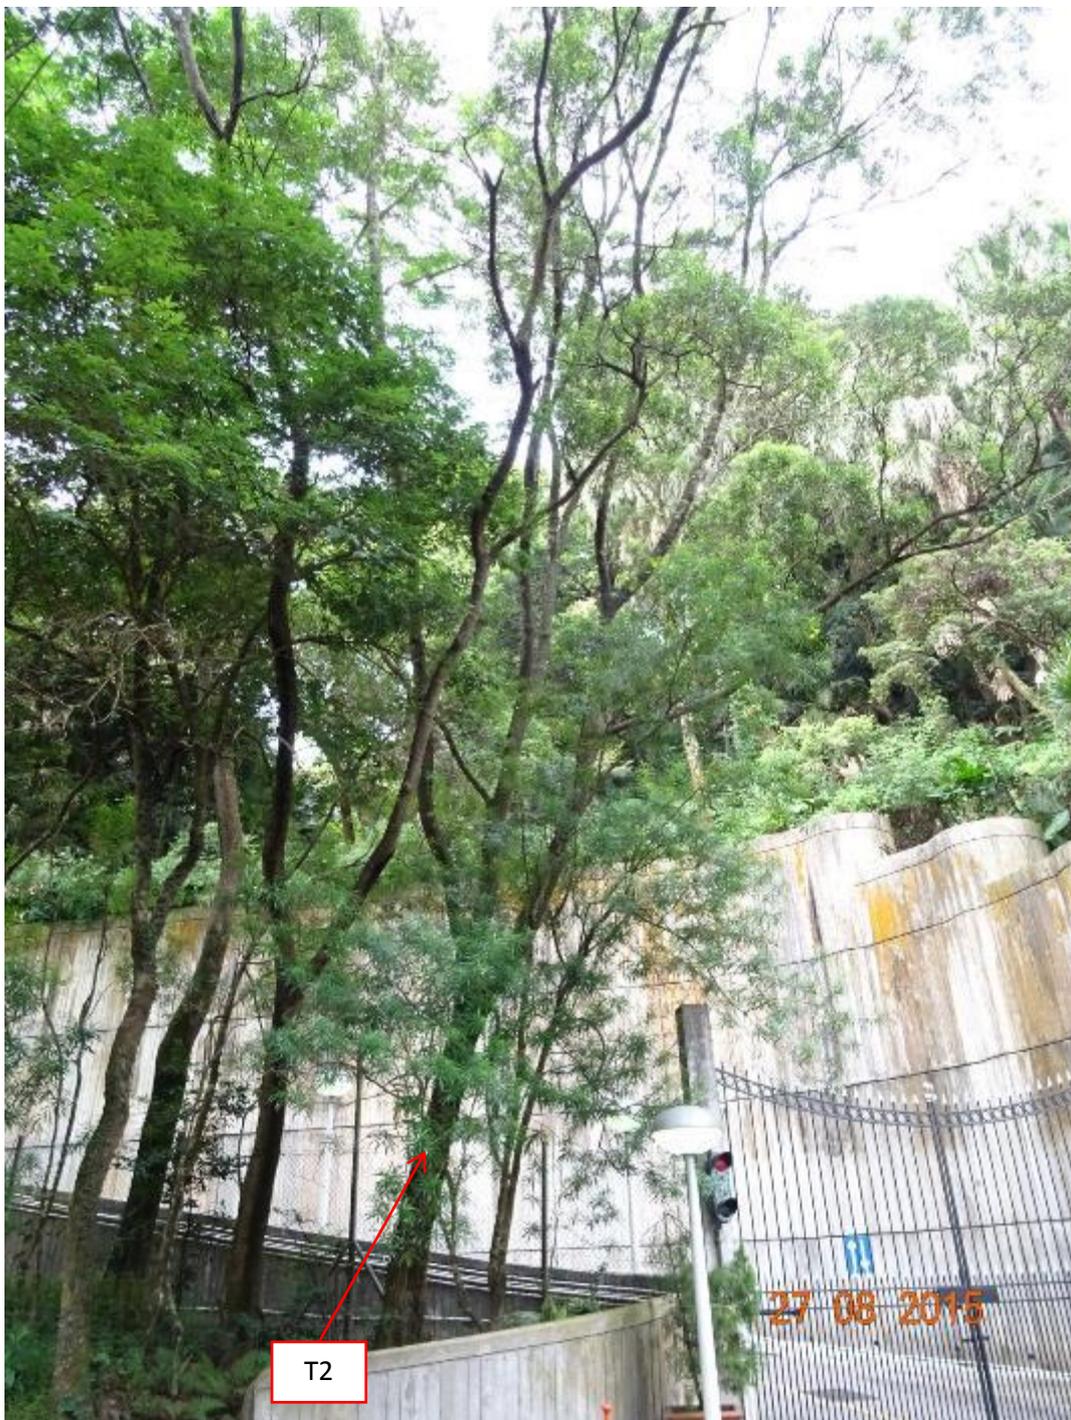
Overview of the subject tree T2. Due to high target rating (close to the gate), crown cleaning the dead branches are recommended.

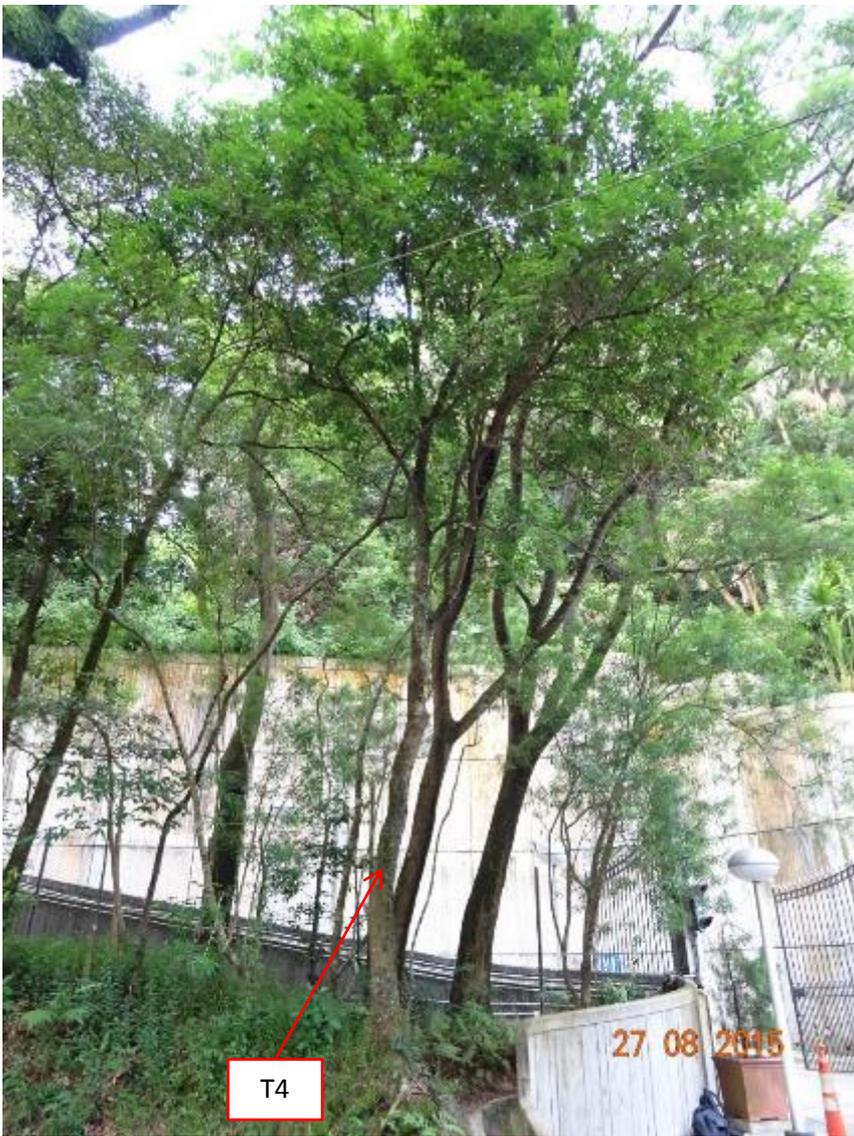
Overview of the subject tree T4.

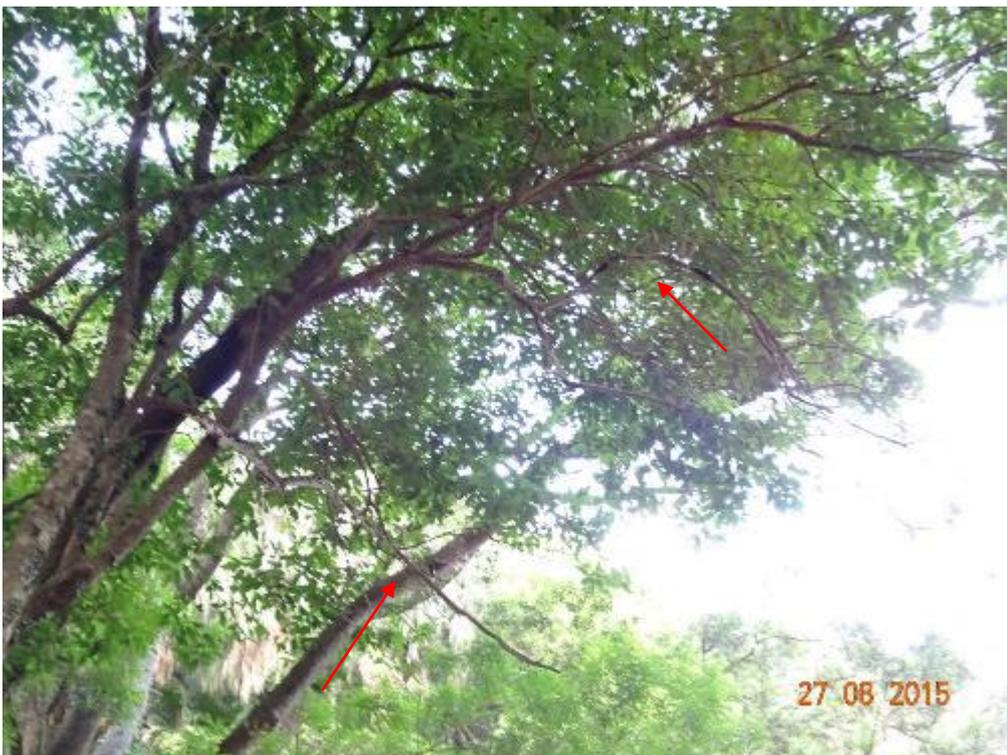
T4: Crown cleaning to remove dead branches is recommended.

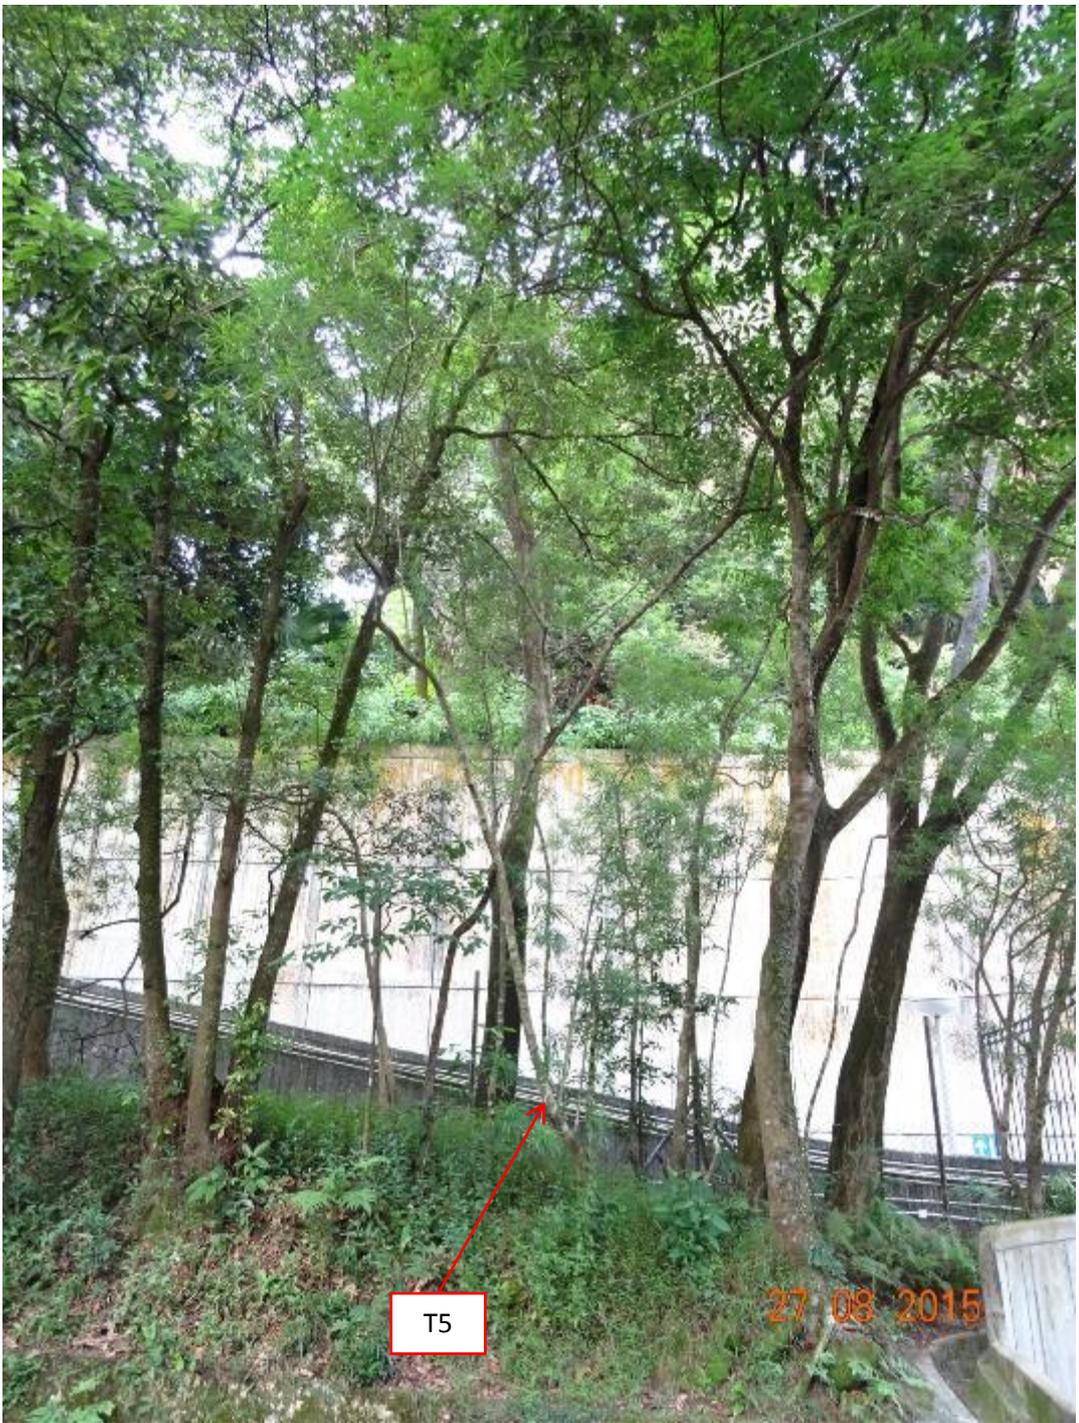
Overview of the subject tree T5. Crown cleaning is recommended.

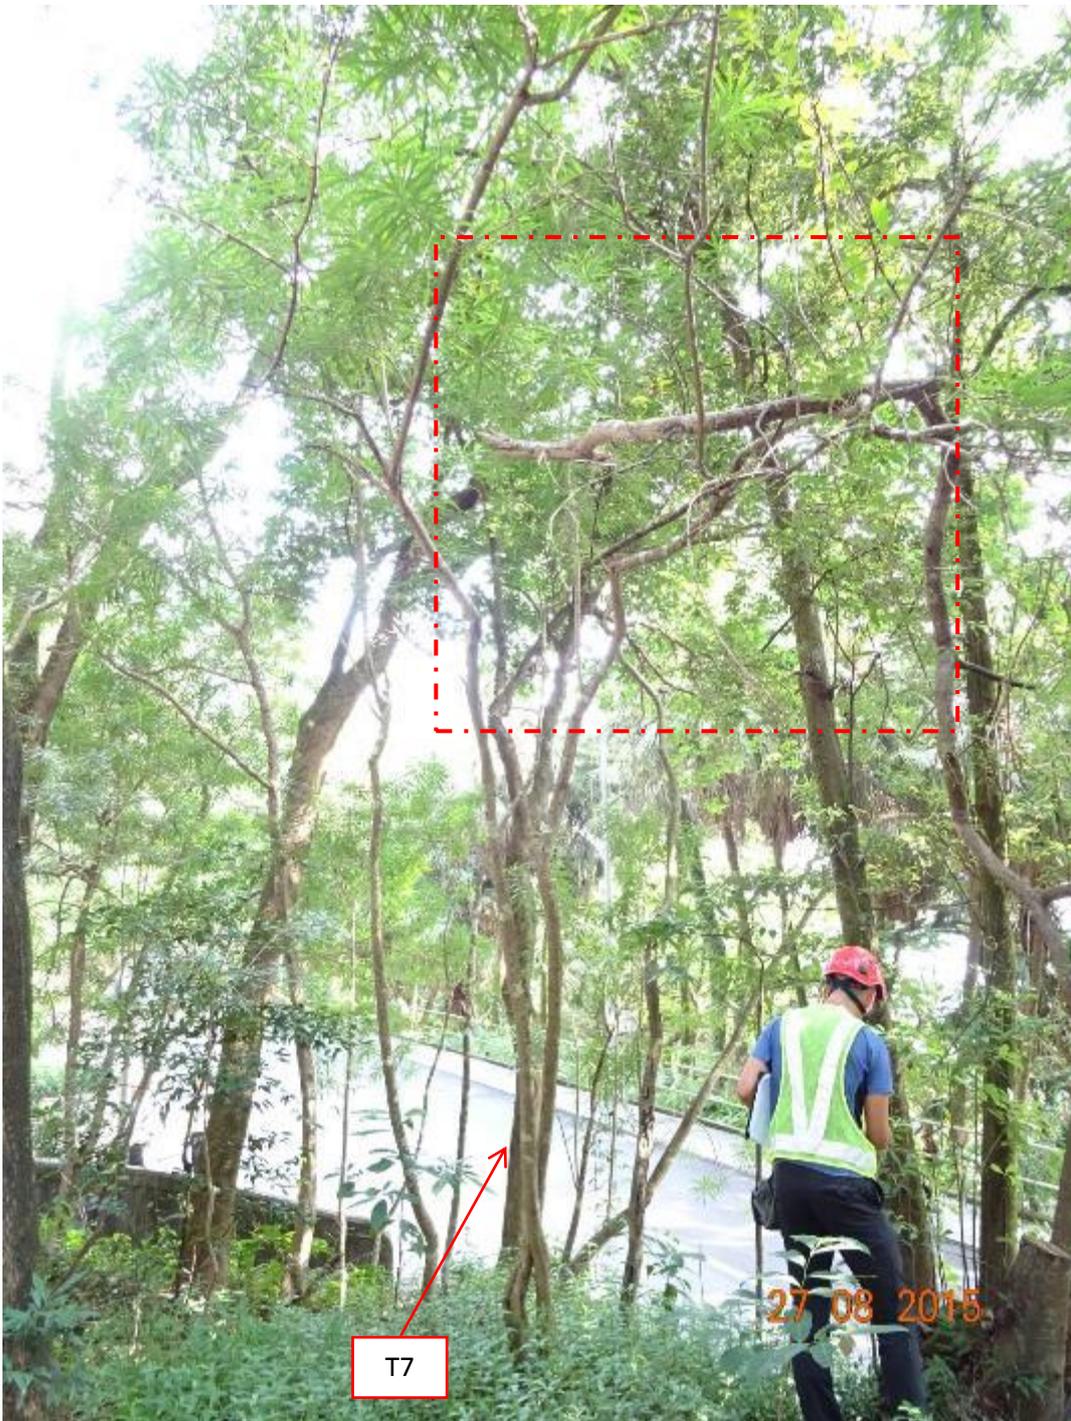
Overview of the subject tree T7. Remove the hanger is recommended.

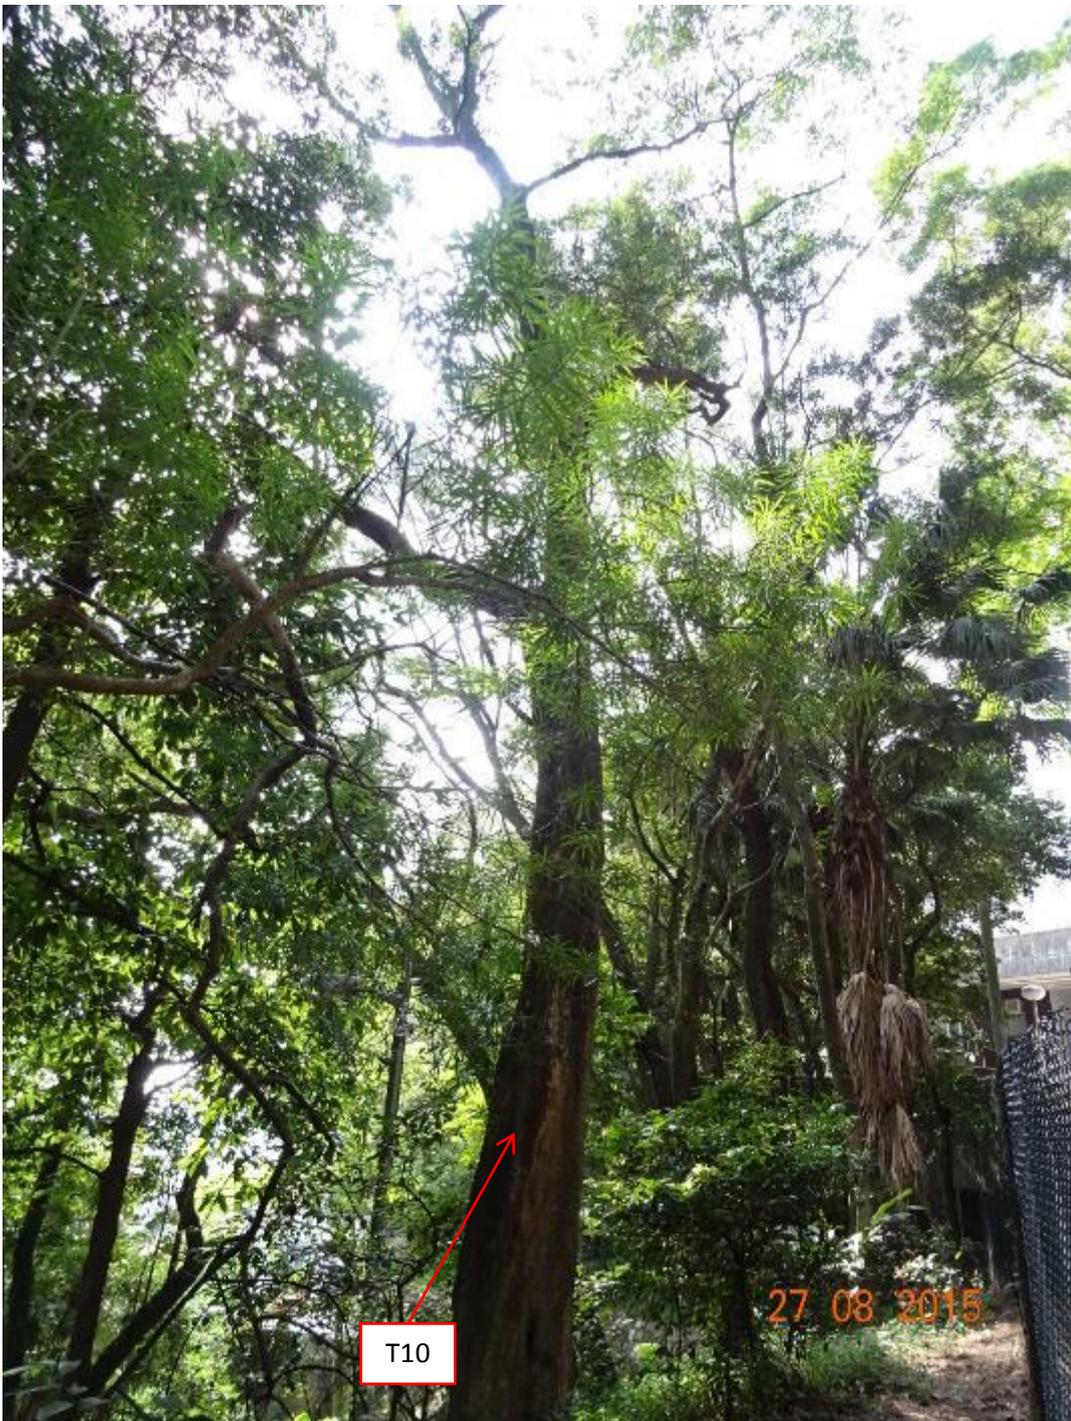
Overview of the subject tree T10. Crown cleaning is recommended.

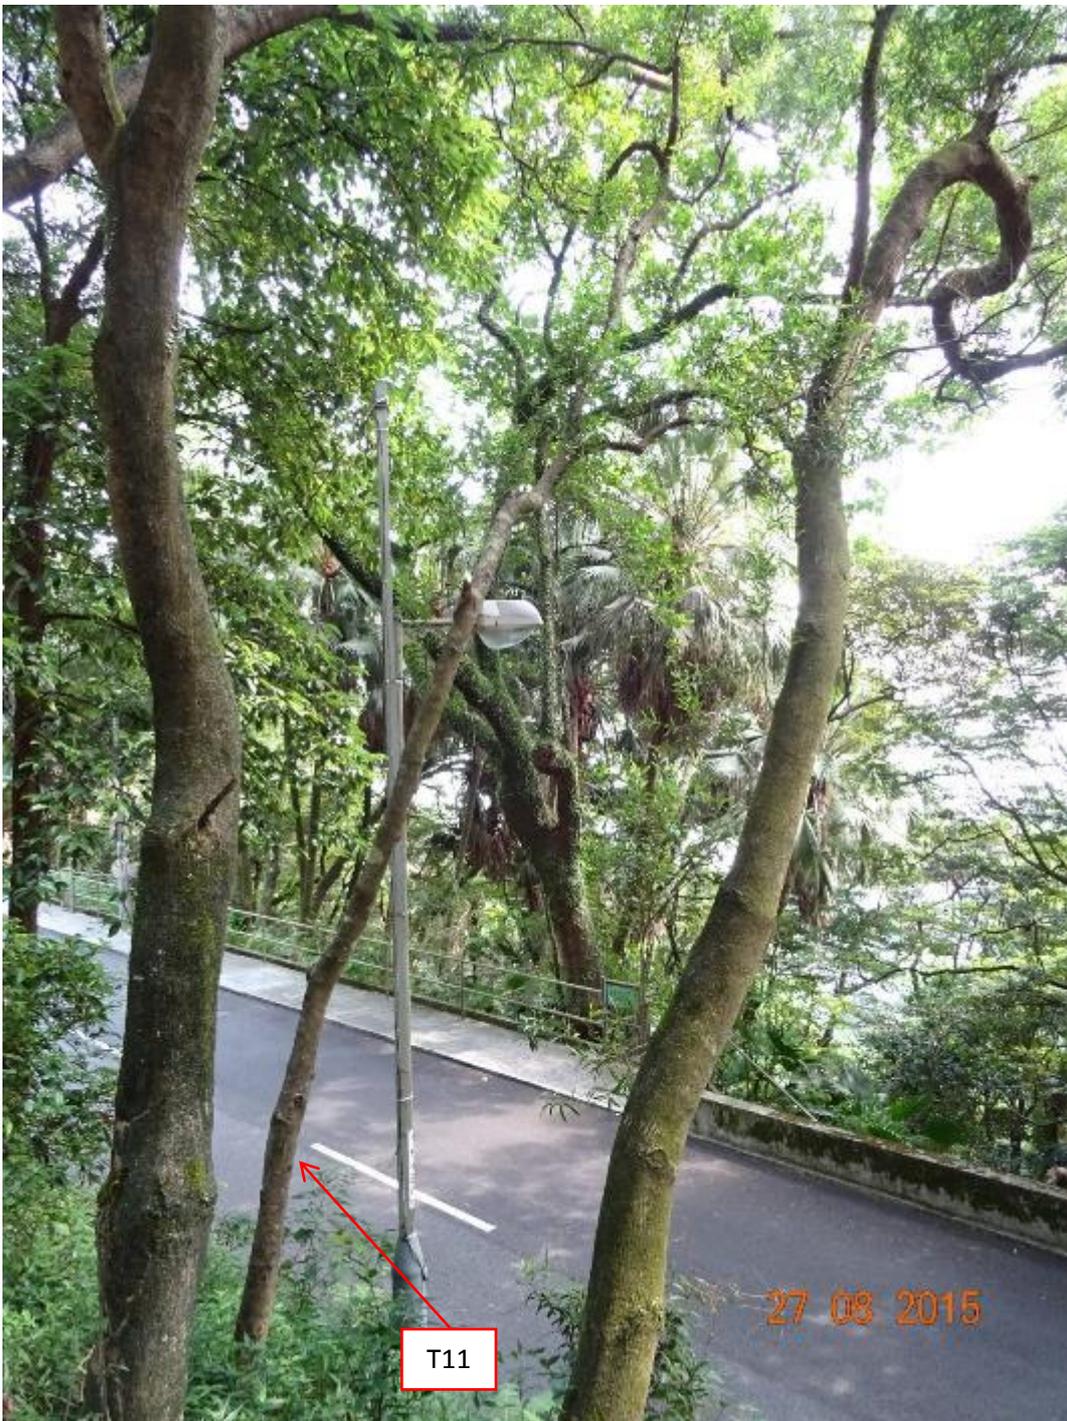
Overview of the subject tree T11. Crown cleaning is recommended.

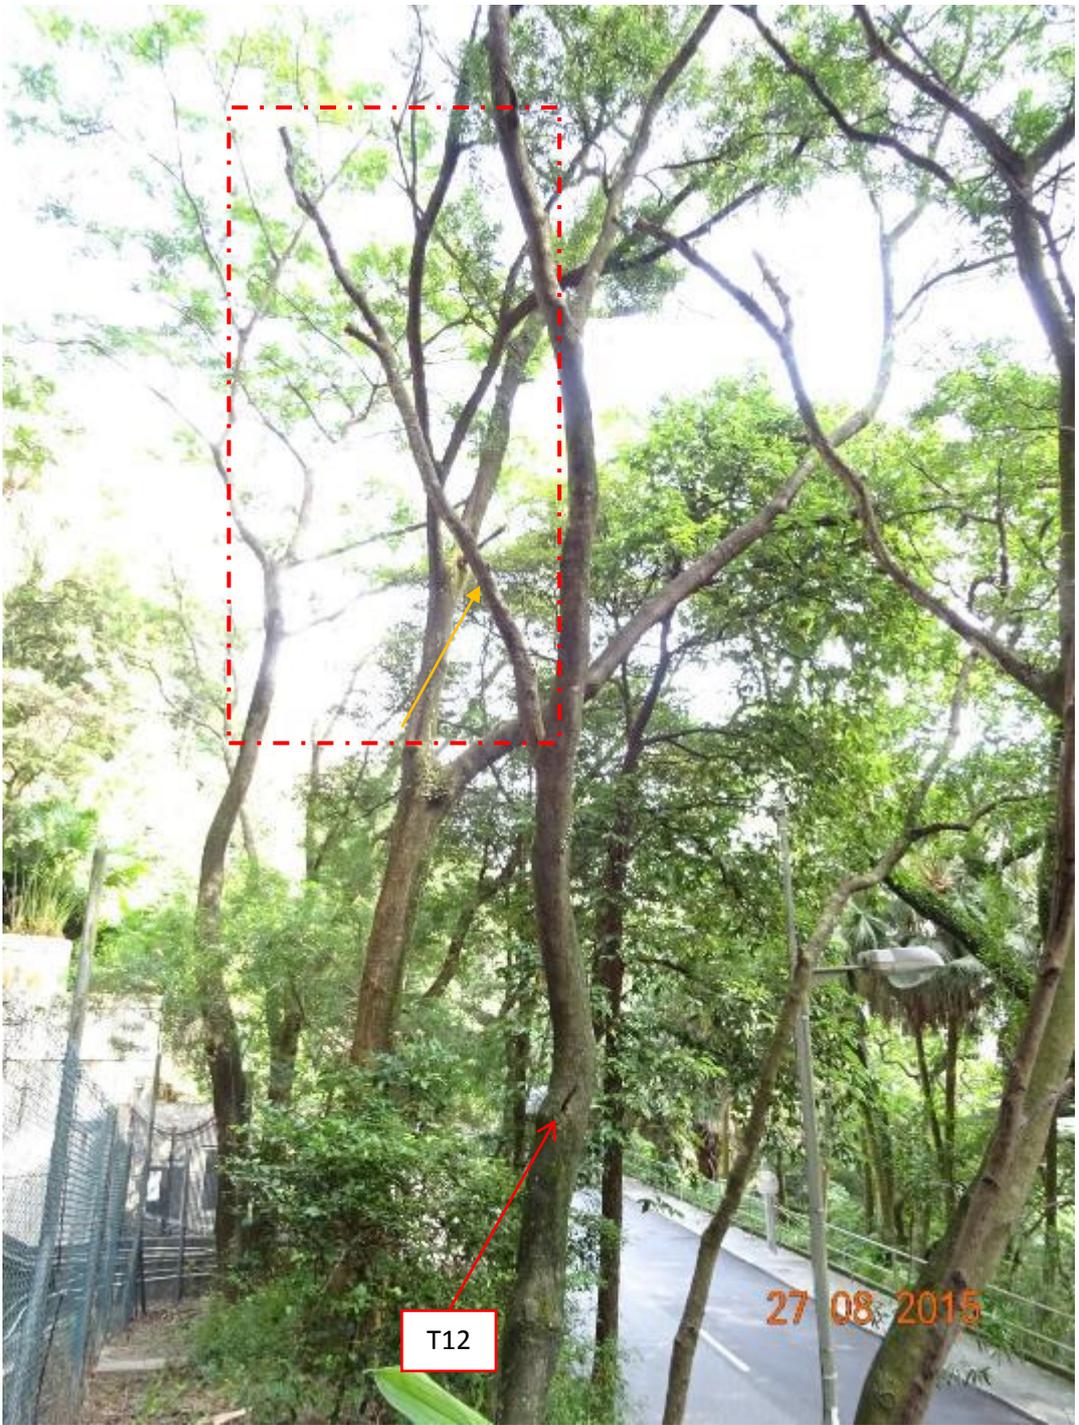
T12

Overview of the subject tree T12. Crown cleaning is recommended.

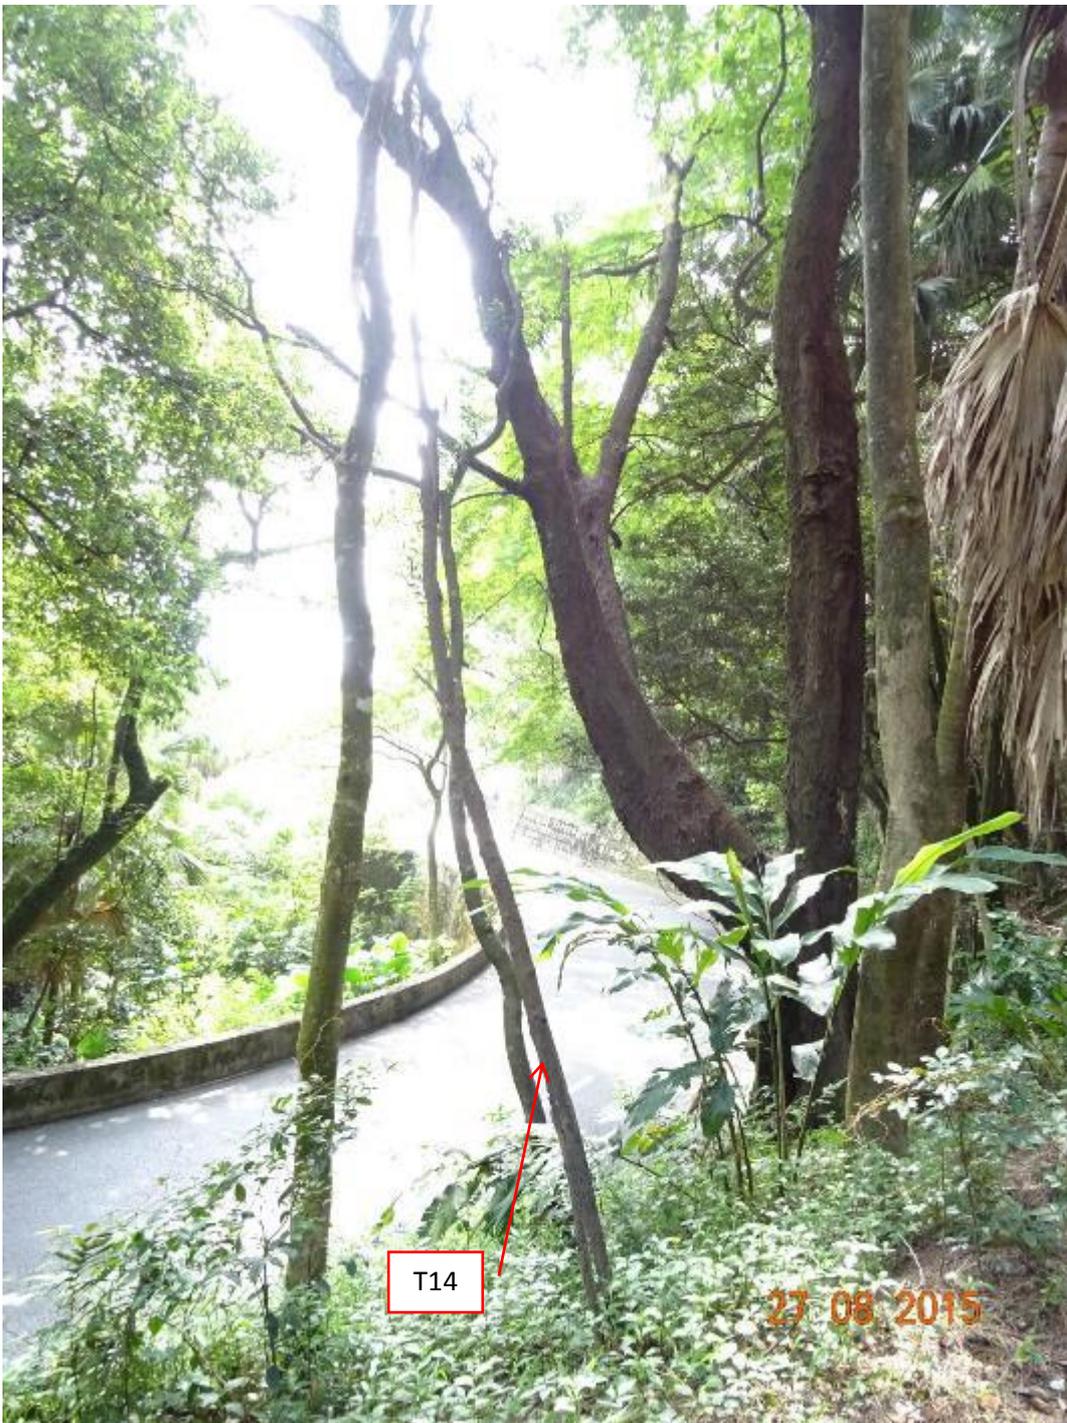
Overview of the subject tree T14. Removal the dead tree is recommended.

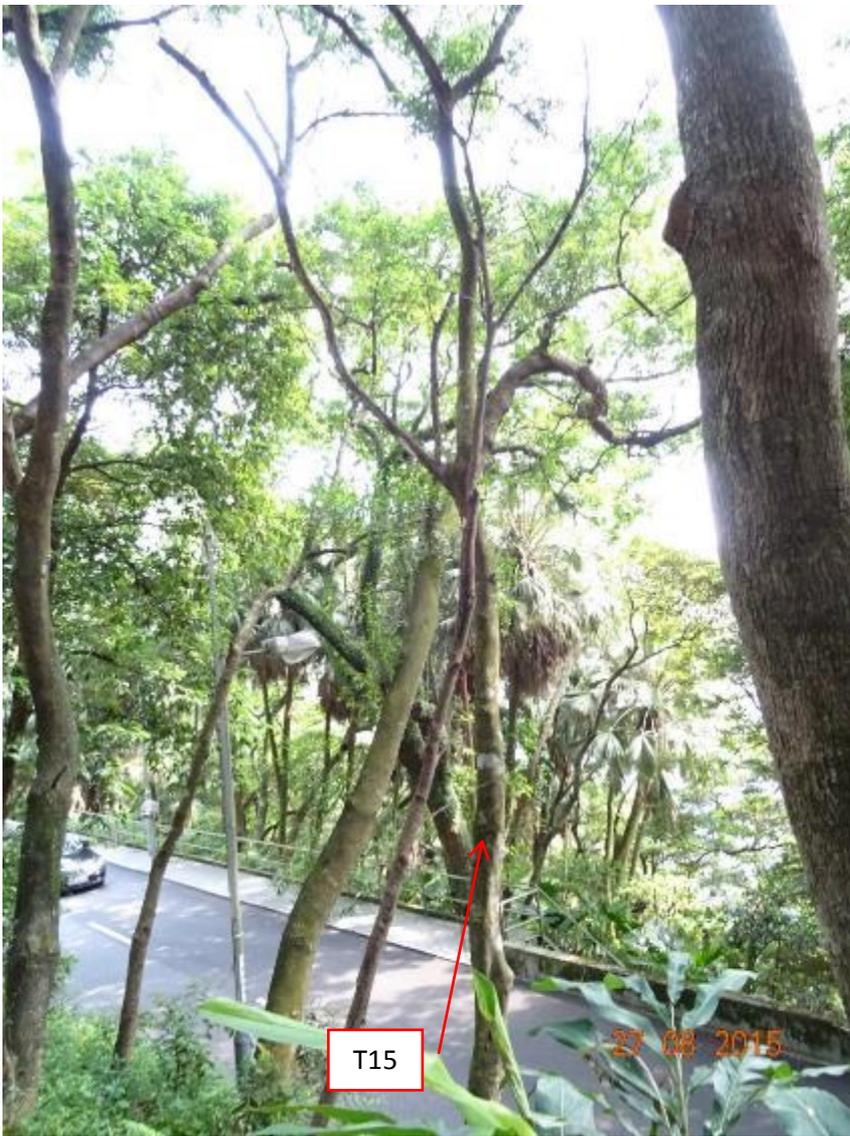
Overview of the subject tree T15. Crown cleaning is recommended.

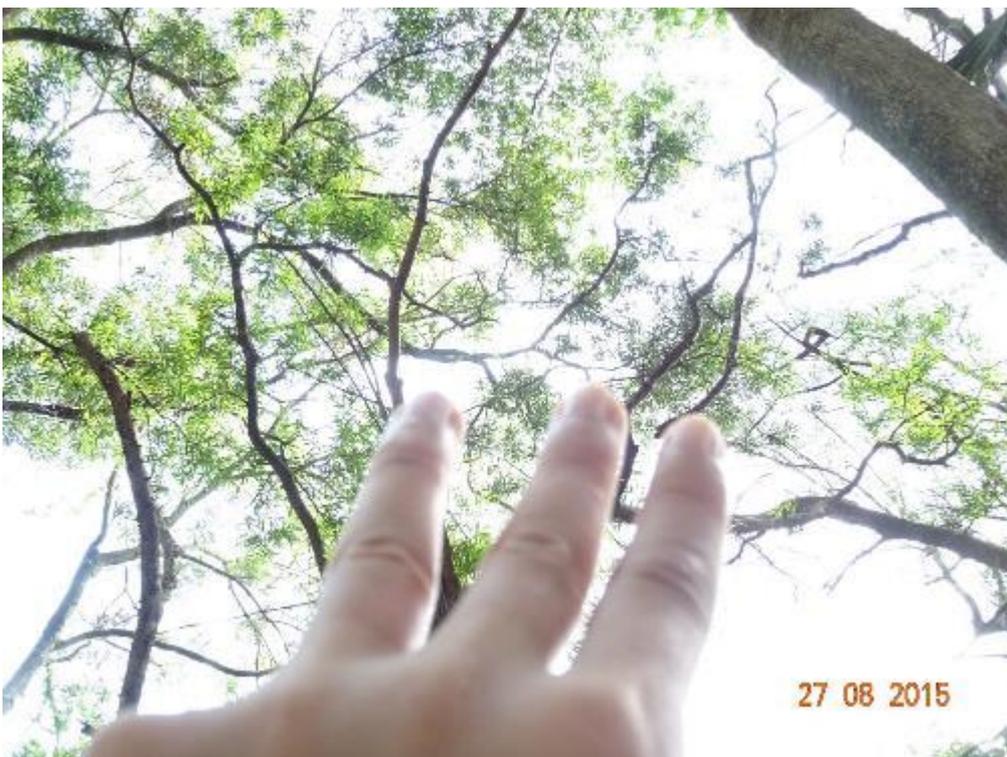
T15: Remove the dead branches is recommended.

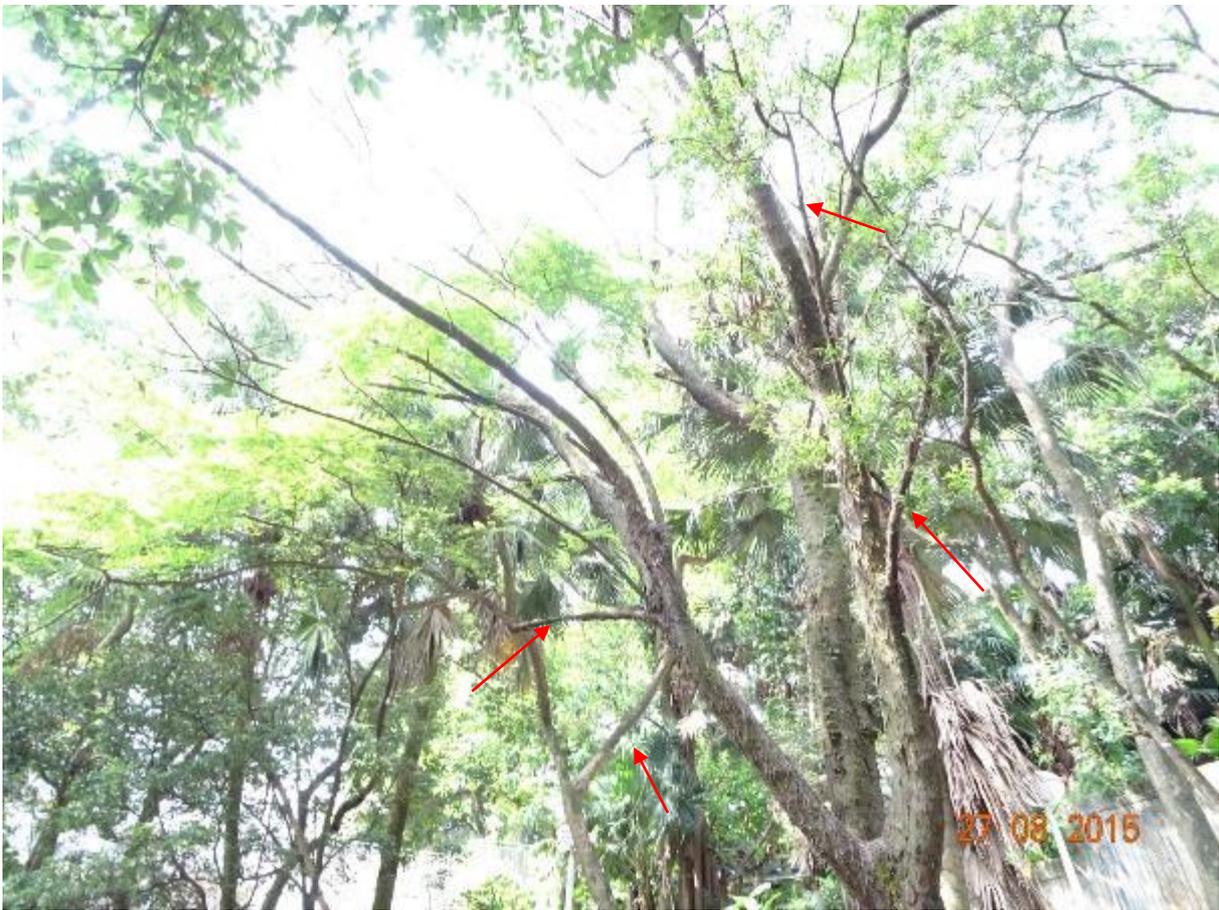
T19: Remove the dead branches close to the road is recommended.

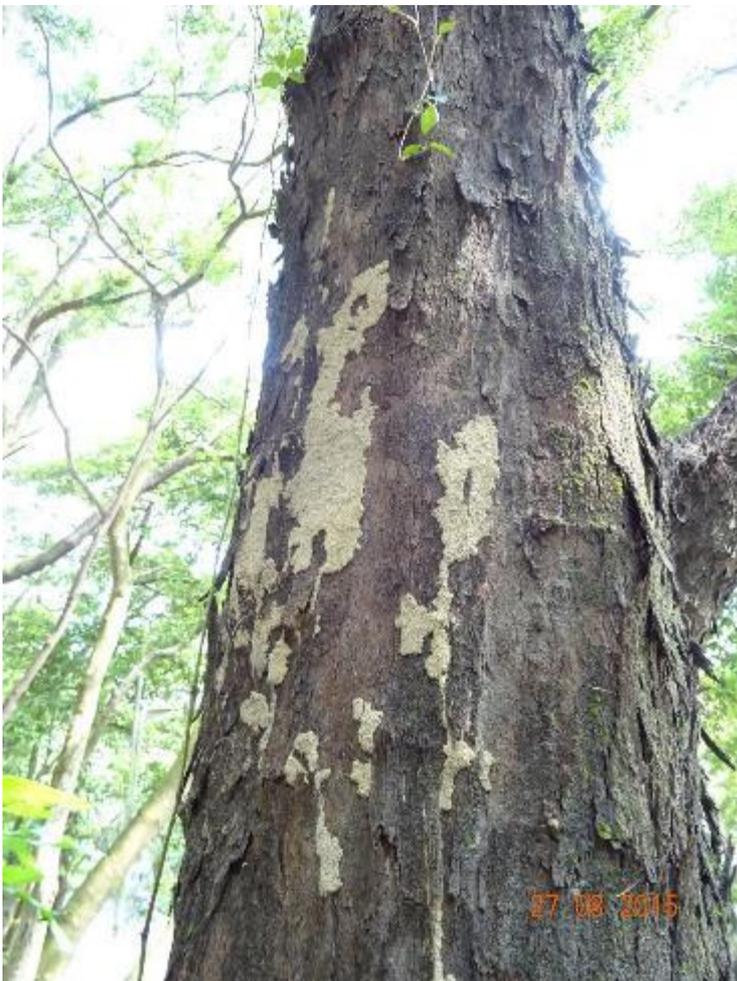
T19: Mud tube is observed along the trunk. But no active termite is noted.

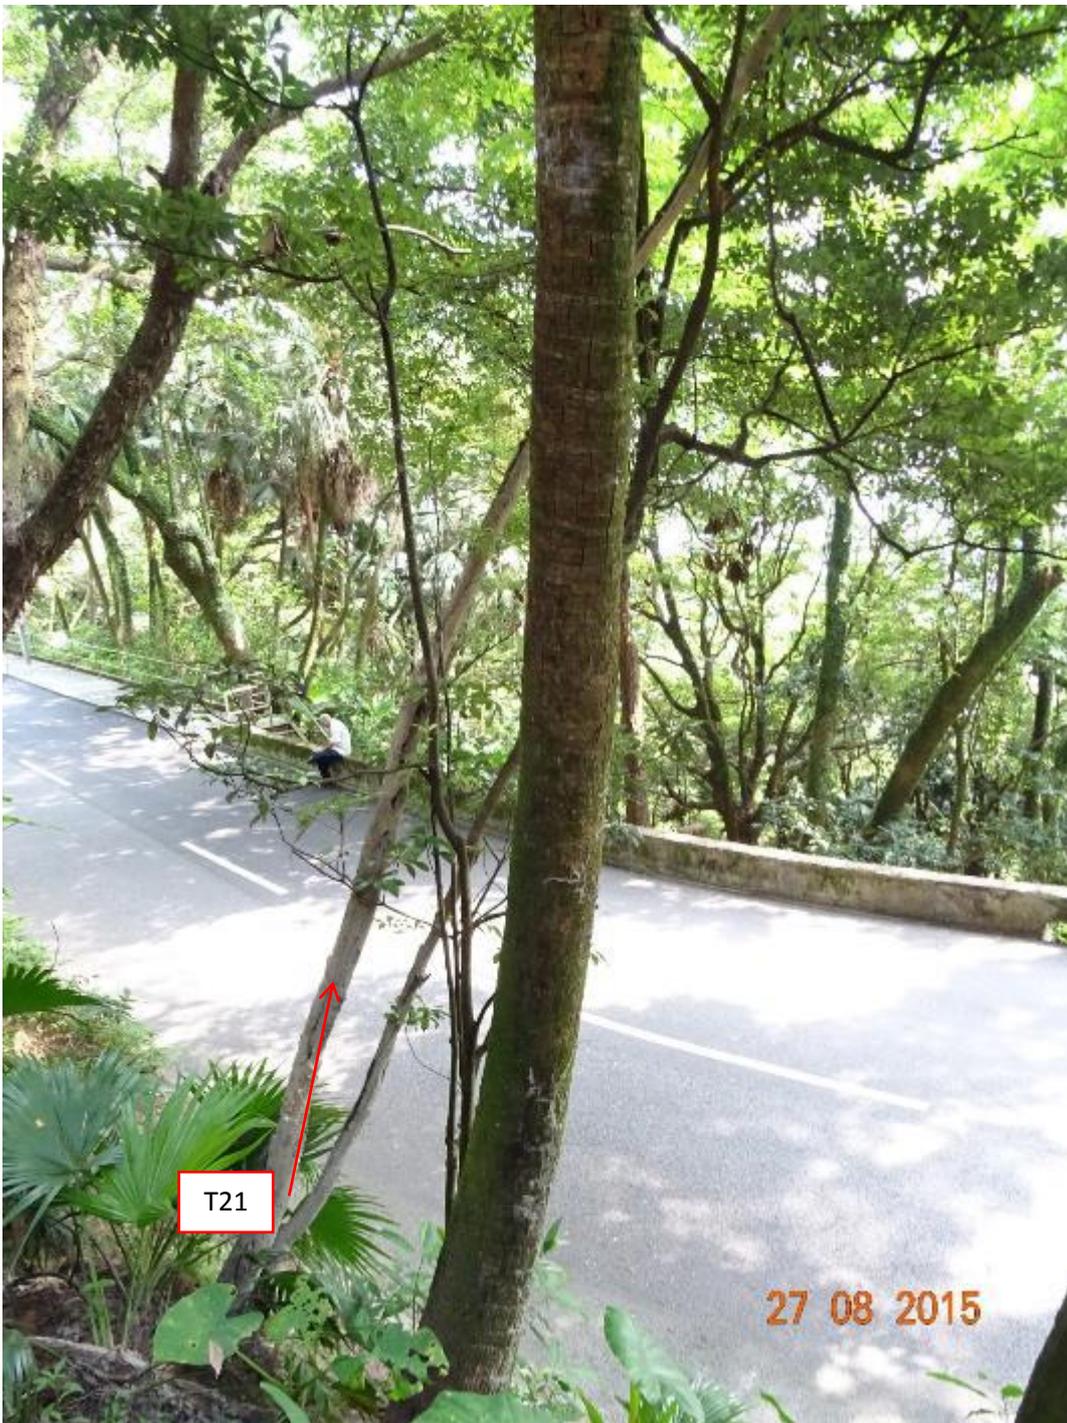
Overview of the subject tree T21. Remove the dead tree is recommended (Close to the road, high target rating).

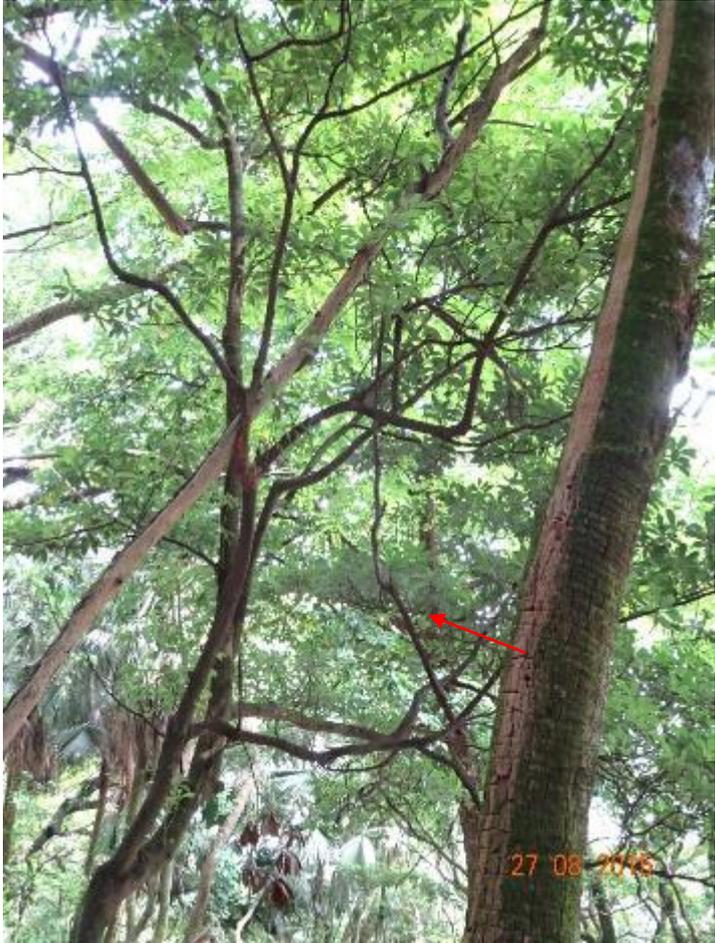
T22: Remove the hanger is recommended.

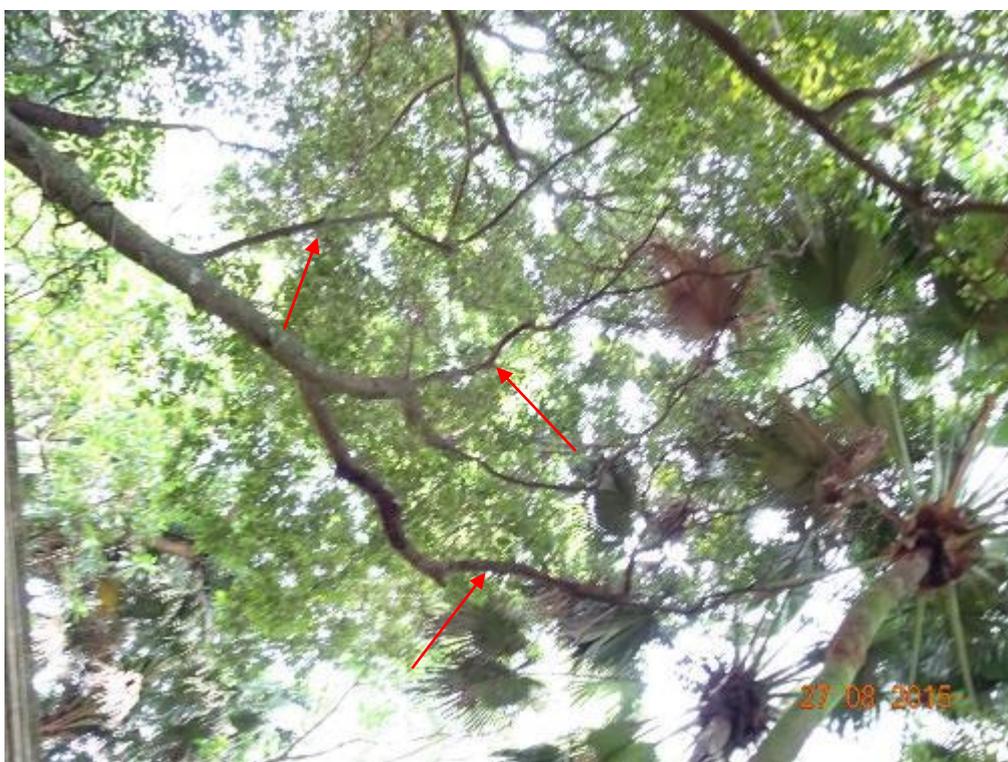
T25: Crown cleaning is recommended.

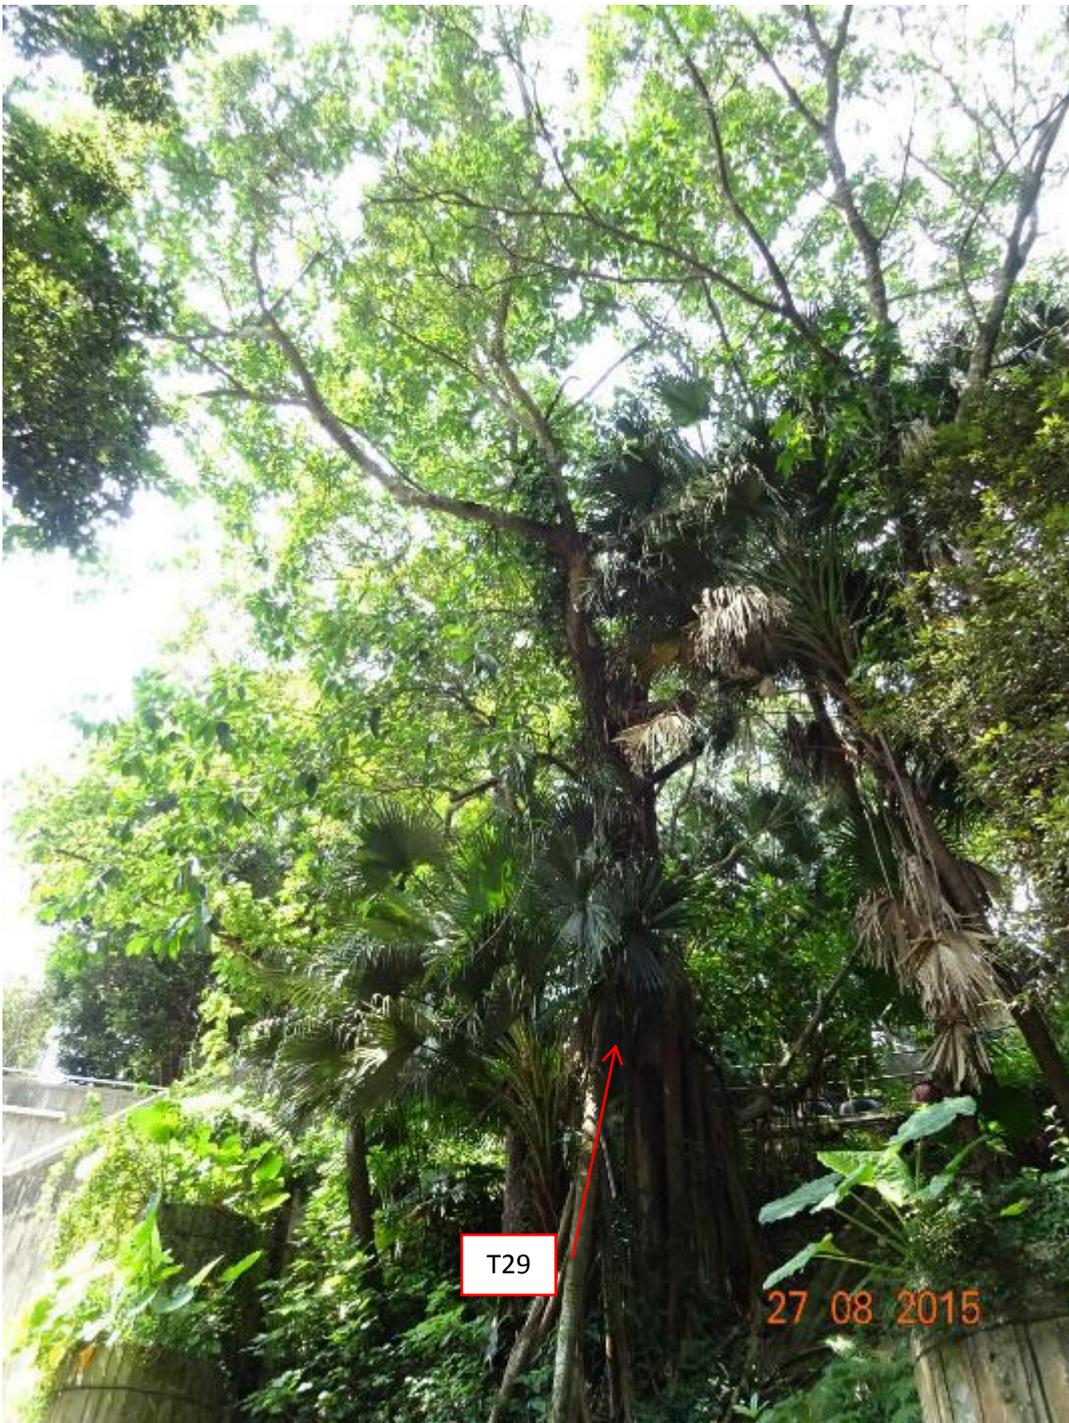
Overview of the subject tree T29. Crown cleaning is recommended.
