Scope of Work
Trim and removal of trees
away from security fence and
alongside Barker Road

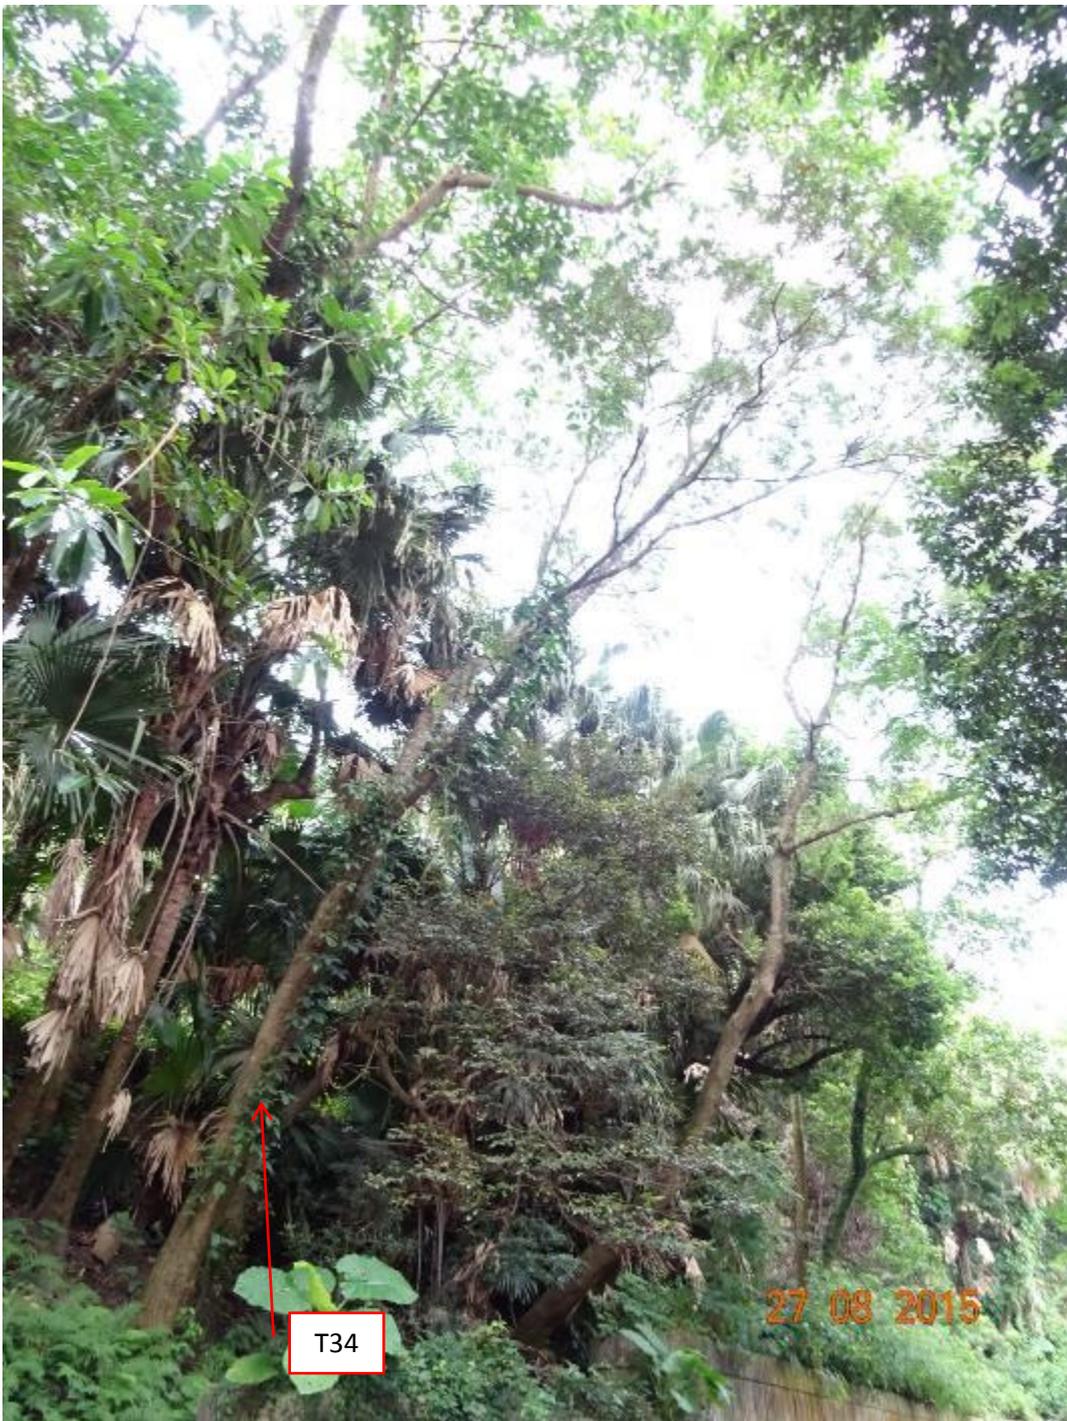
Overview of the subject tree T34. Crown cleaning is recommended.

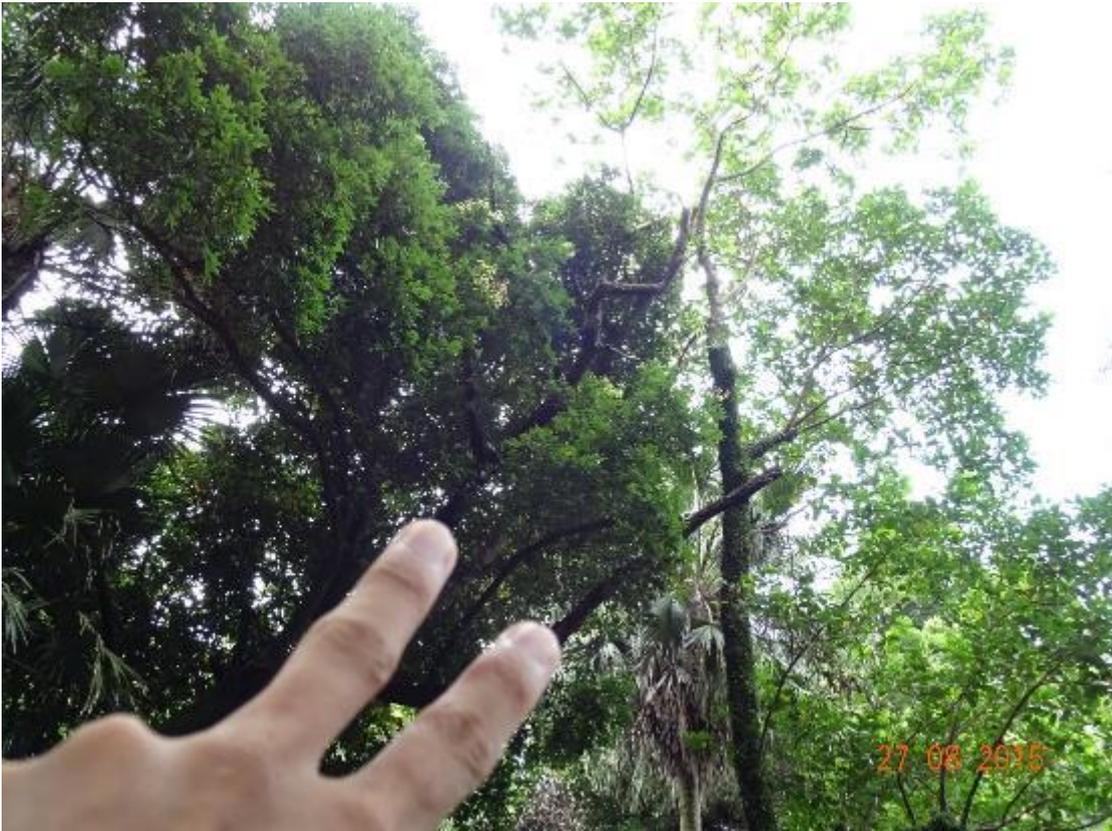
T41: Remove two large dead branches above walkway is recommended.

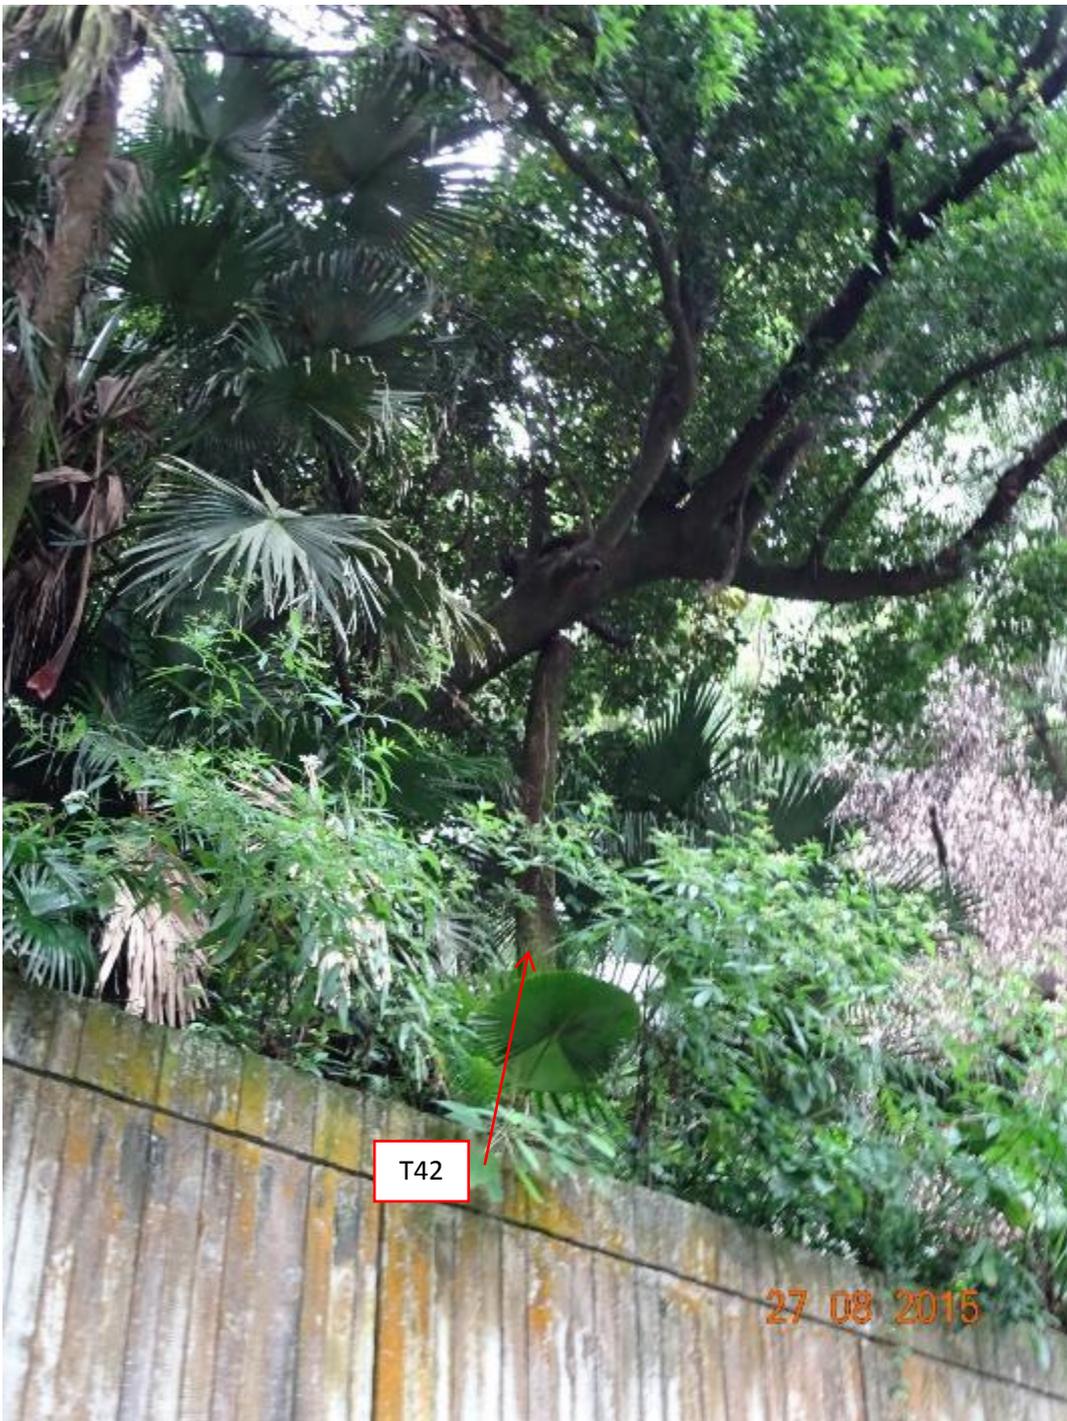
Overview of the subject tree T42. Remove this dead palm is recommended.

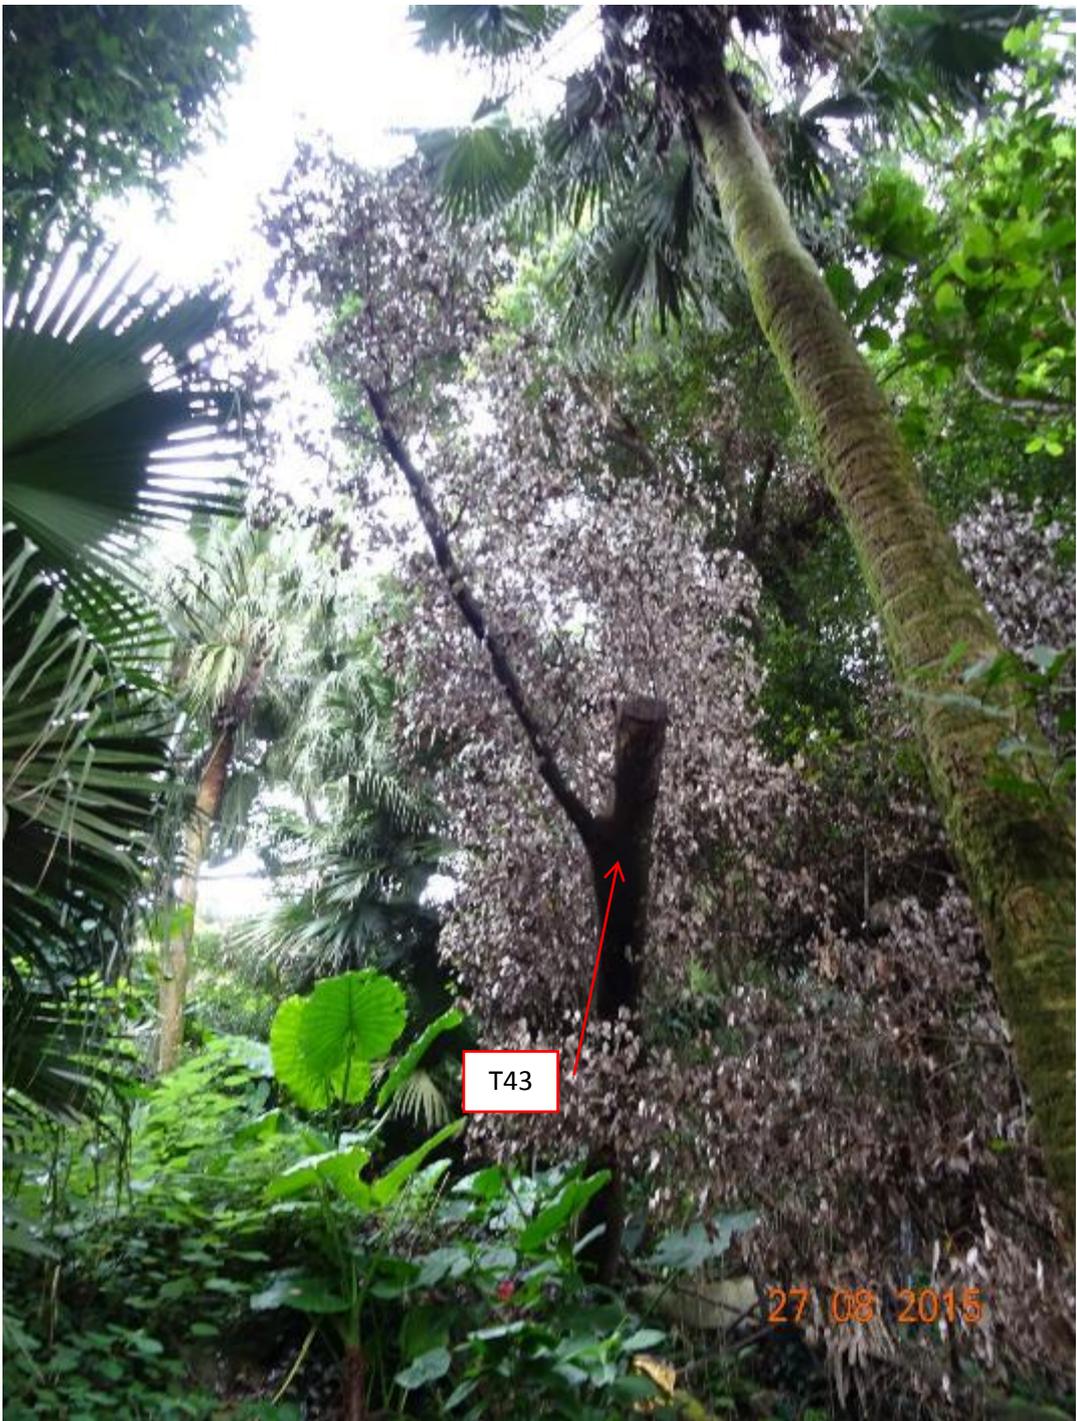
Overview of the subject tree T43. Remove the dead tree is recommended.

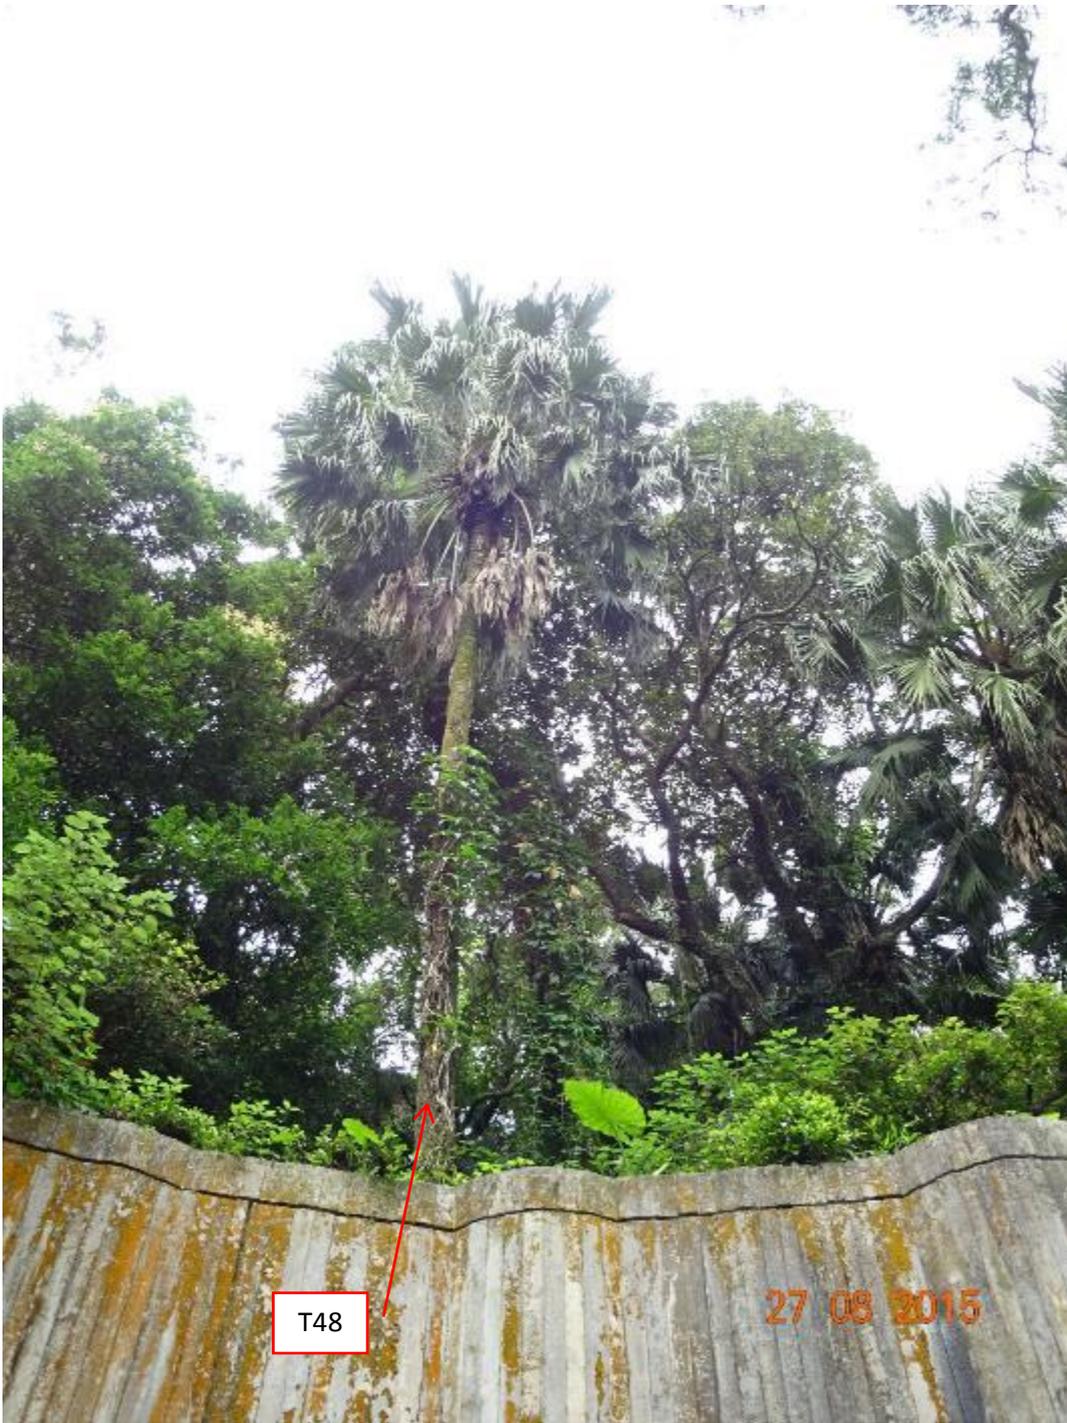
Overview of the subject tree T48. Crown cleaning is recommended.

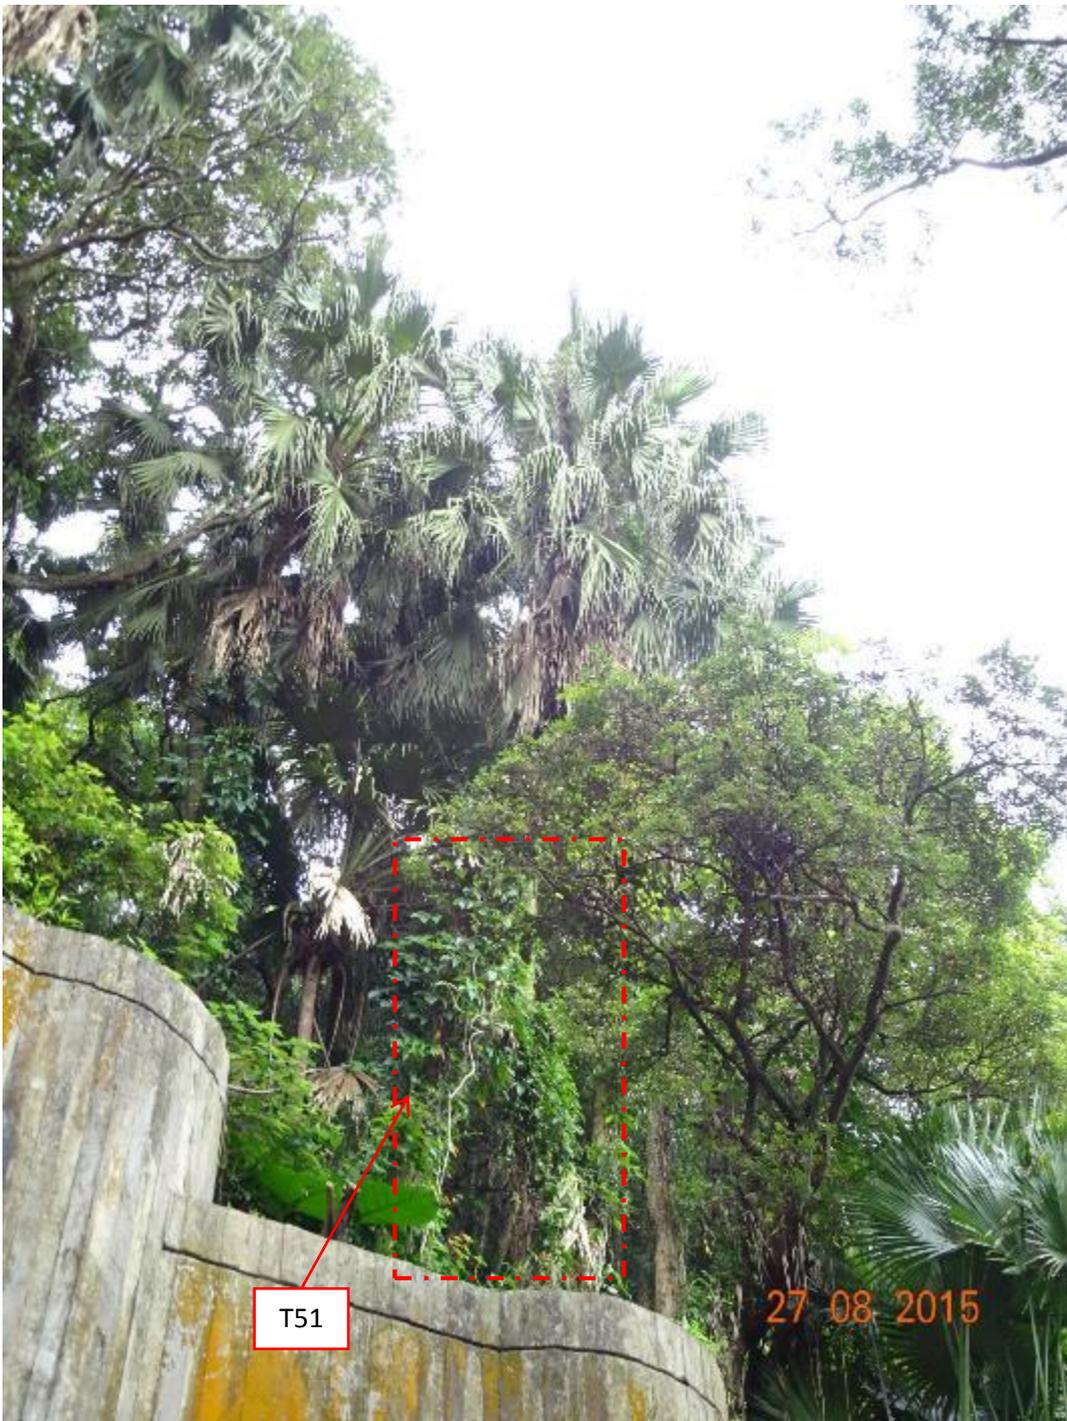
Overview of the subject tree T51. Remove the climber is recommended.

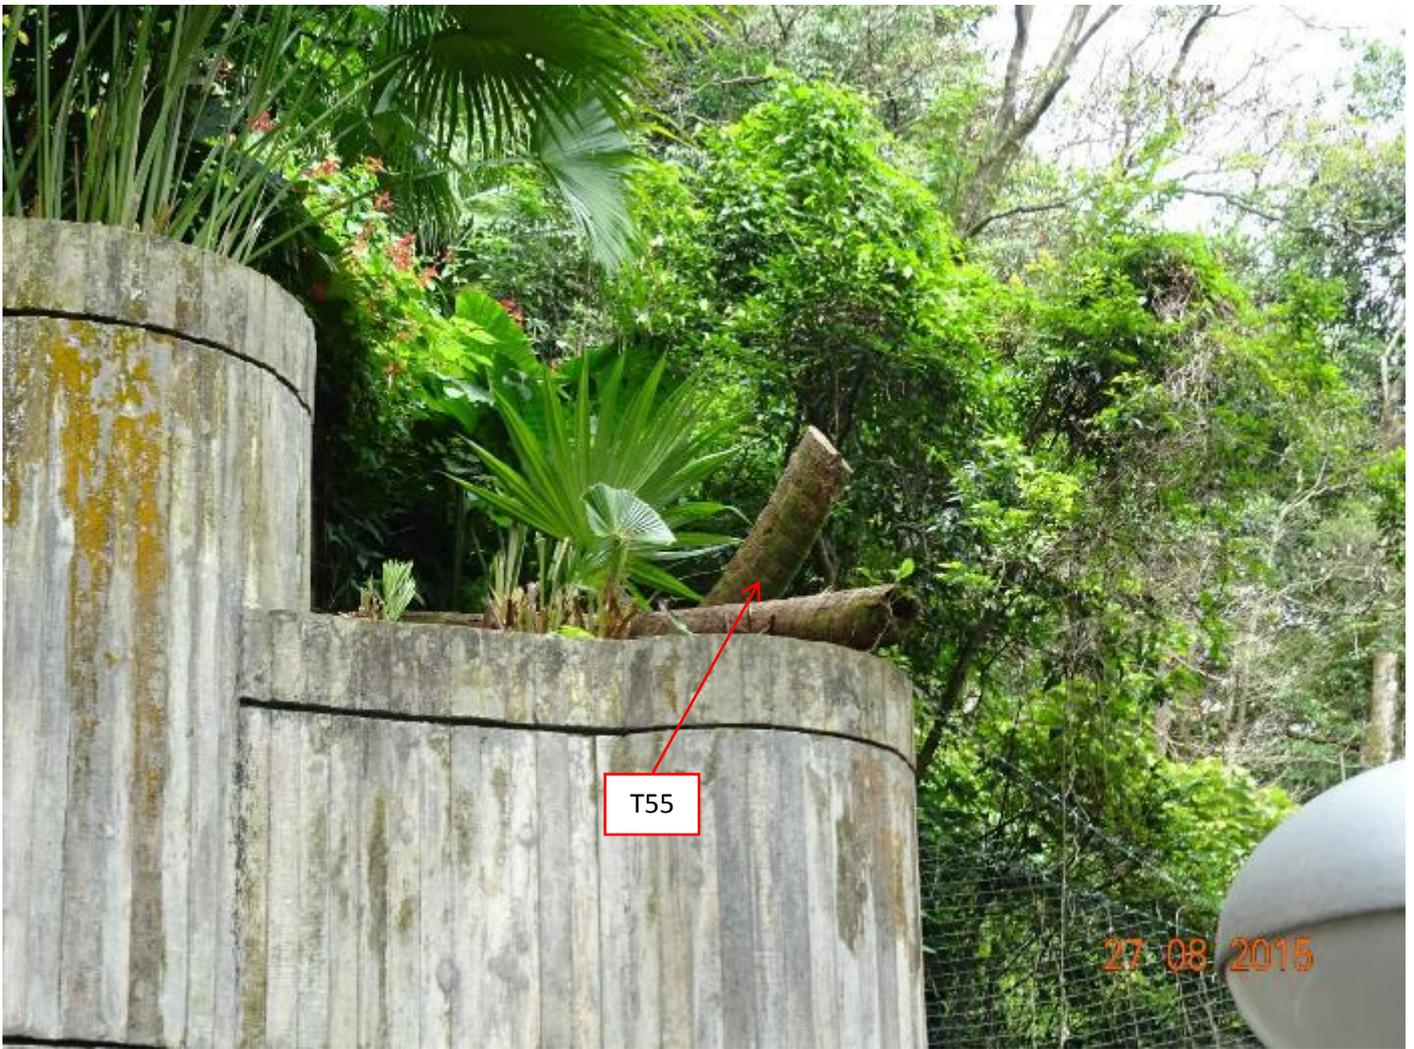
Overview of the subject tree T55. Removal is recommended.

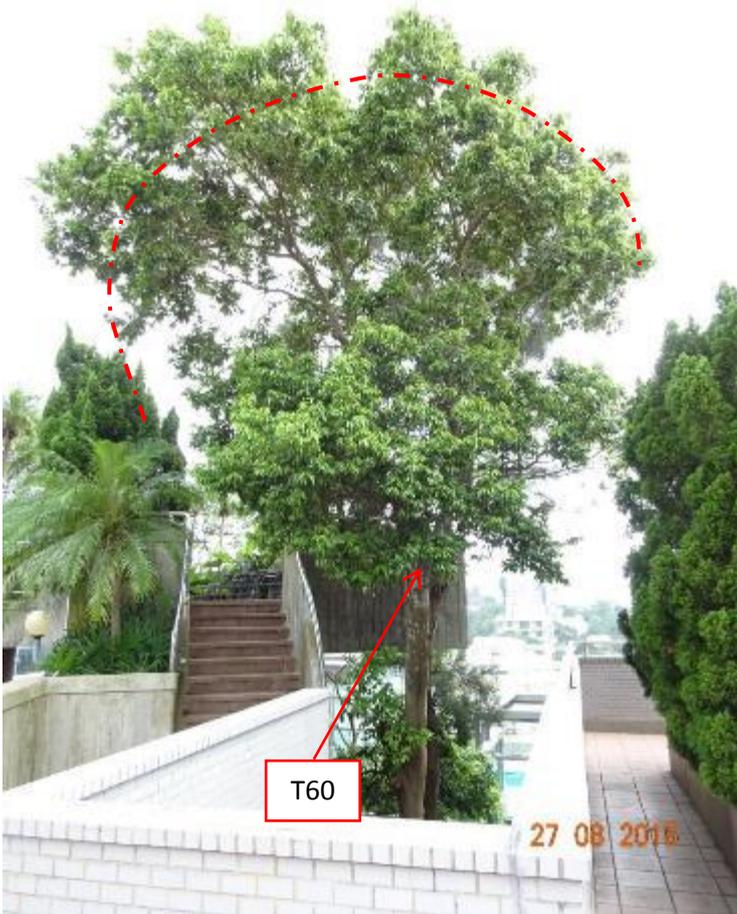
Overview of the subject tree T60. Crown reduction to reduce the lever arm (expose to the wind) is recommended.

T60: Poor taper form to withstand the wind.

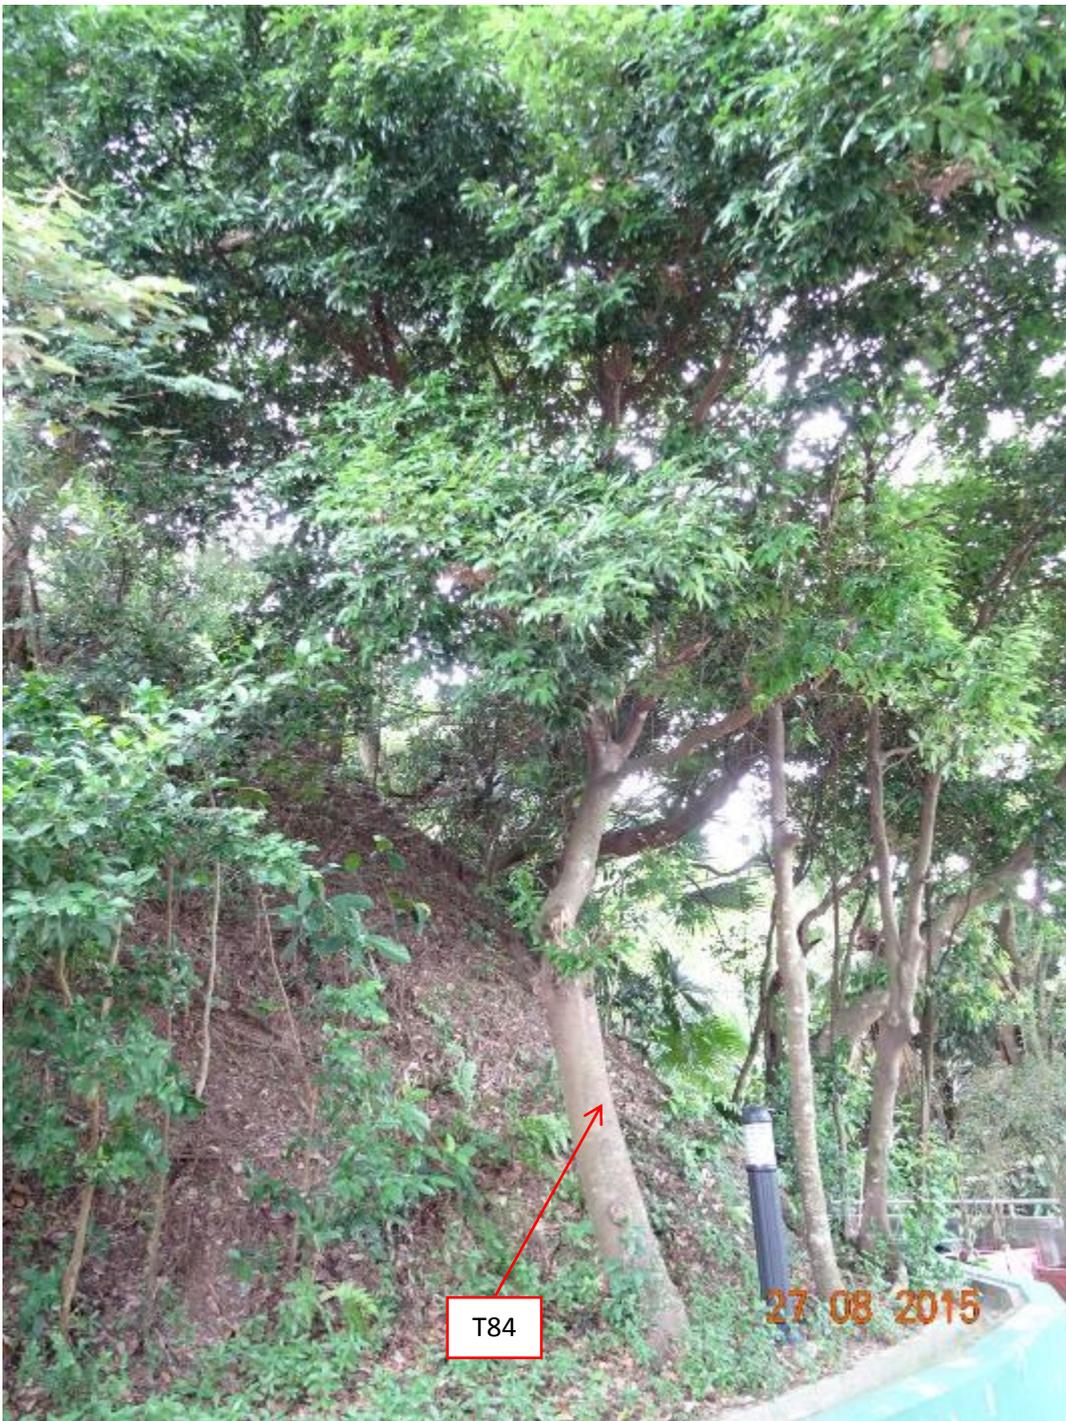
Overview of the subject tree T84. Crown cleaning is recommended.

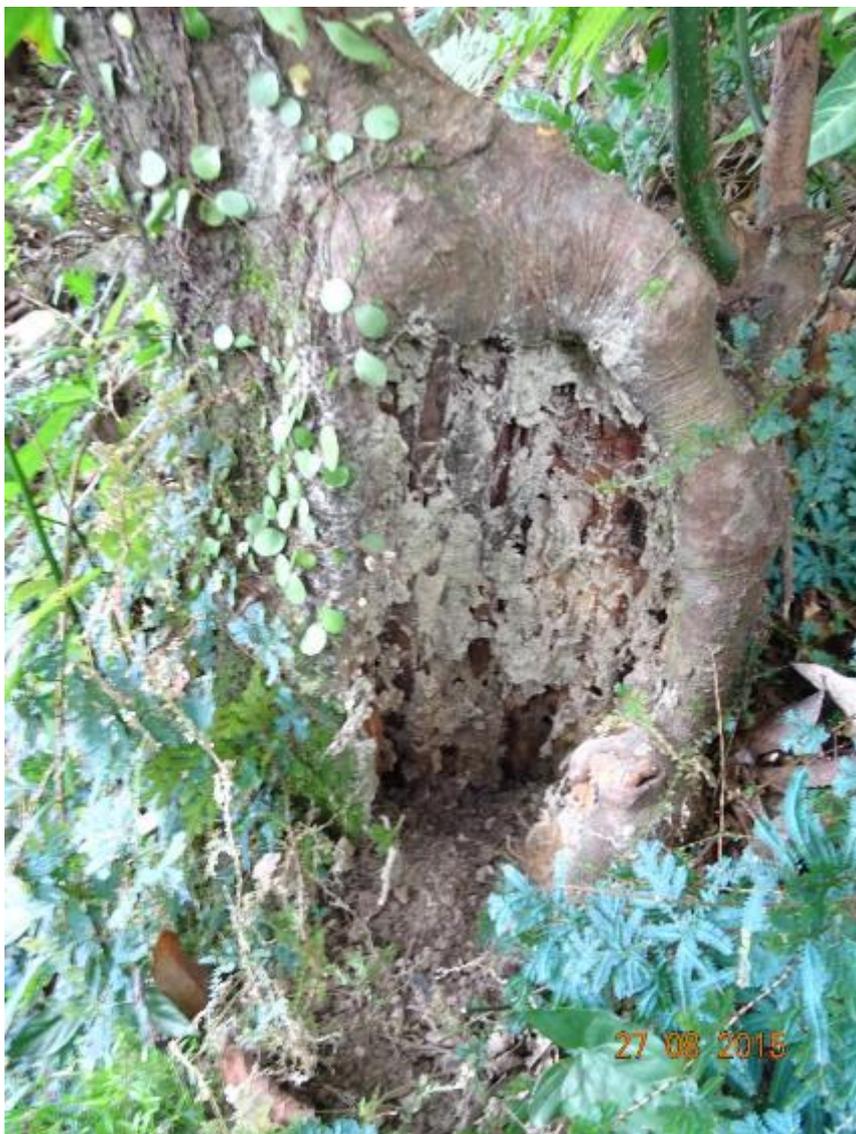
T88: Decay cavity is observed at the trunk base. Form 2 tree assessment is recommended.

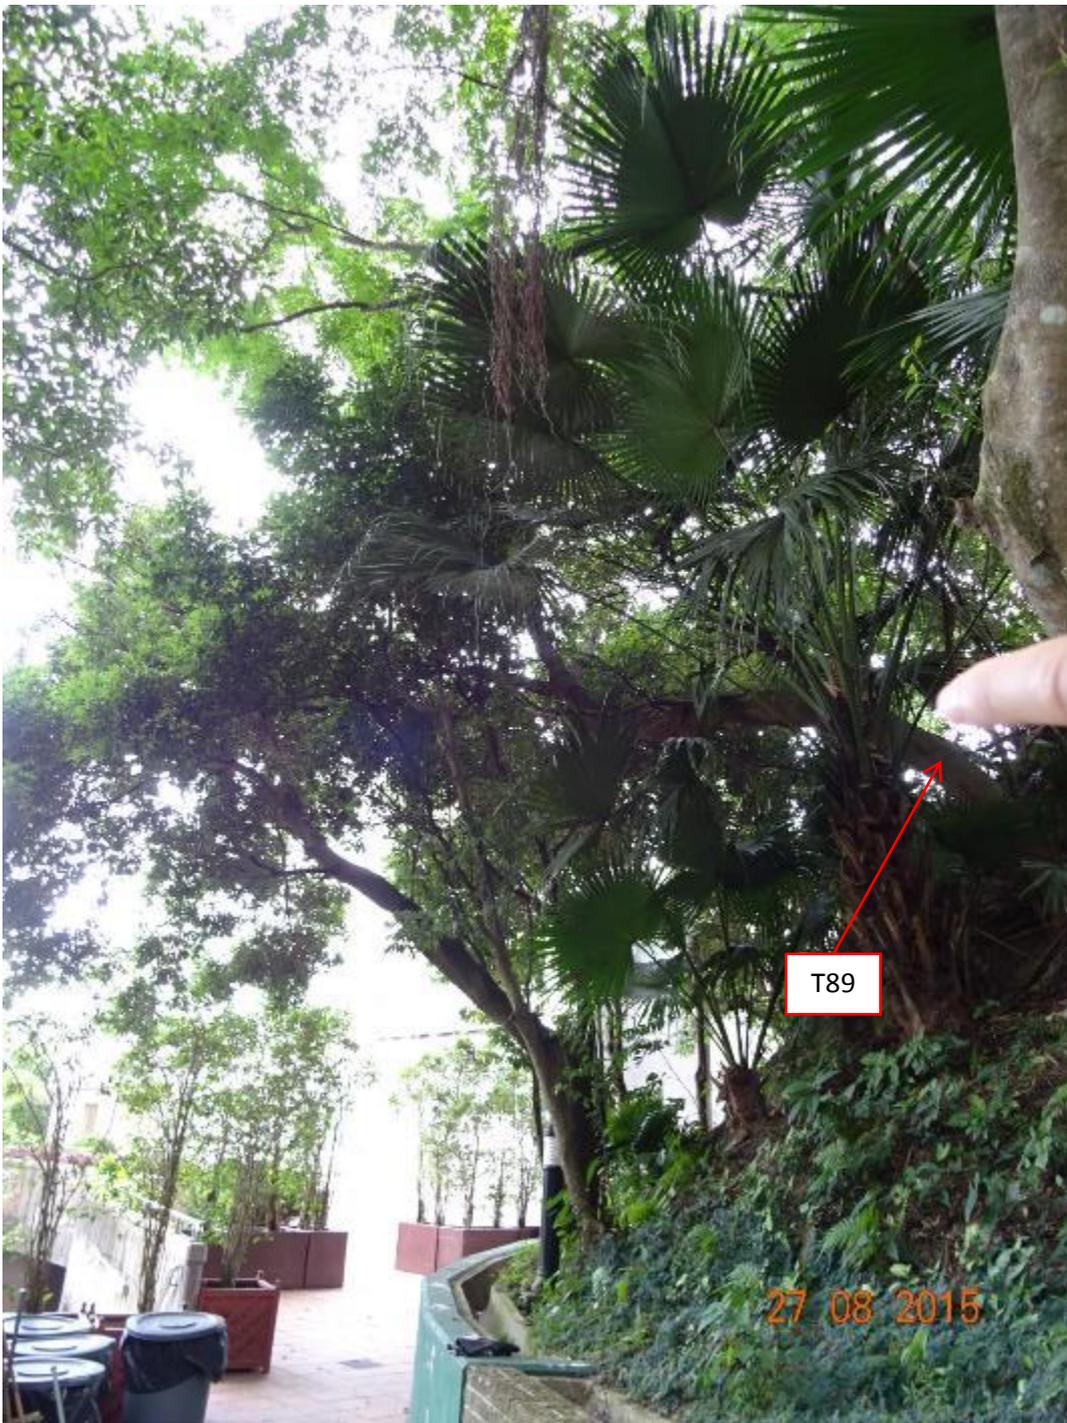
Overview of the subject tree T89. Crown cleaning is recommended.

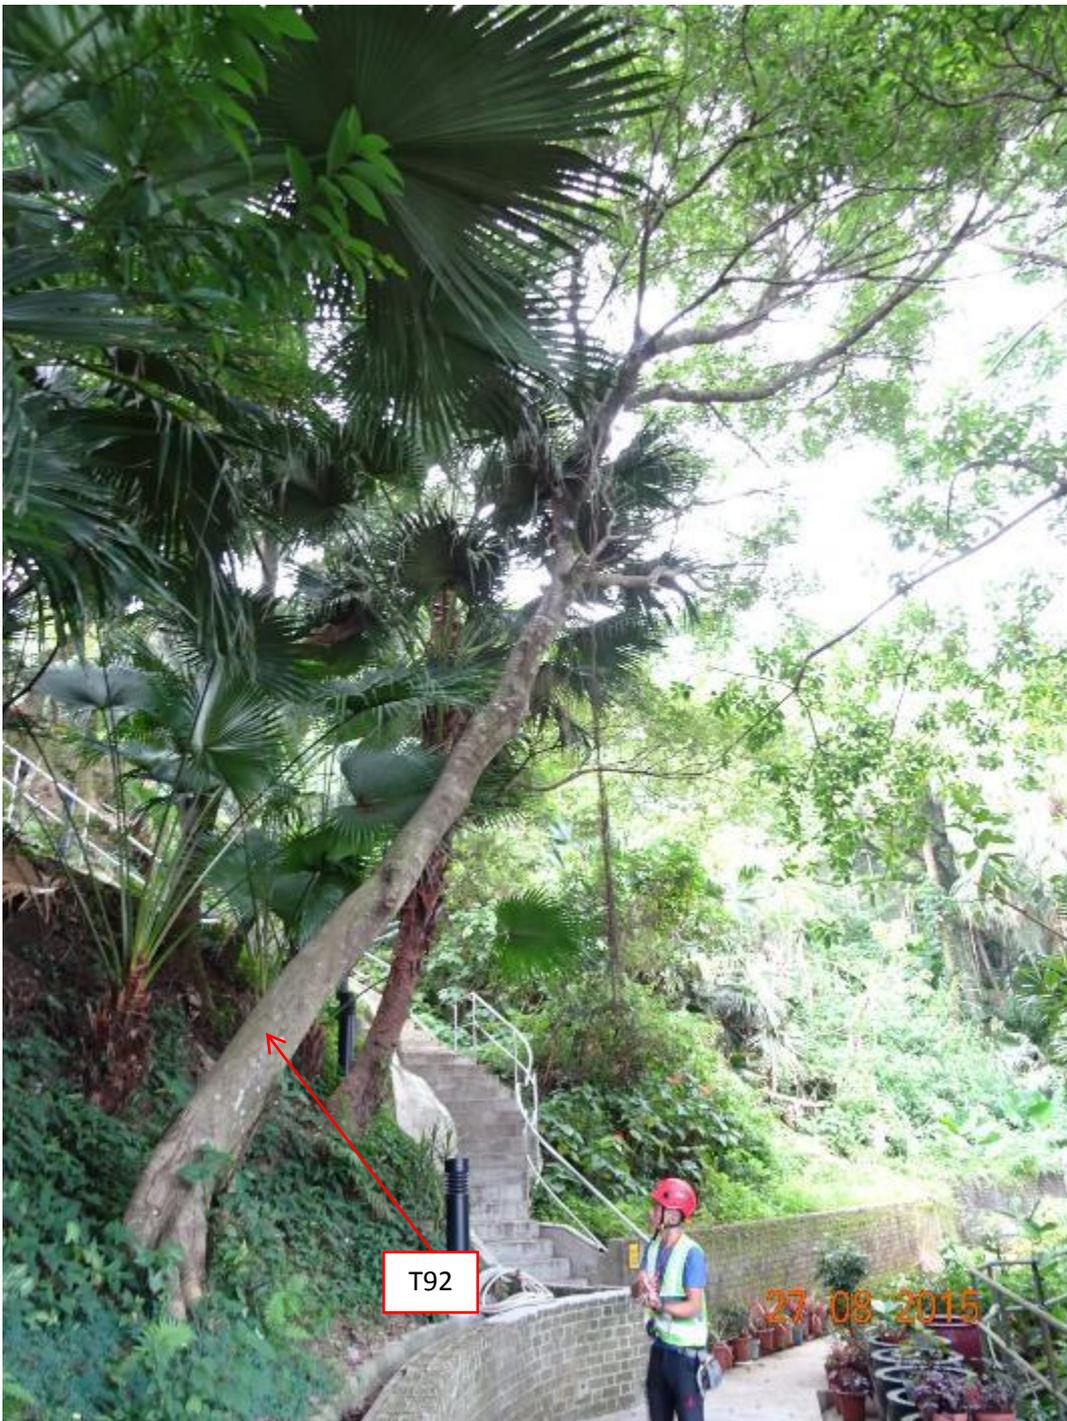
Overview of the subject tree T92. Crown cleaning is recommended.

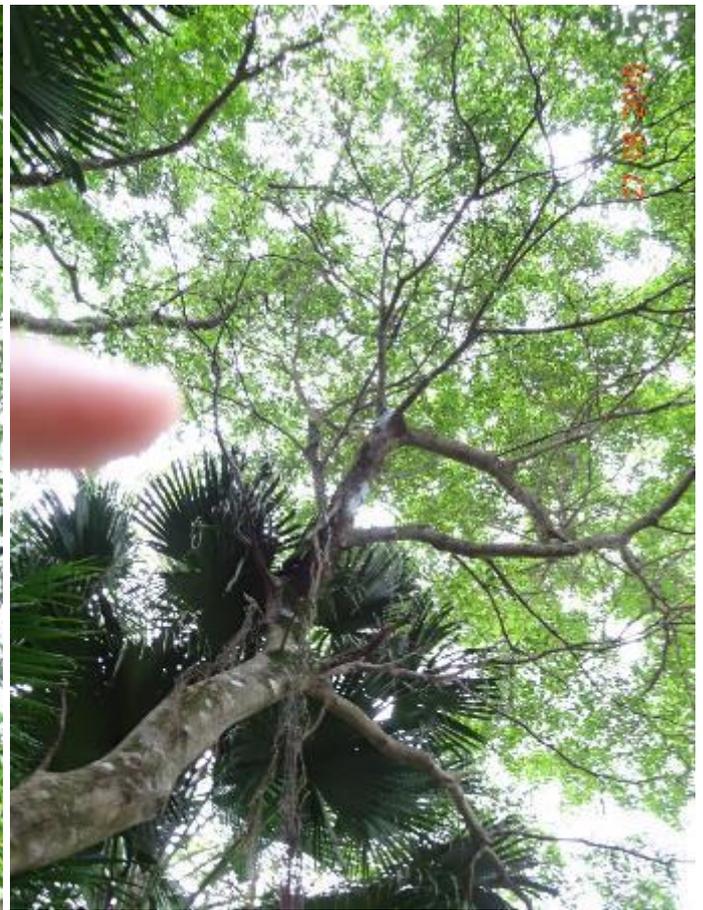
T92: Remove the dead branches above the walkway is recommended.

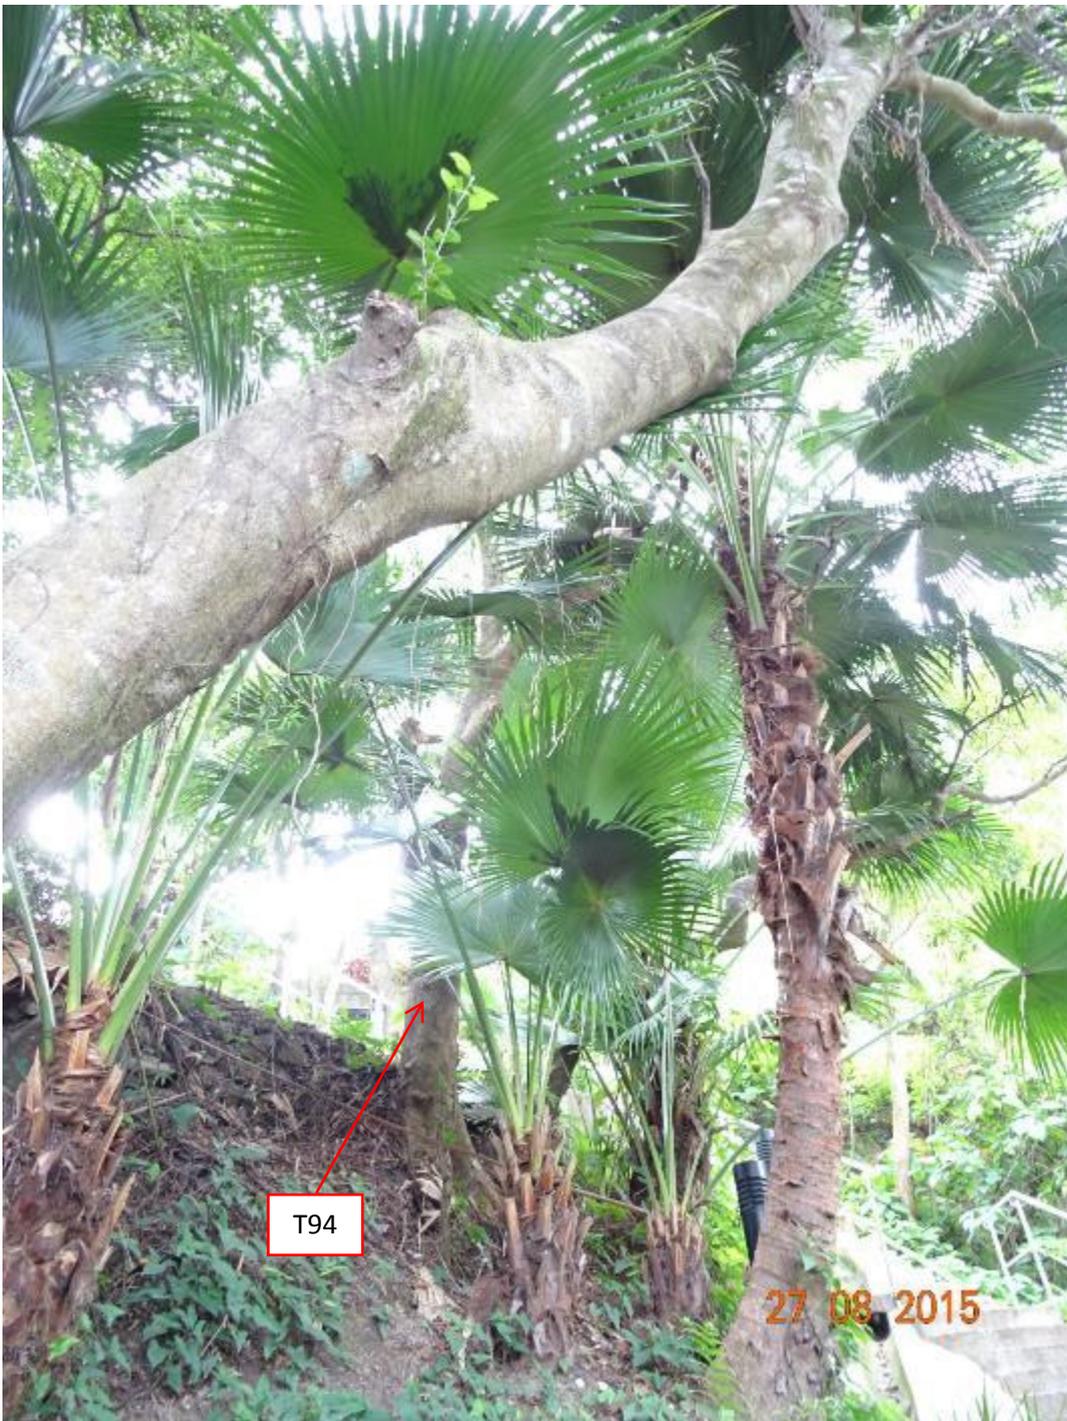
Overview of the subject tree T94. Crown cleaning is recommended.

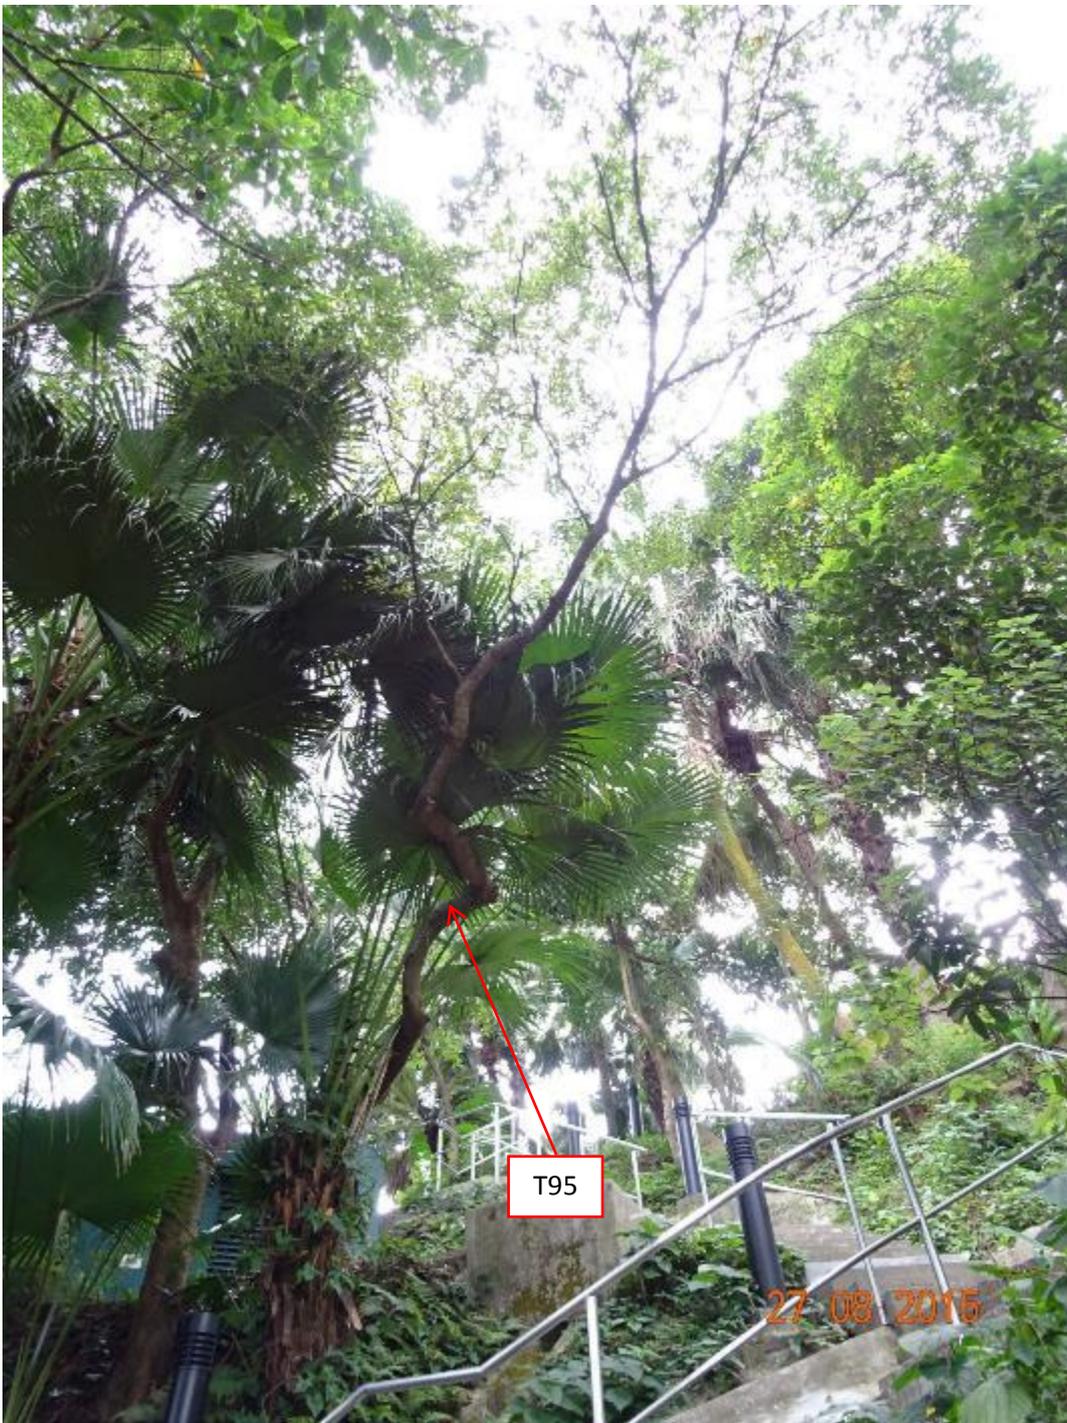
Overview of the subject tree T95. The tree is leaning towards to the stairs.

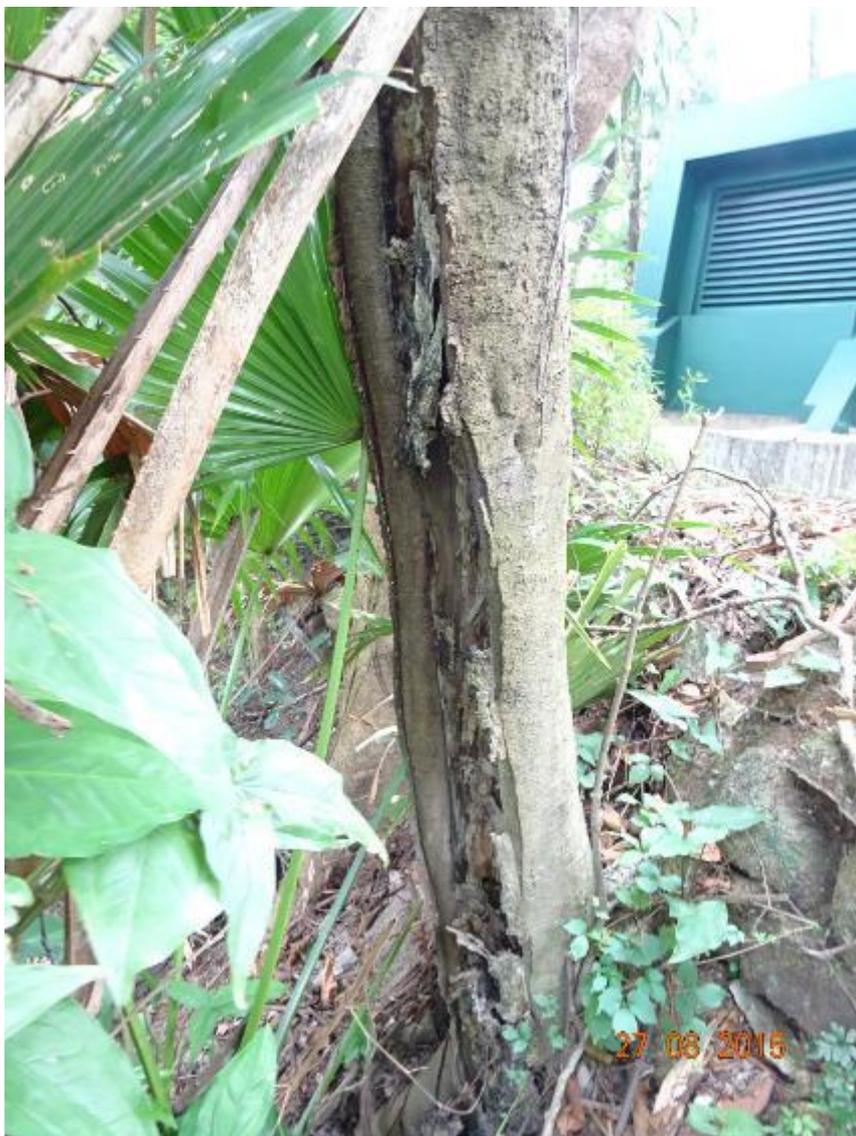
T95: Long wound with large decay area is observed at the trunk. Due to the high target rating, next to the stairs, removal is recommended.

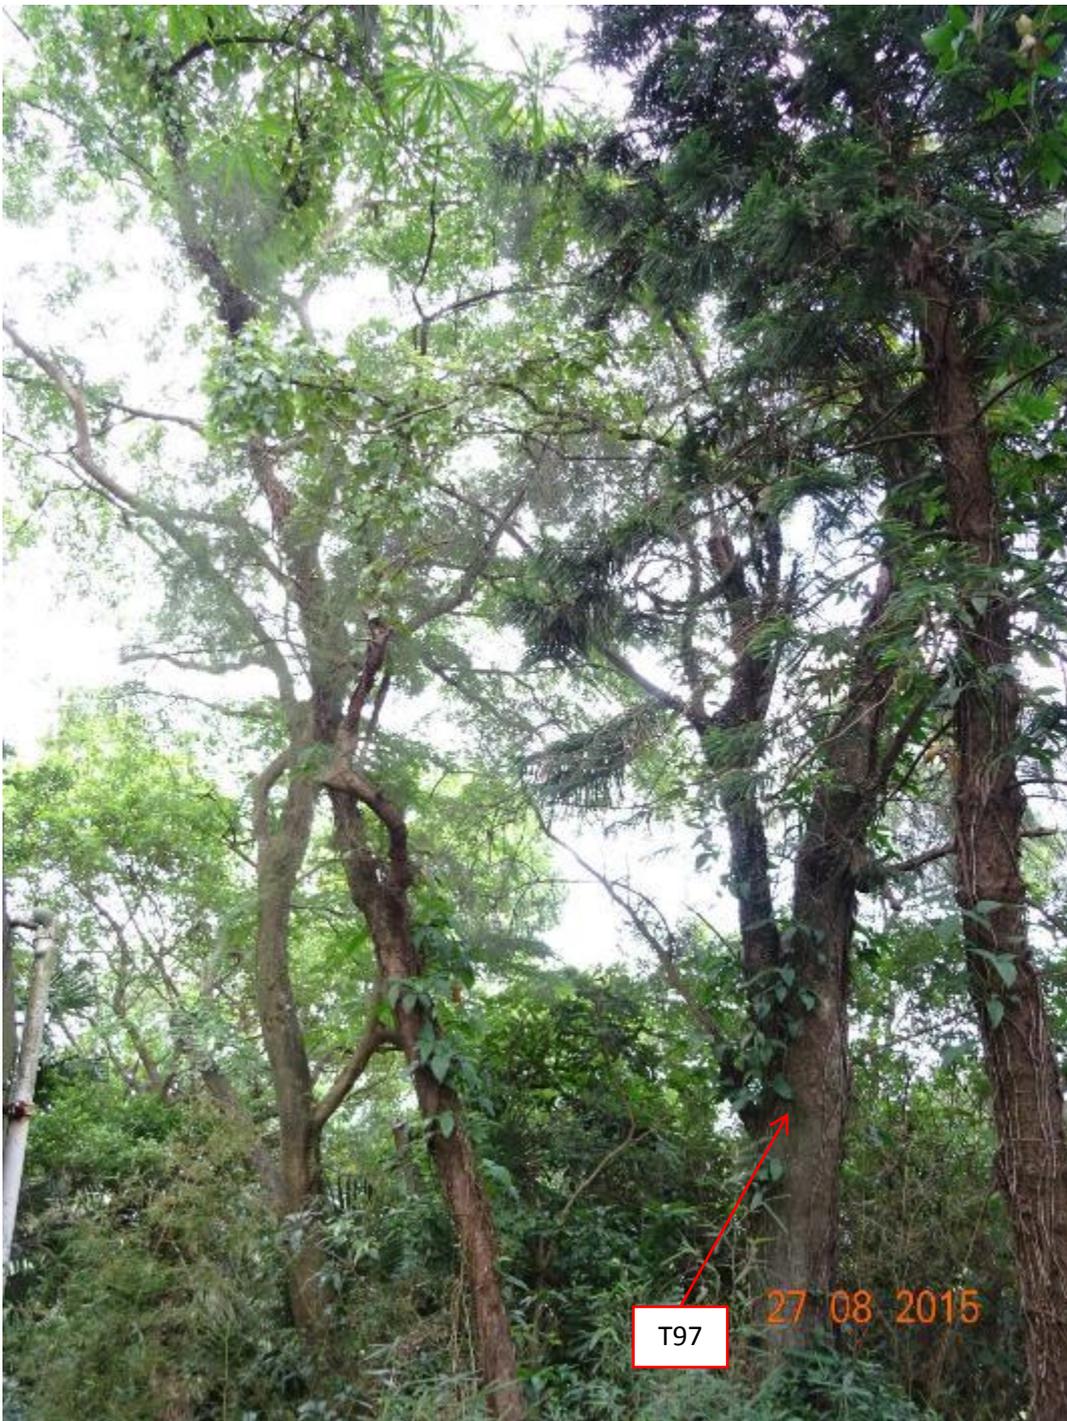
Overview of the subject tree T97. Remove the climber is recommended.
