Scope of Work
Trim and removal of trees
away from security fence and
alongside Barker Road

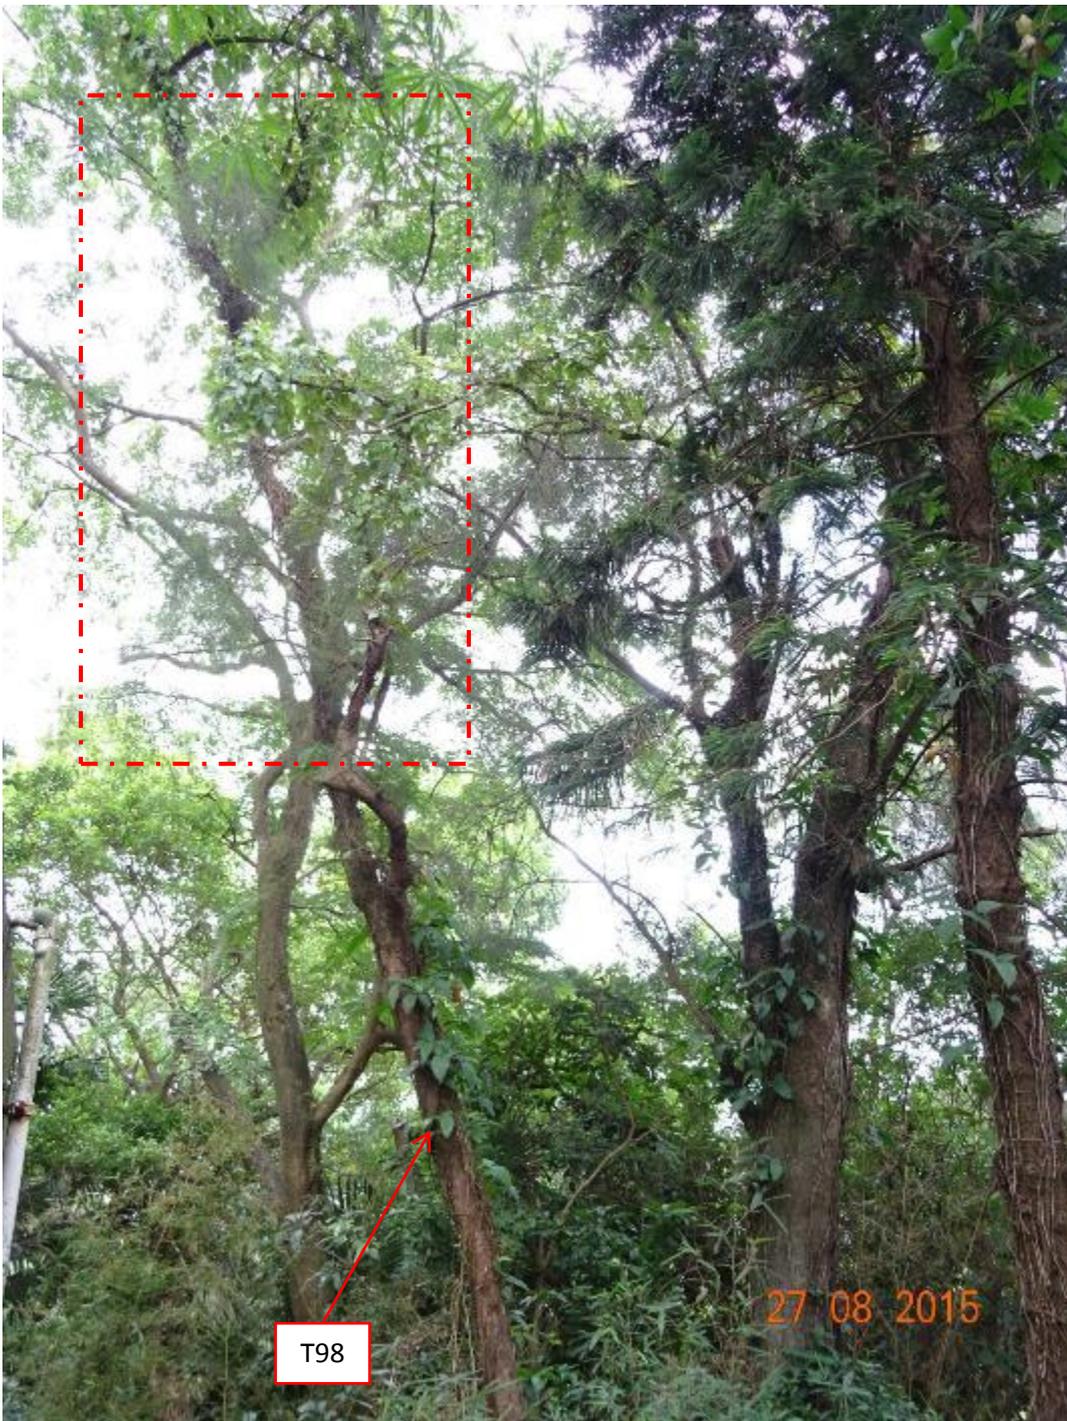
Overview of the subject tree T98. Remove the climber is recommended.

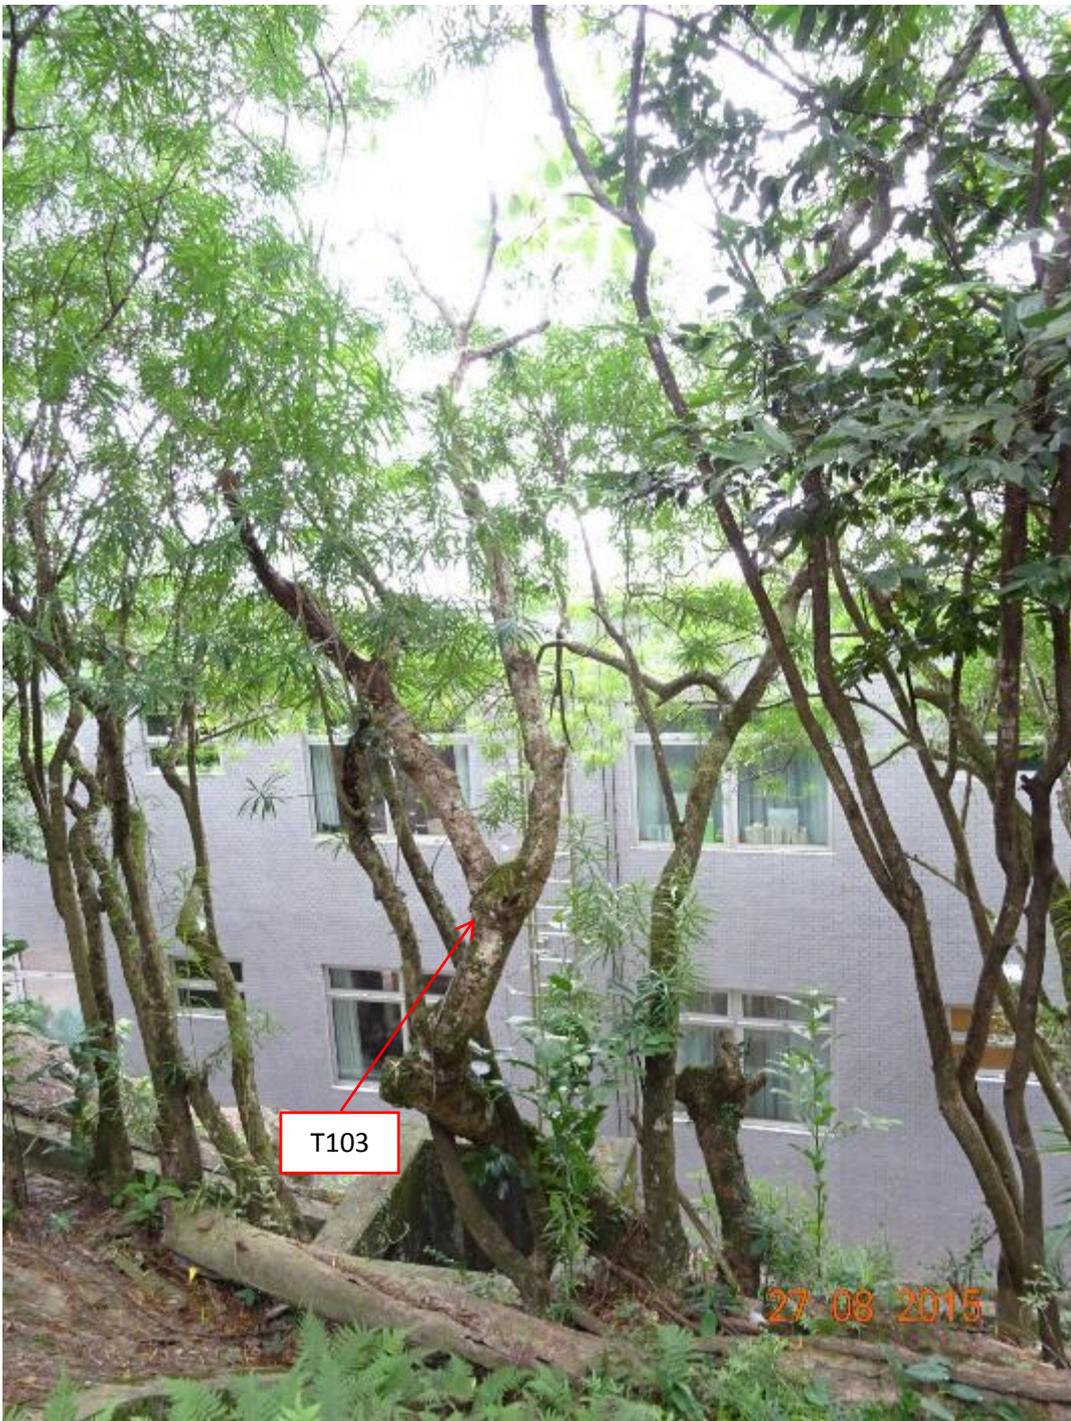
Overview of the subject tree T103. The health condition is poor associated with low foliage density, and hindering the growth of adjacent tree, removal is recommended.

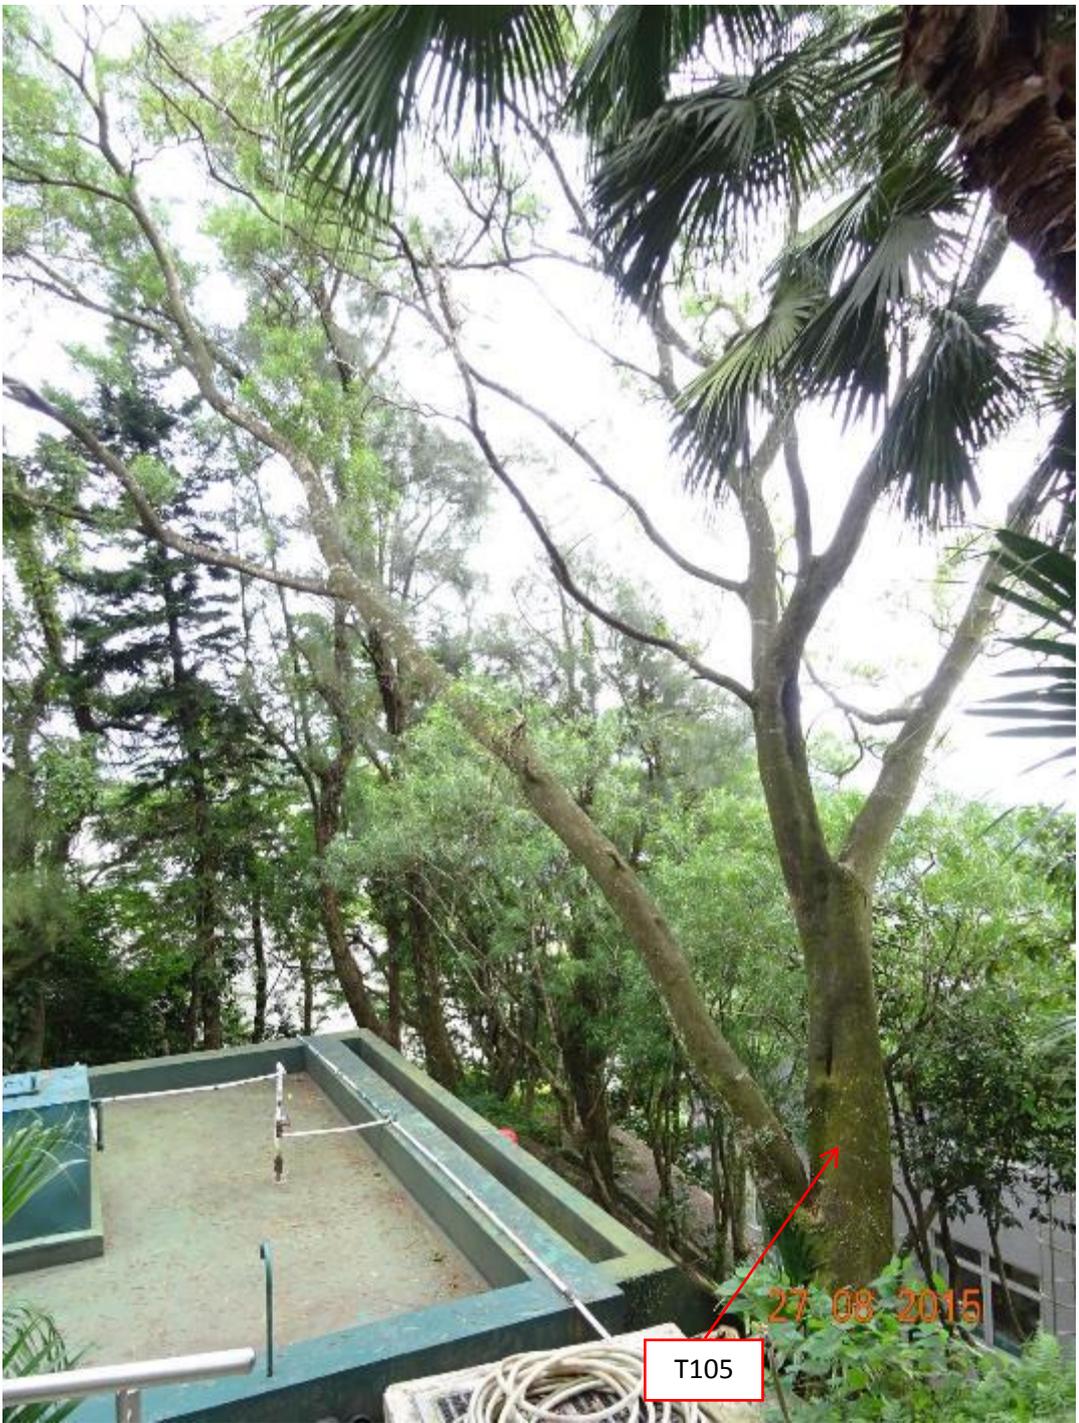
Overview of the subject tree T105. The health condition is fair, associated with dieback twigs. Further monitoring the health and structural condition is recommended.

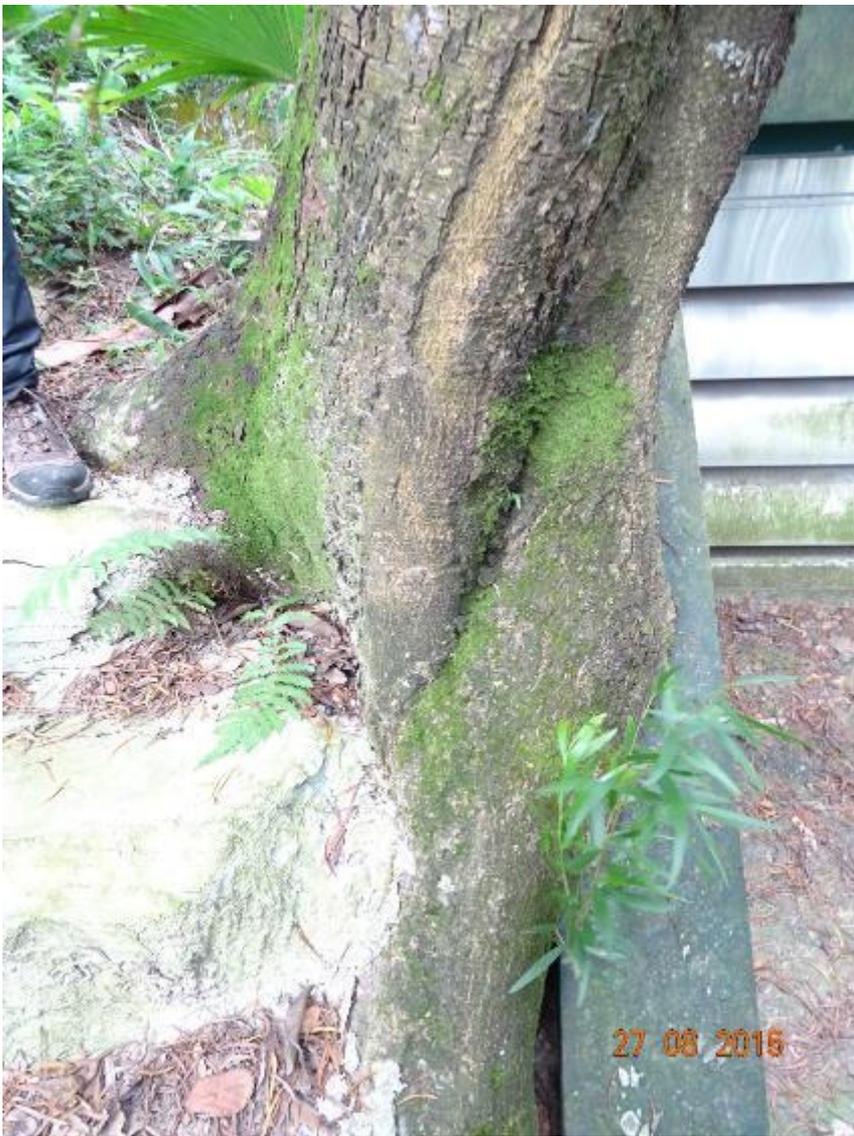
T105: The root is in contact with the concrete.

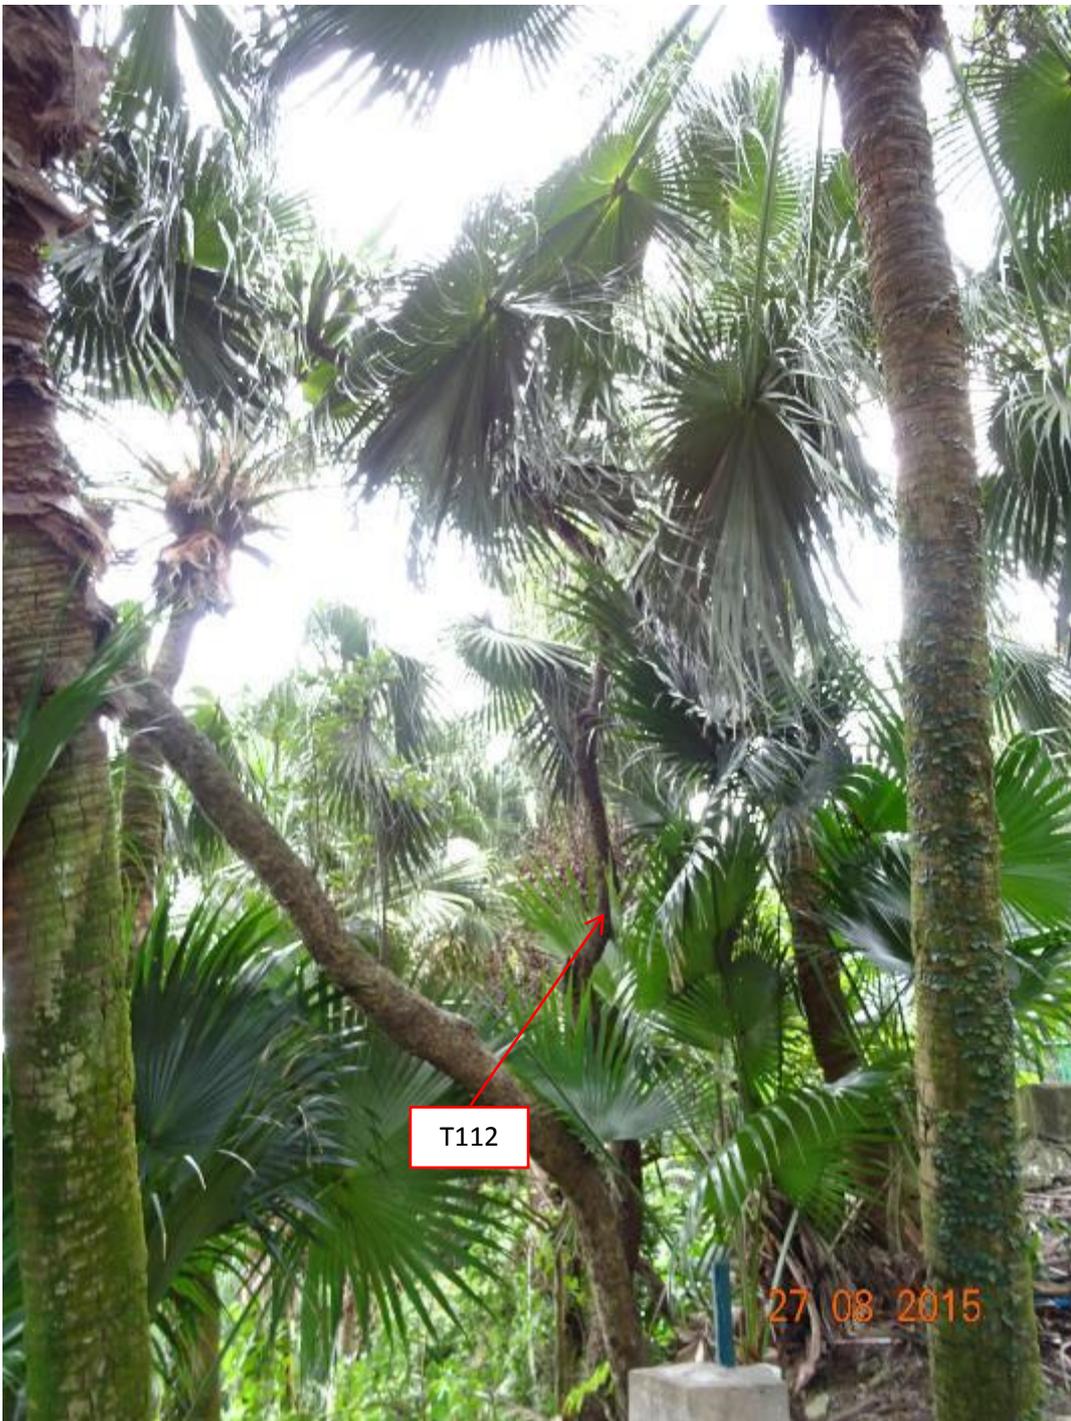
Overview of the subject dead tree T112. Removal is recommended.

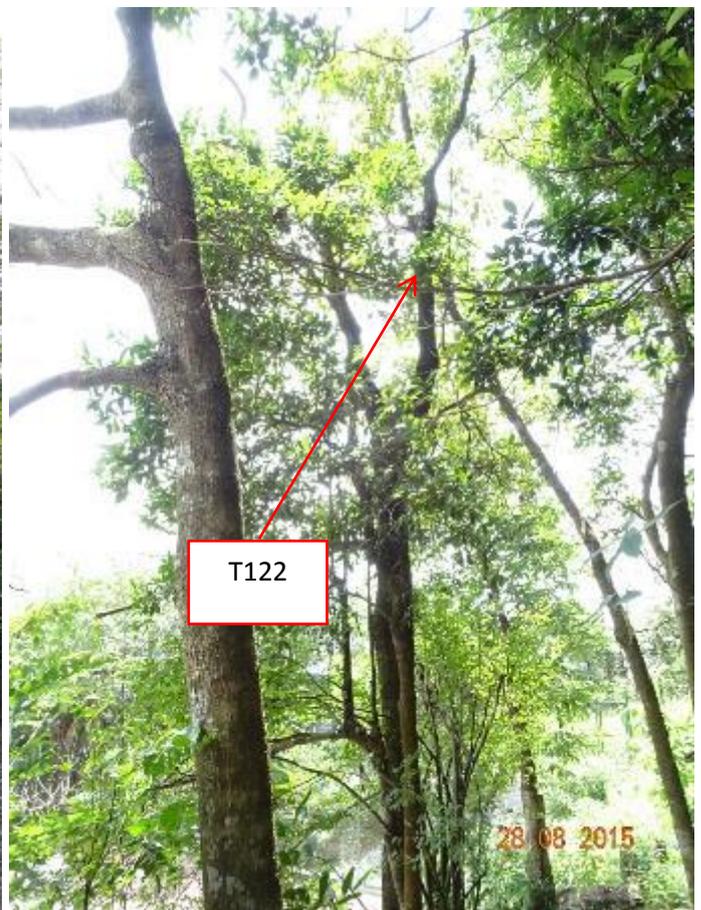
Overview of the subject tree T122. Remove the dead tree is recommended.

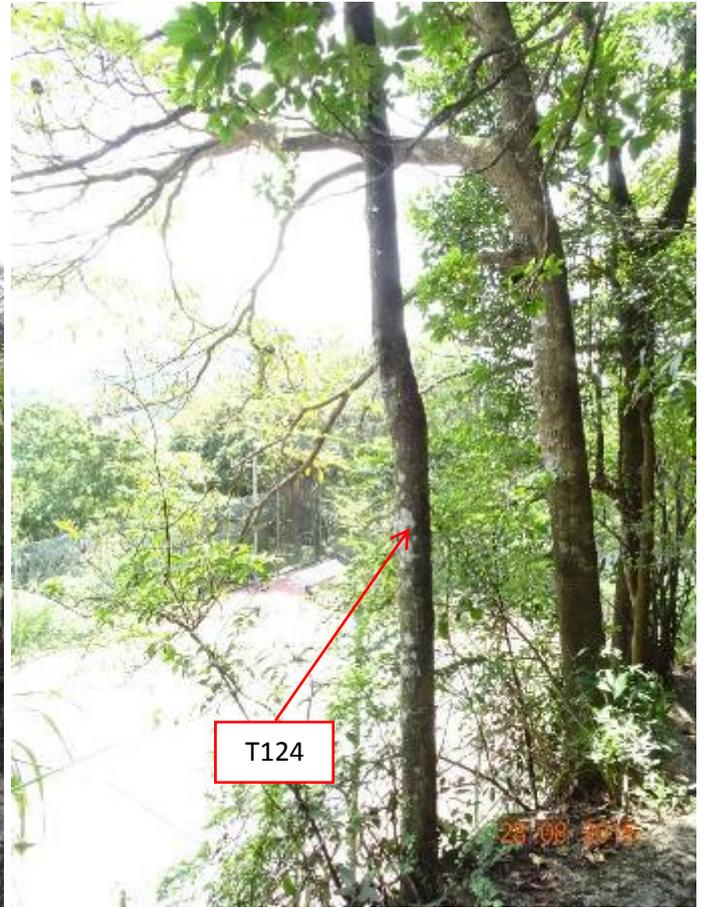
Overview of the subject tree T124. Remove the dead tree is recommended.

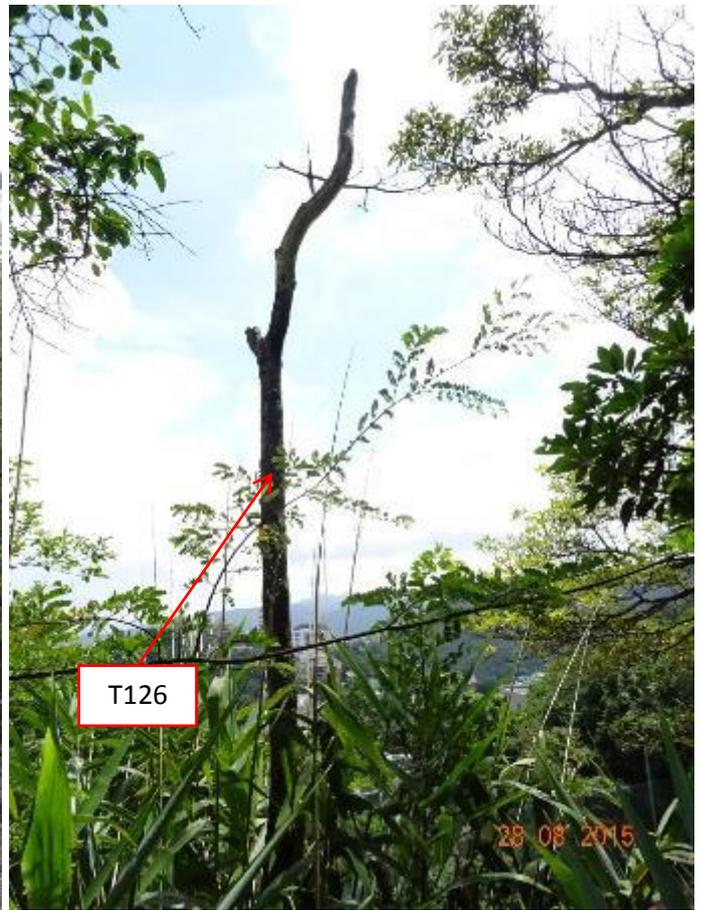
Overview of the subject tree T126. Remove the dead stem is recommended.

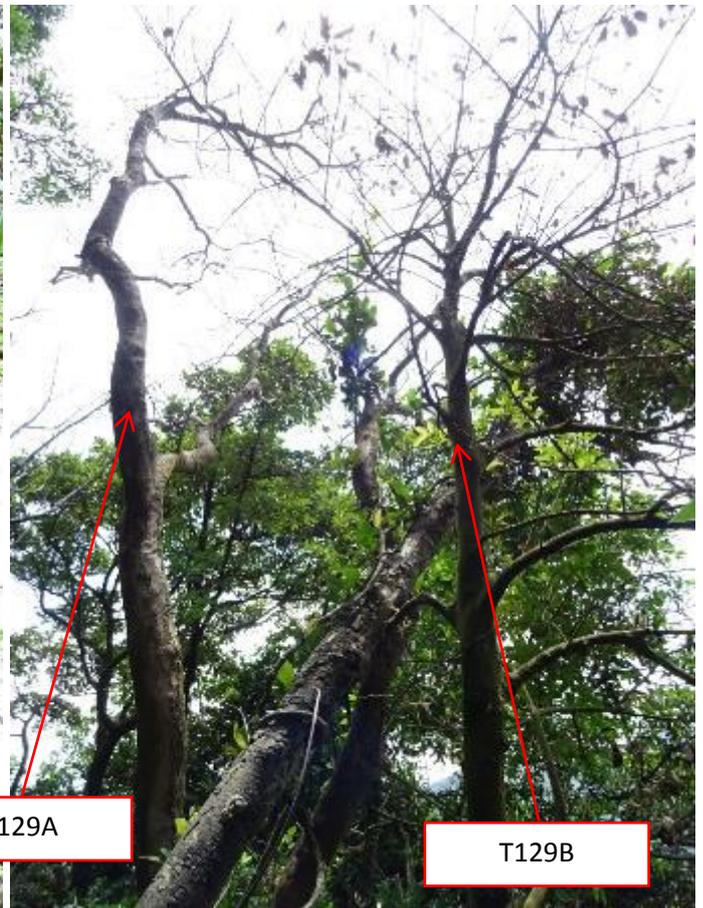
T129A, B are dead. Removal is recommended.

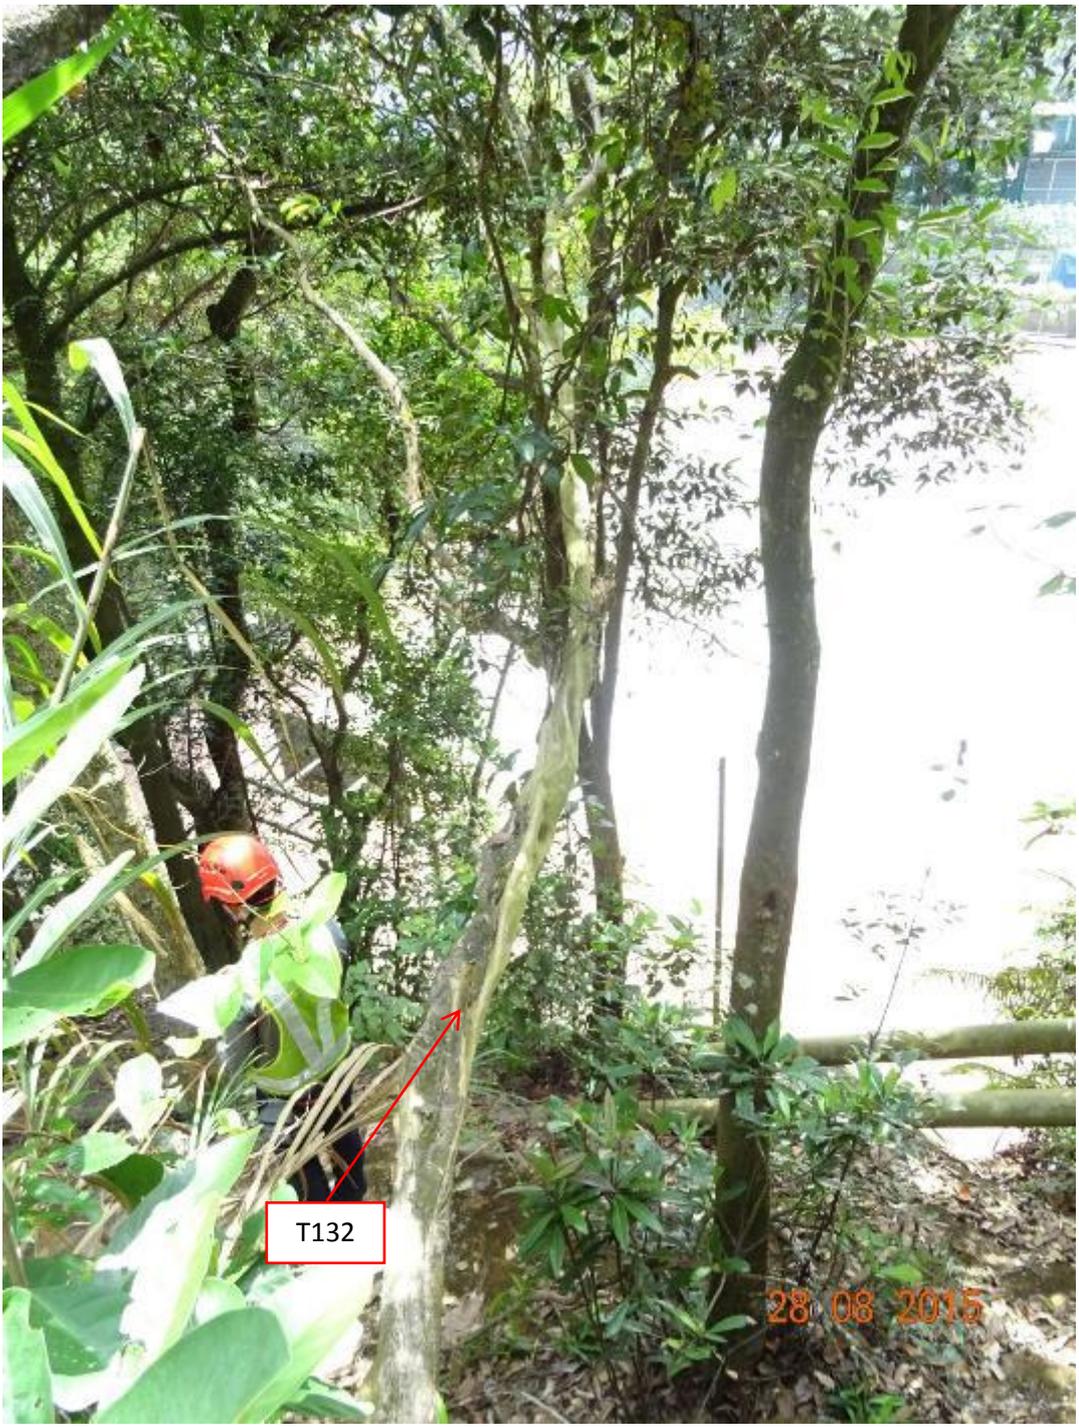
Overview of the subject tree T132. The tree is dead, removal is recommended.

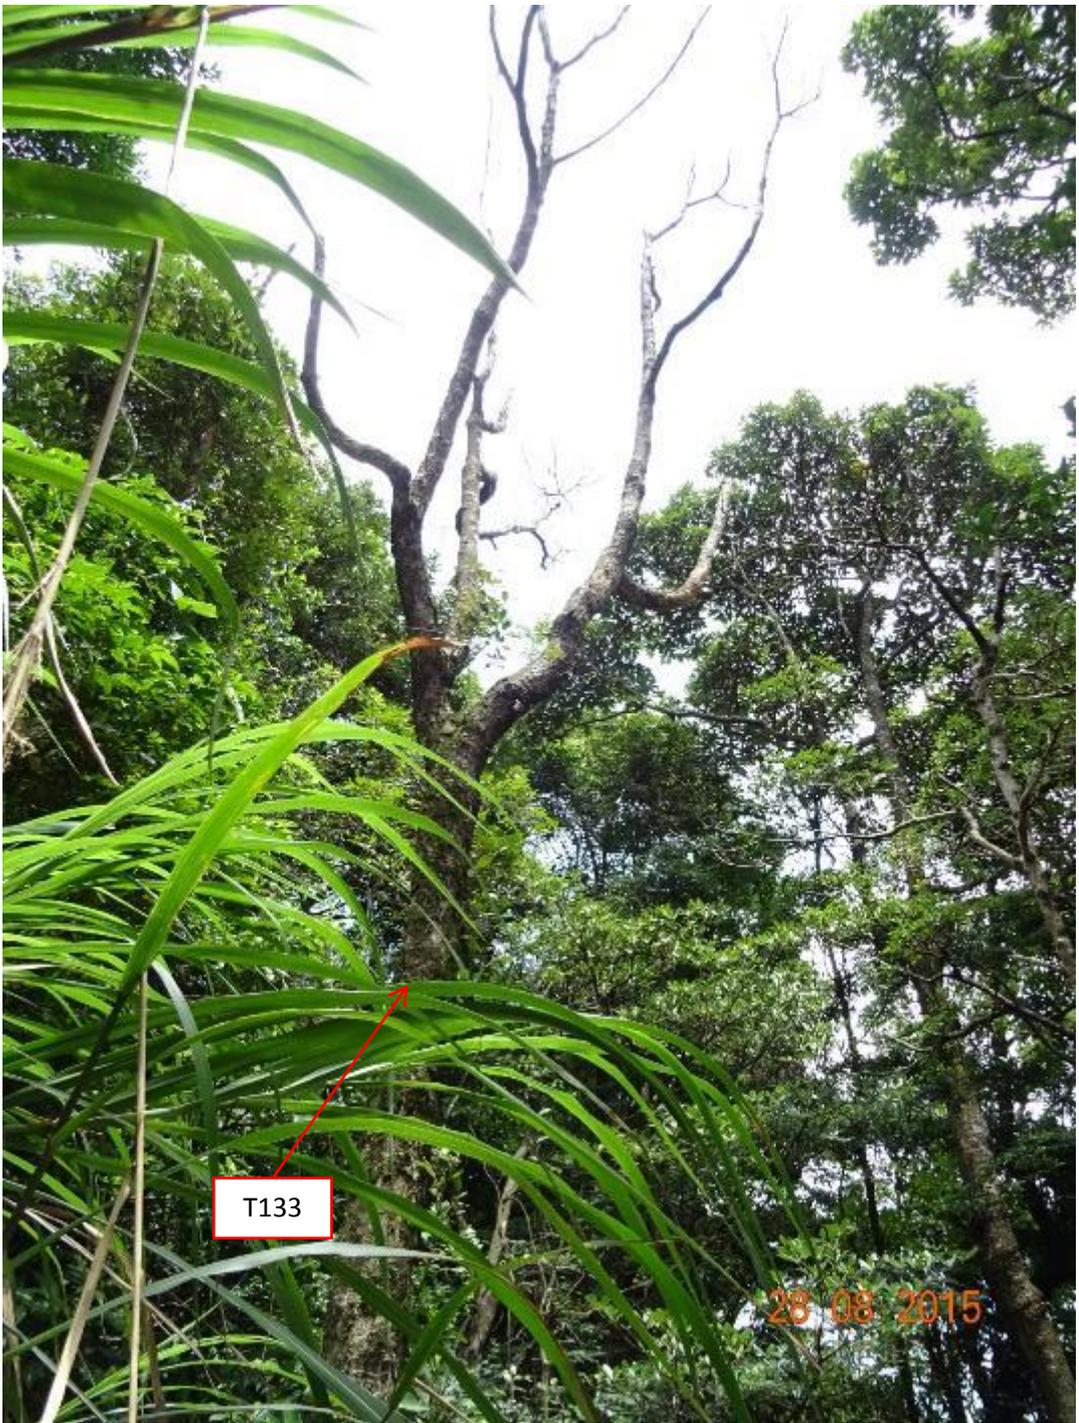
Overview of the subject tree T133. The tree is dead, removal is recommended.

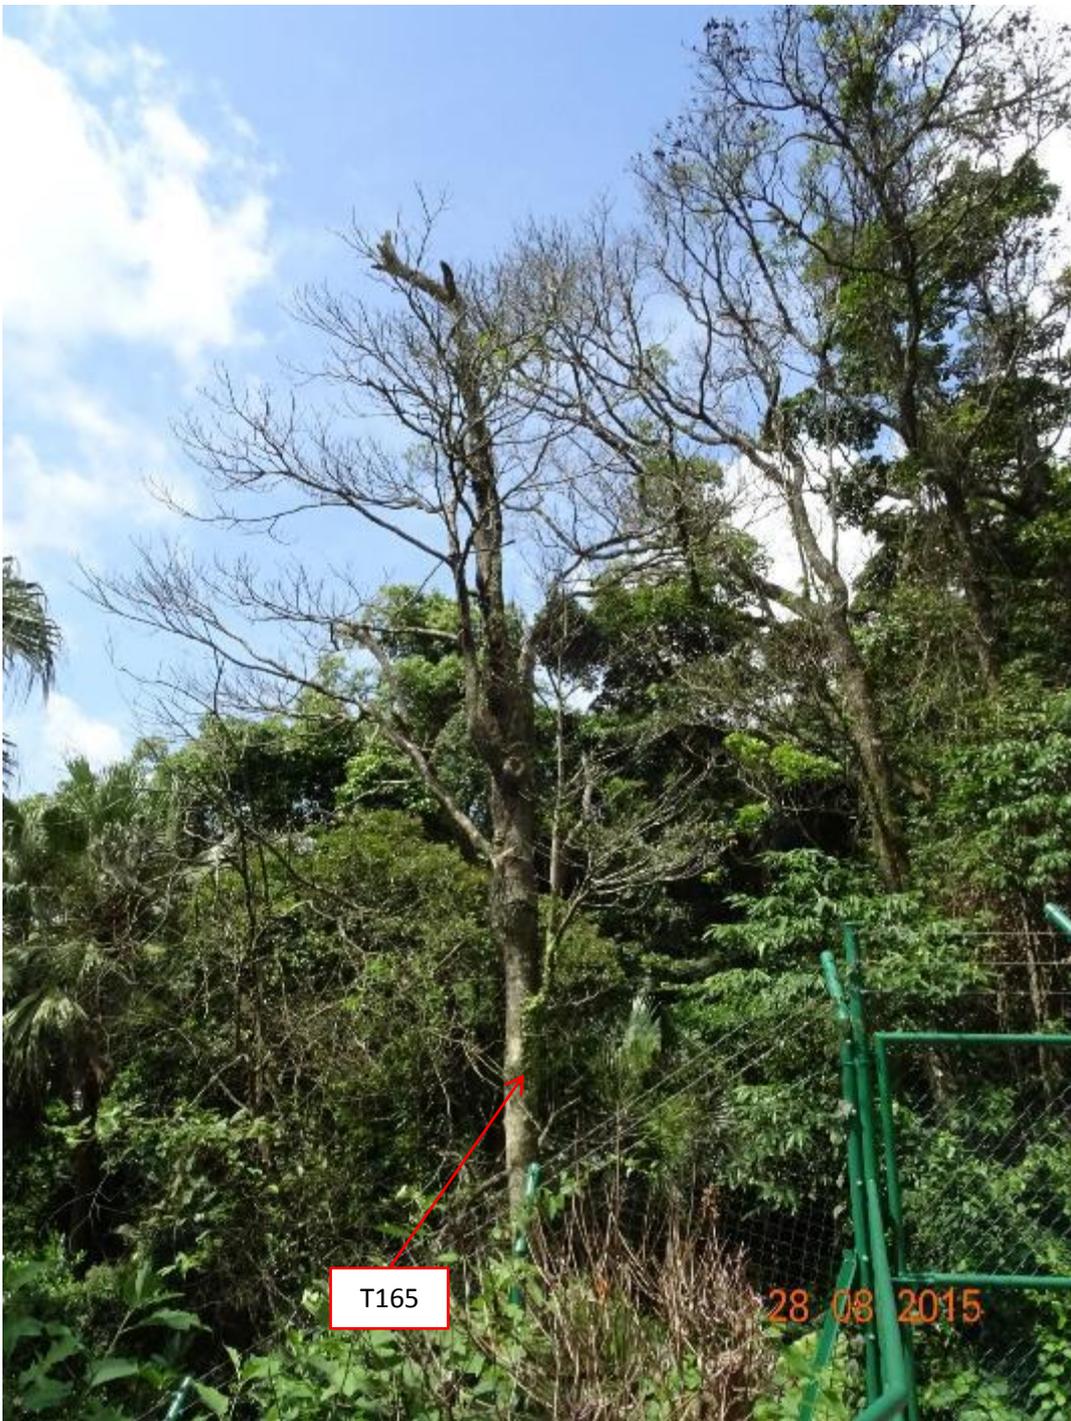
Overview of the subject tree T165. The tree is dead, removal is recommended.

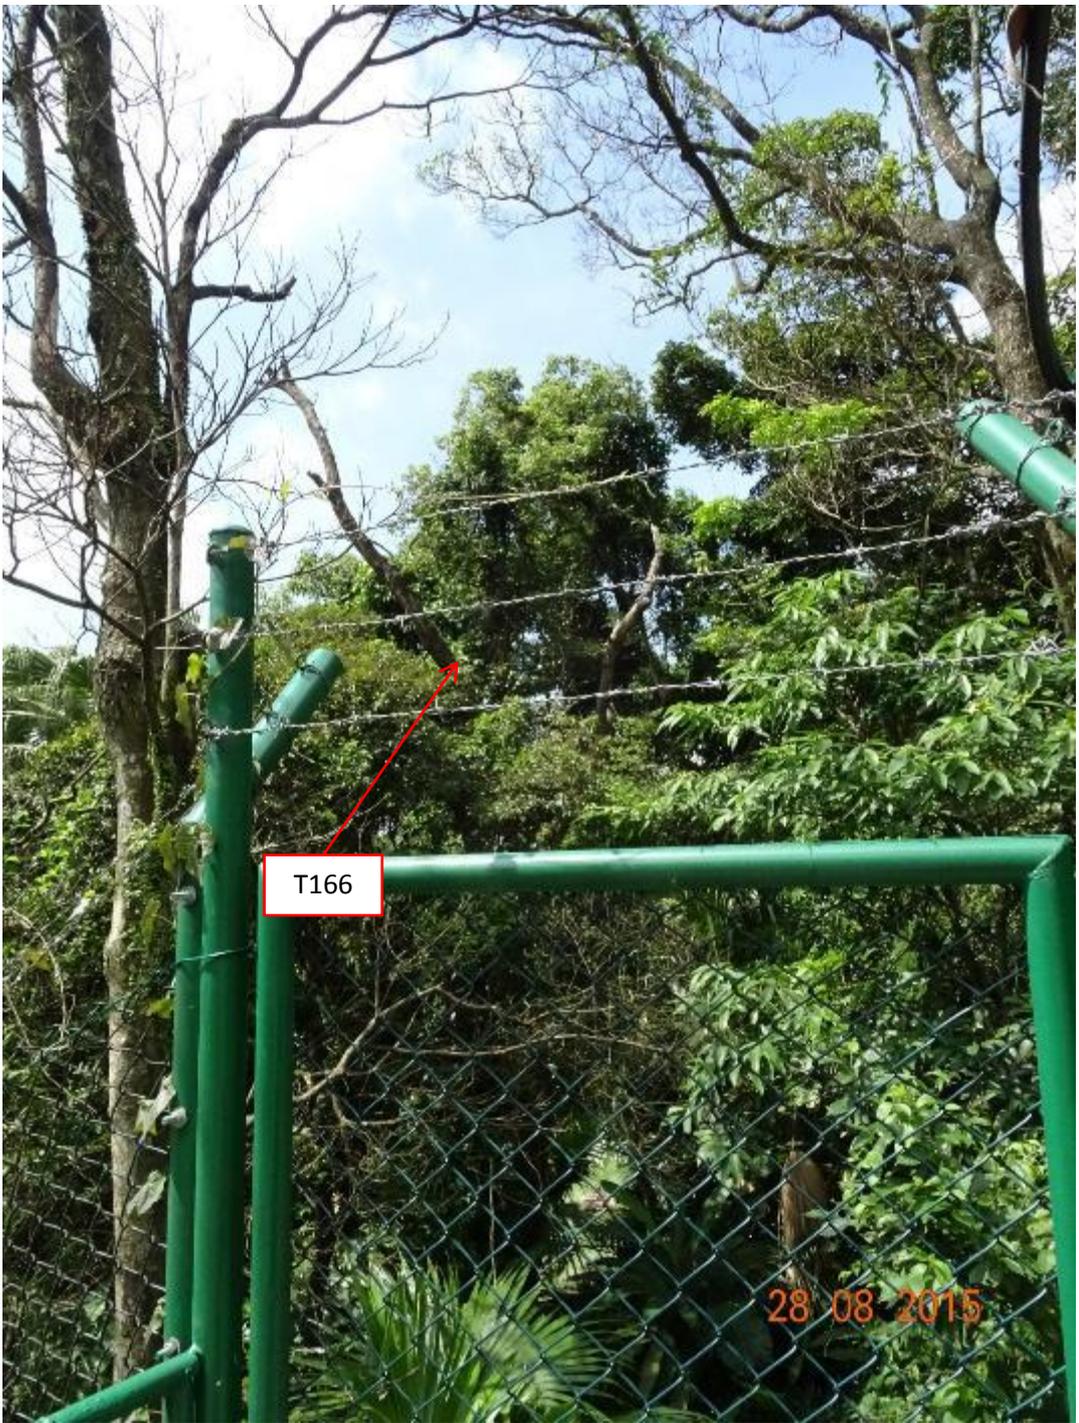
Overview of the subject tree T166. The tree is dead, removal is recommended.

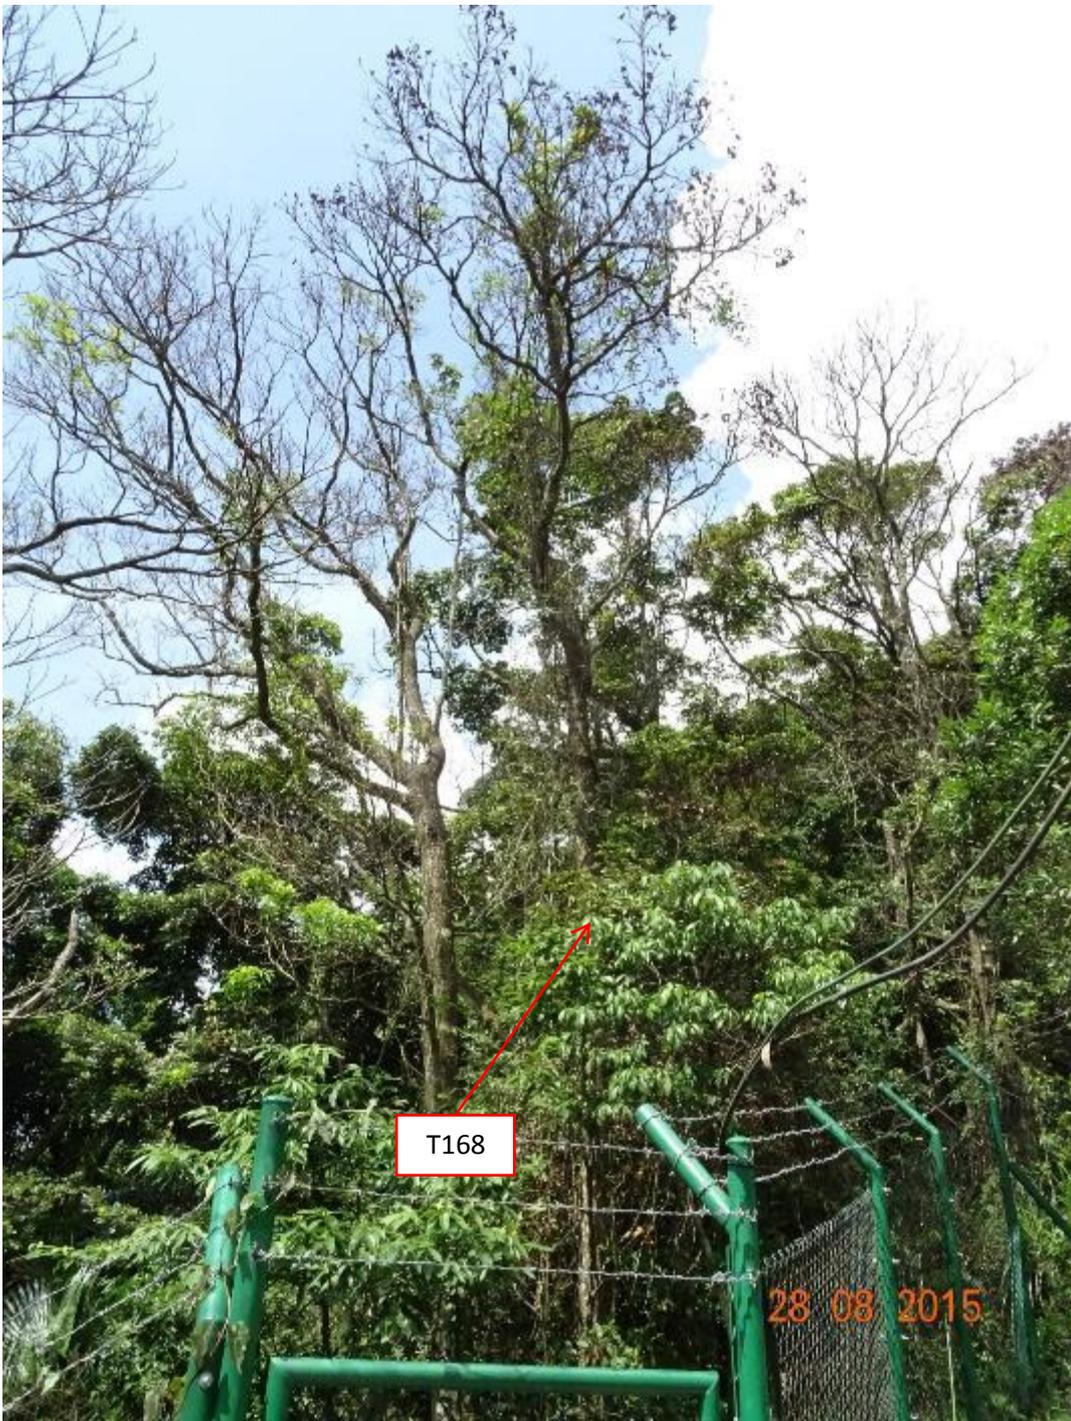
Overview of the subject tree T168. The tree is dead, removal is recommended.

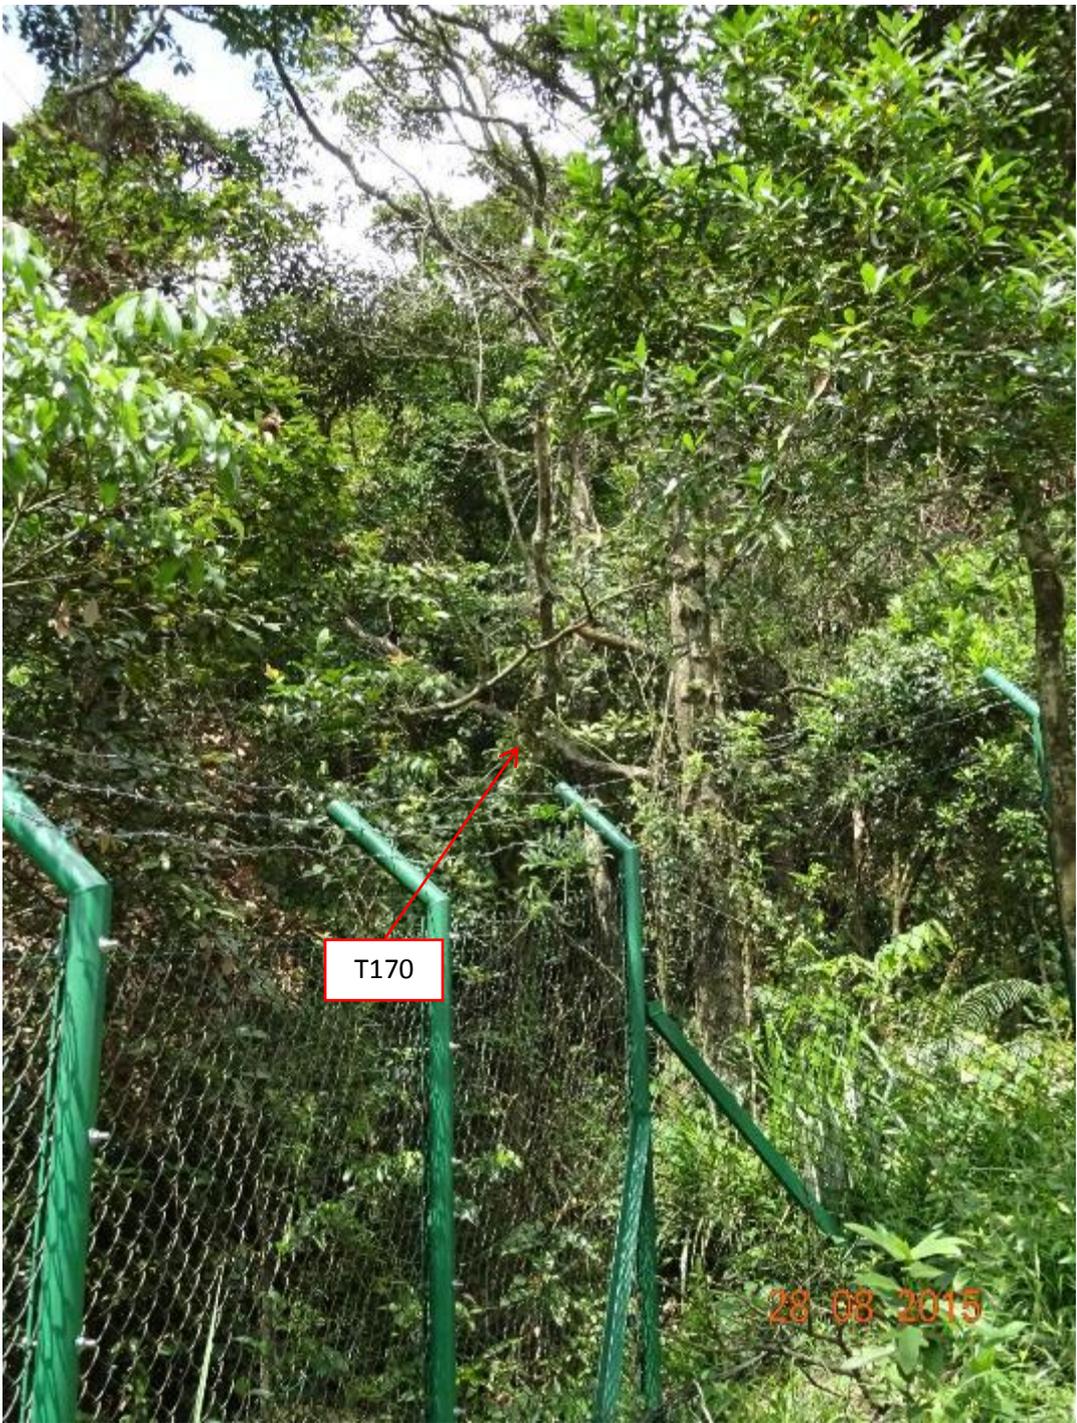
Overview of the subject tree T170. The tree is dead, removal is recommended.

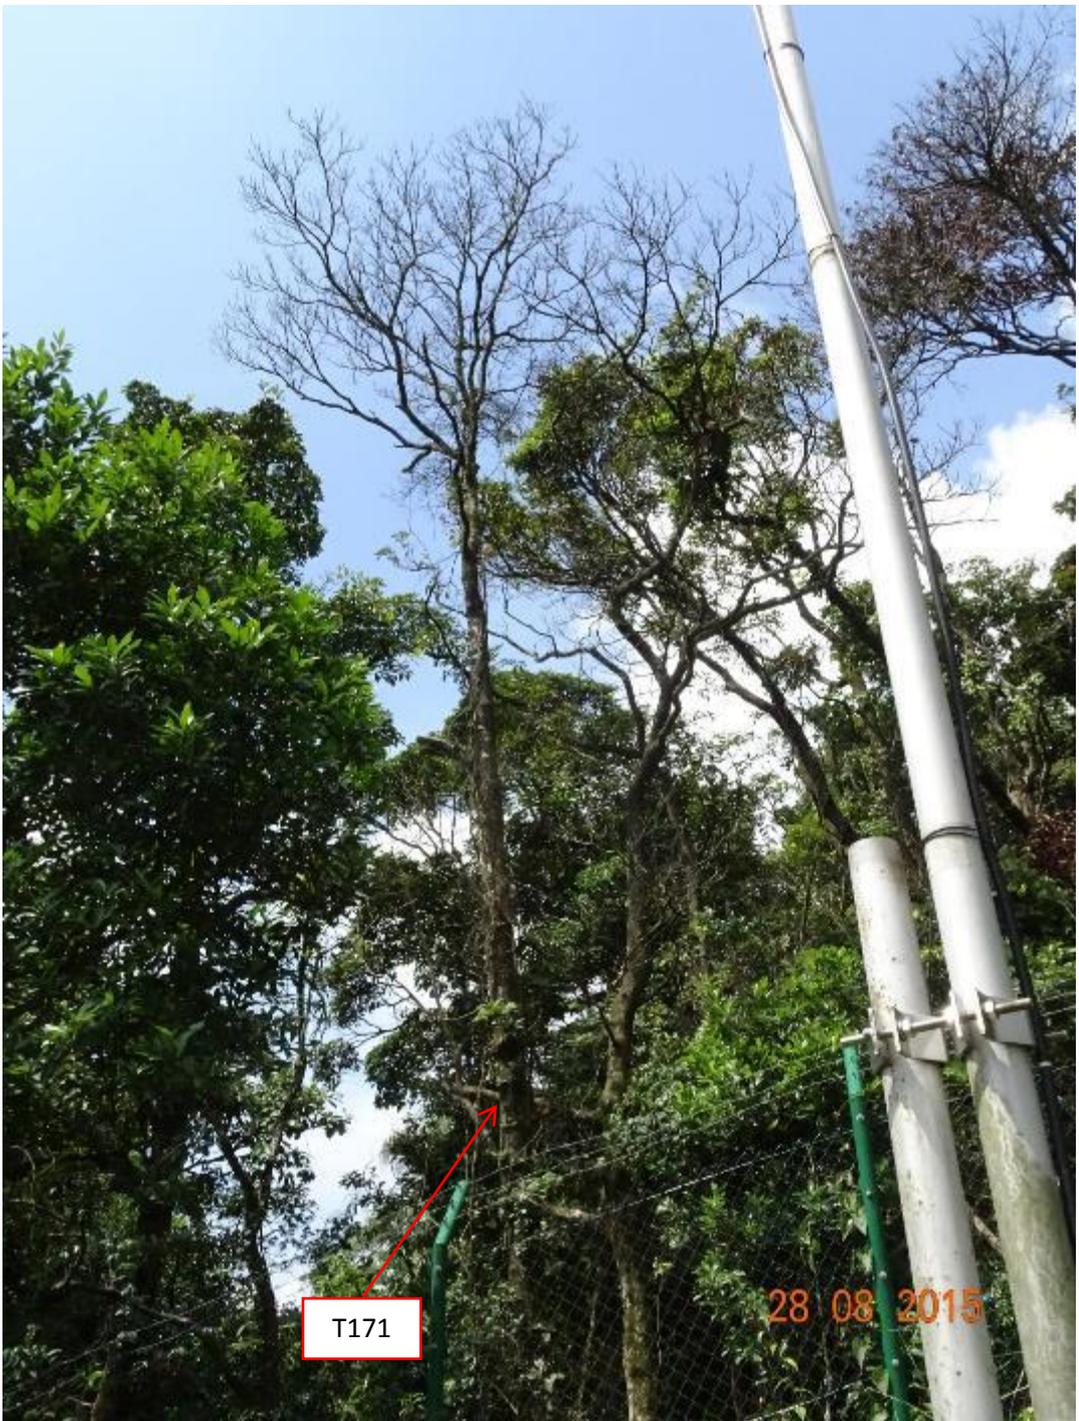
Overview of the subject tree T171. The tree is dead, removal is recommended.

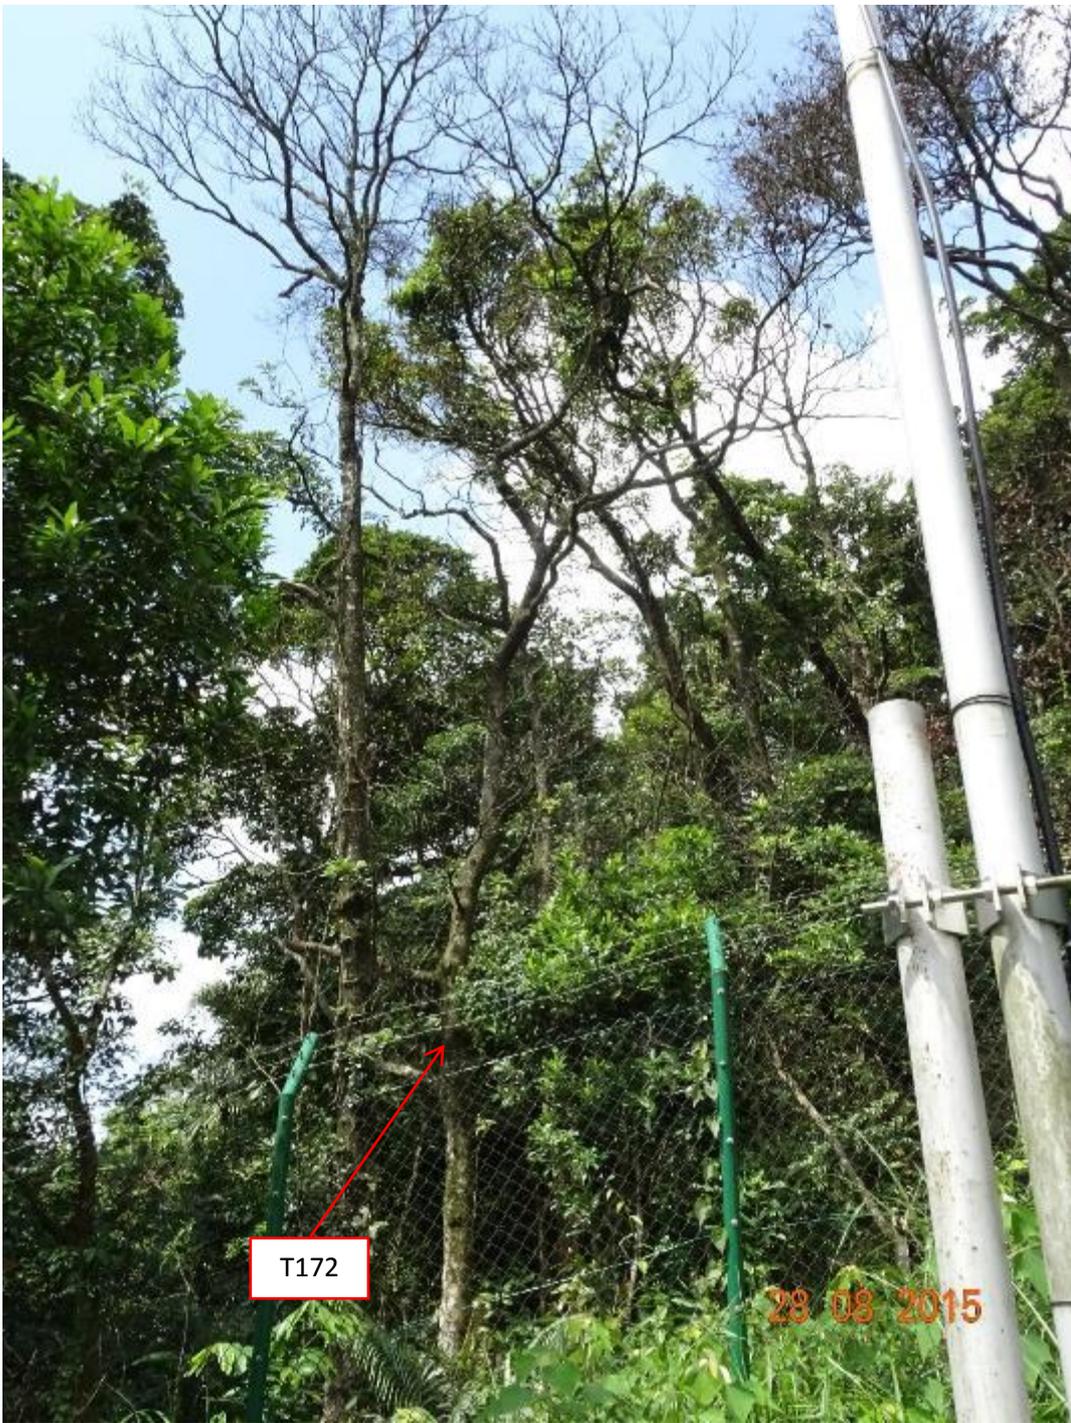
Overview of the subject tree T172. The tree is dead, removal is recommended.
