Scope of Work
Trim and removal of trees
away from security fence and
alongside Barker Road

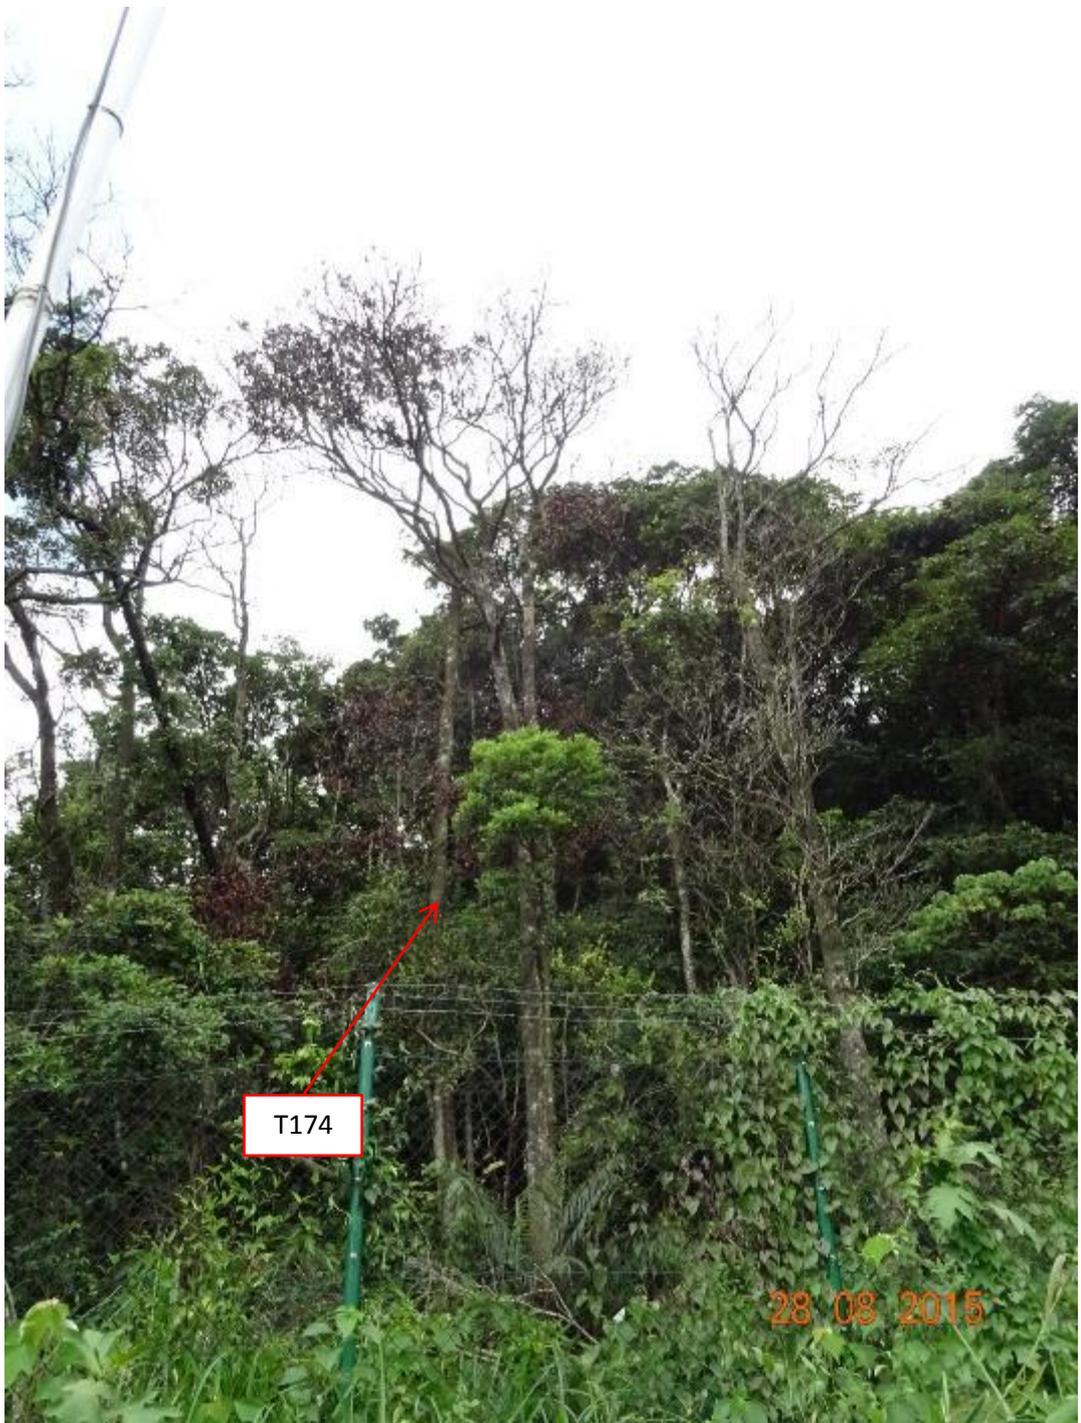
Overview of the subject tree T174. The tree is dead, removal is recommended.

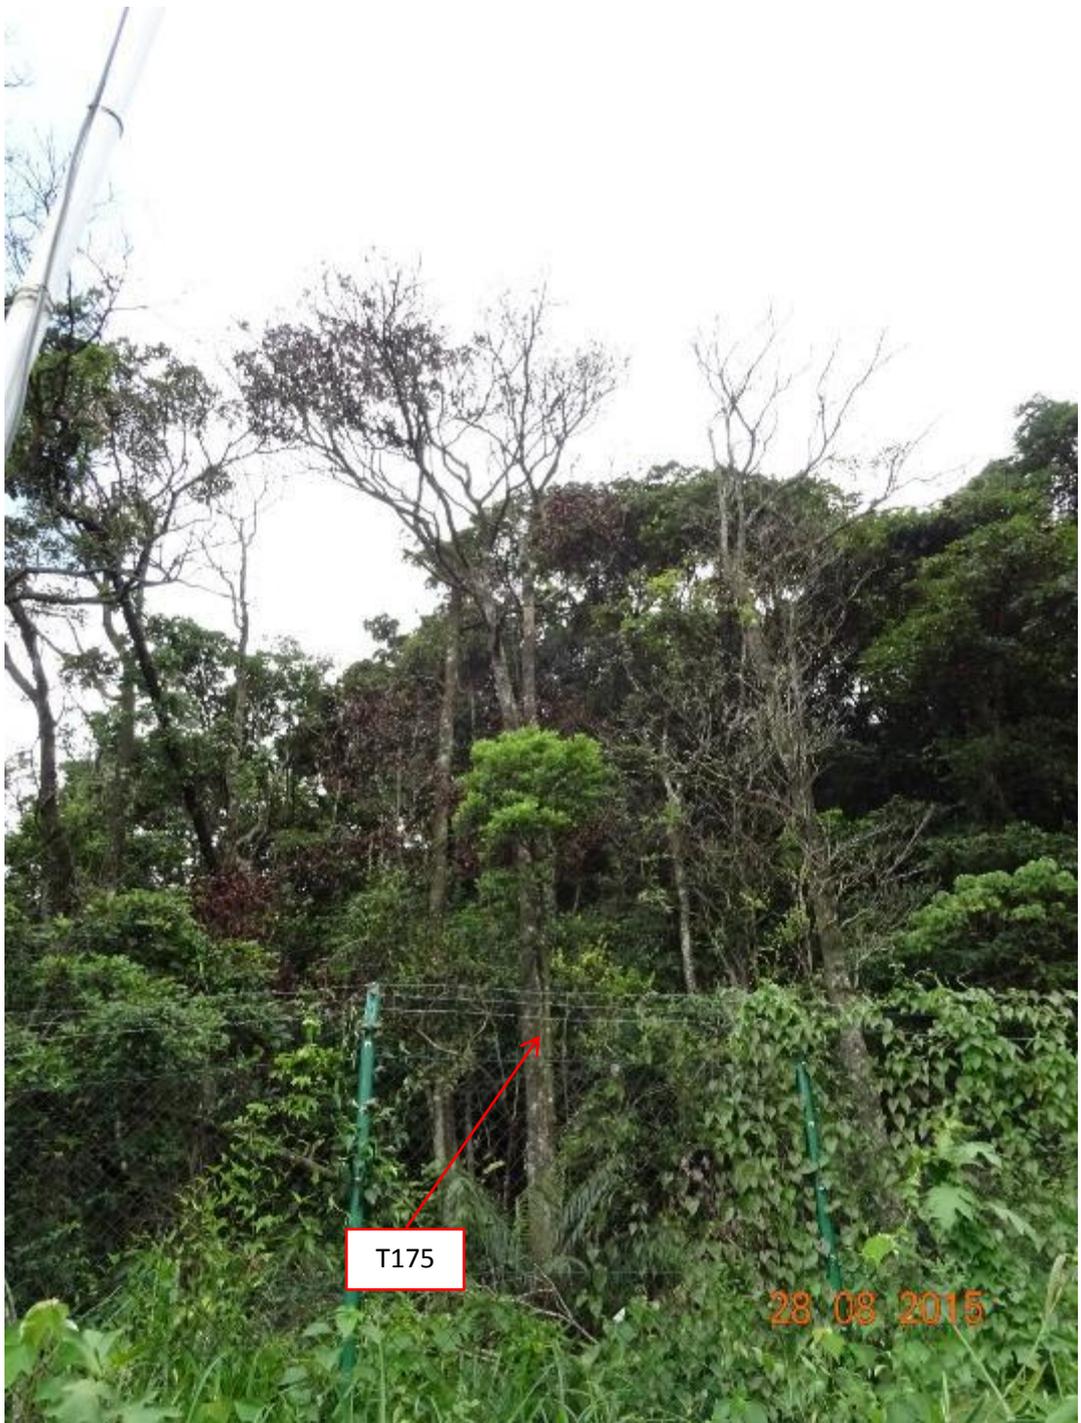
Overview of the subject tree T175. The tree is dead, removal is recommended.

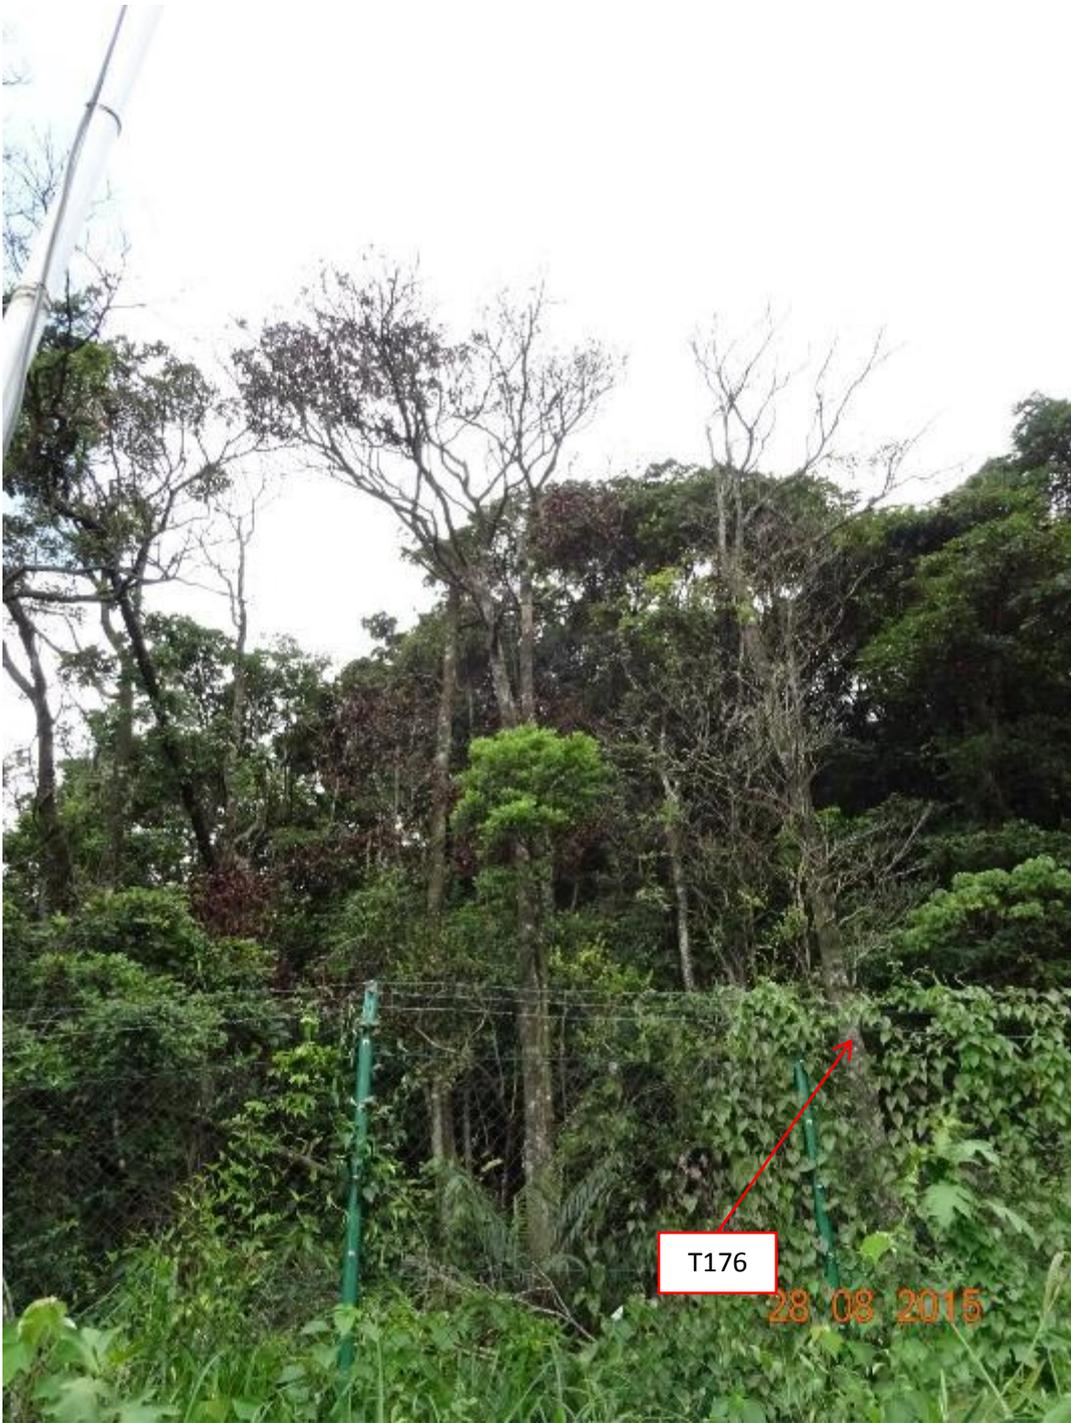
Overview of the subject tree T176. The tree is dead, removal is recommended.

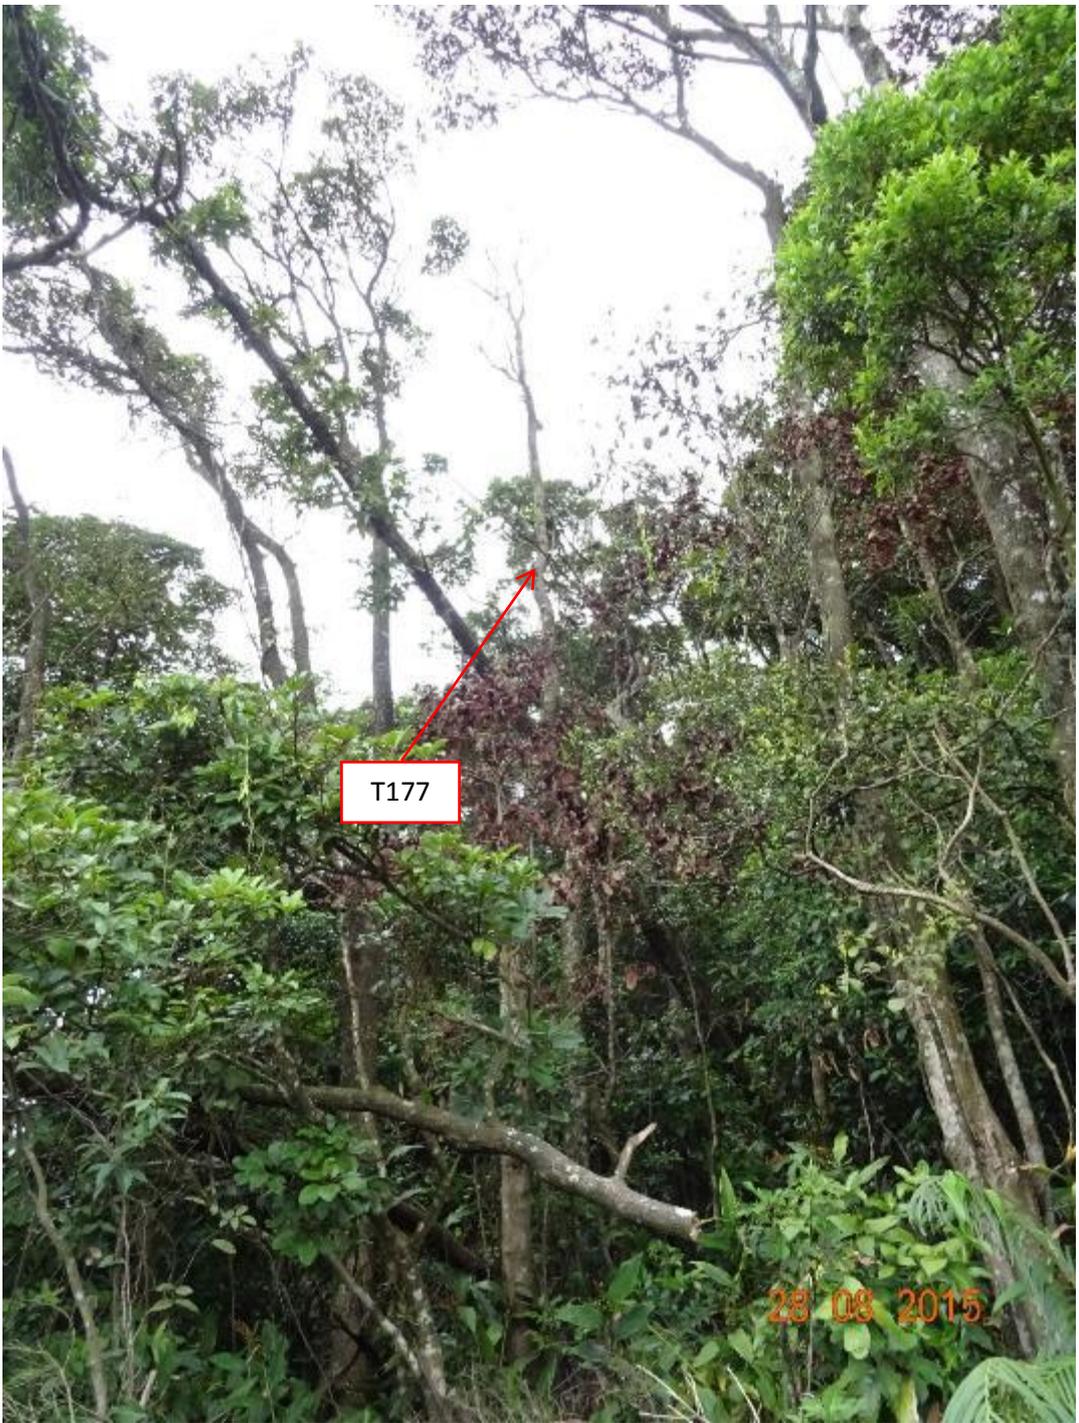
Overview of the subject tree T177. The tree is dead, removal is recommended.

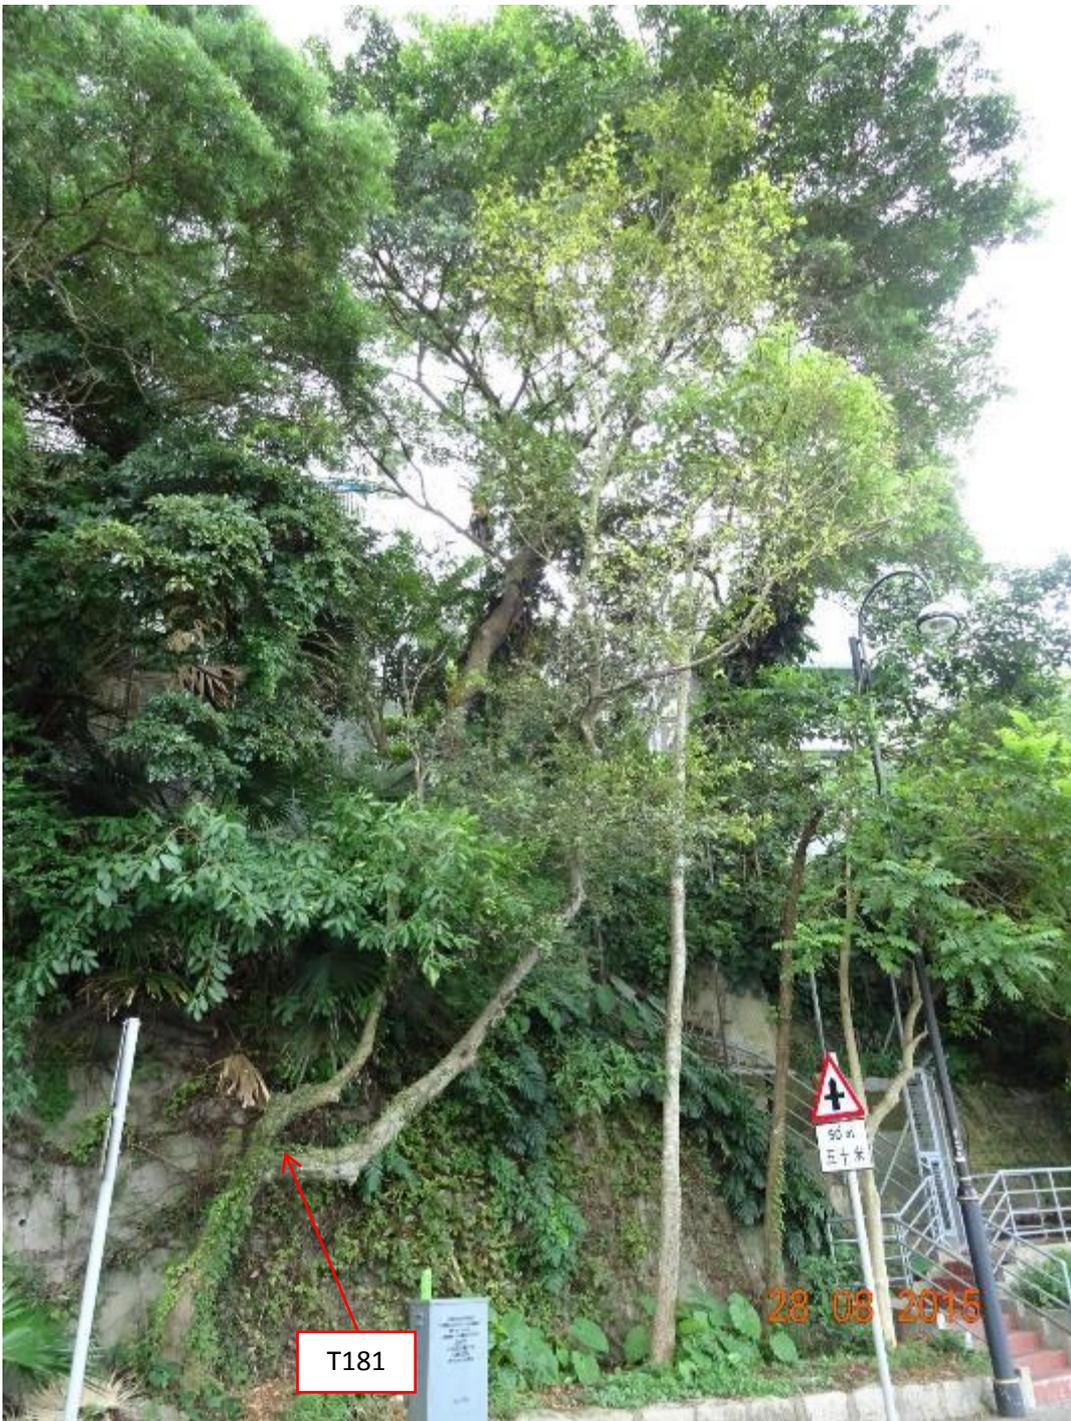
Overview of the subject tree T181. Crown cleaning is recommended.

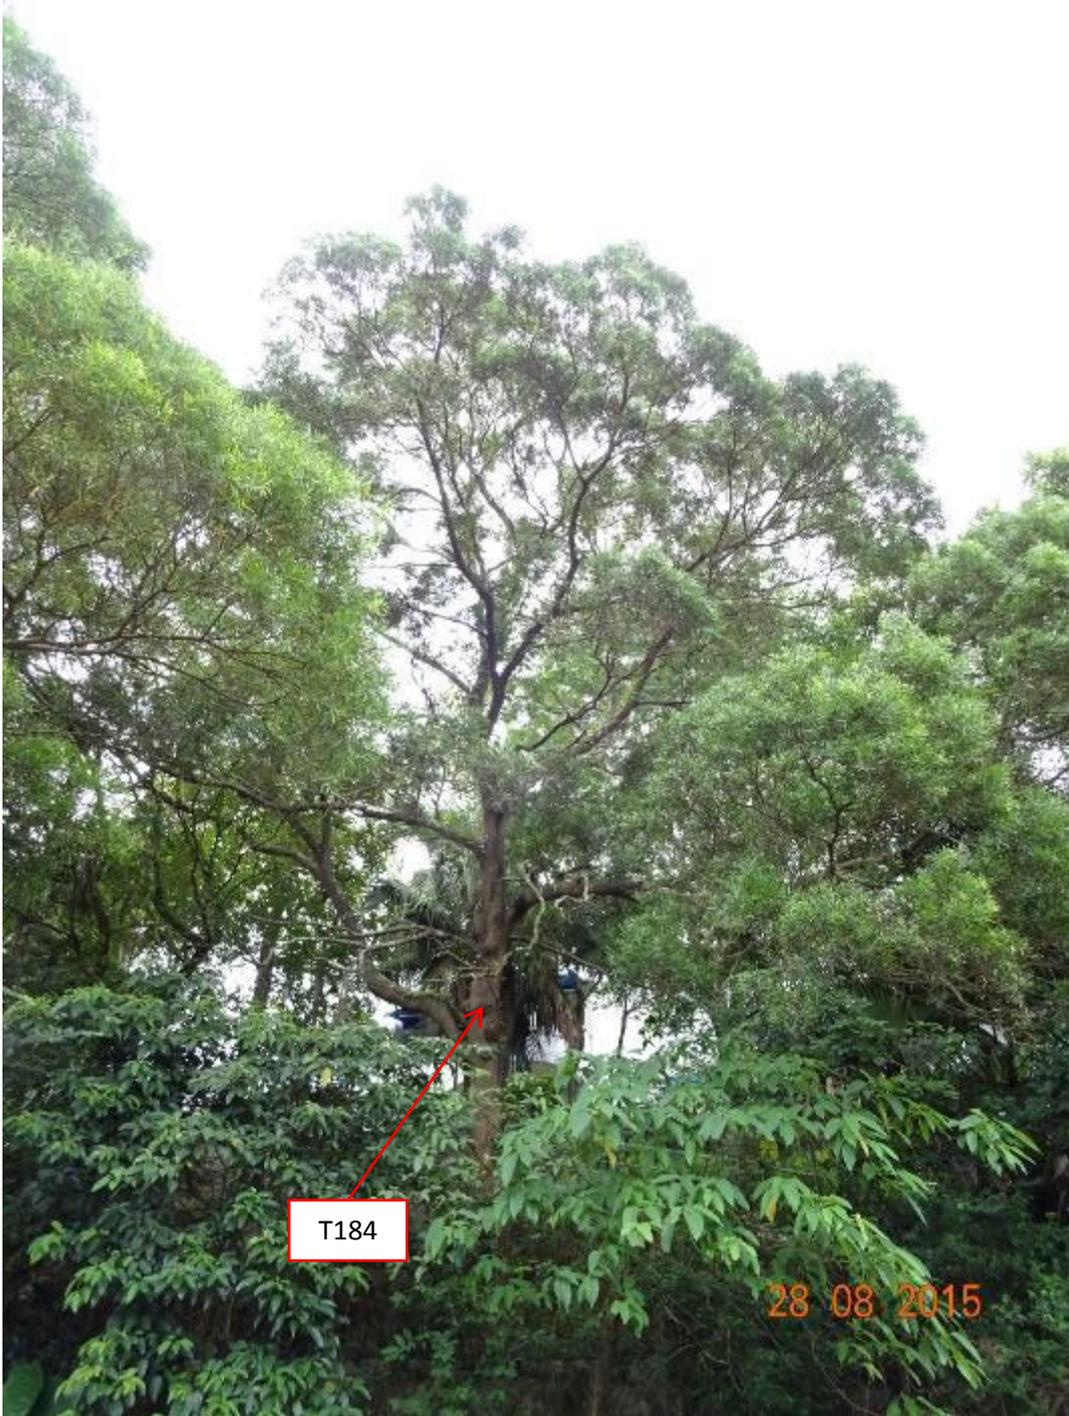
Overview of the subject tree T184. Crown cleaning is recommended.

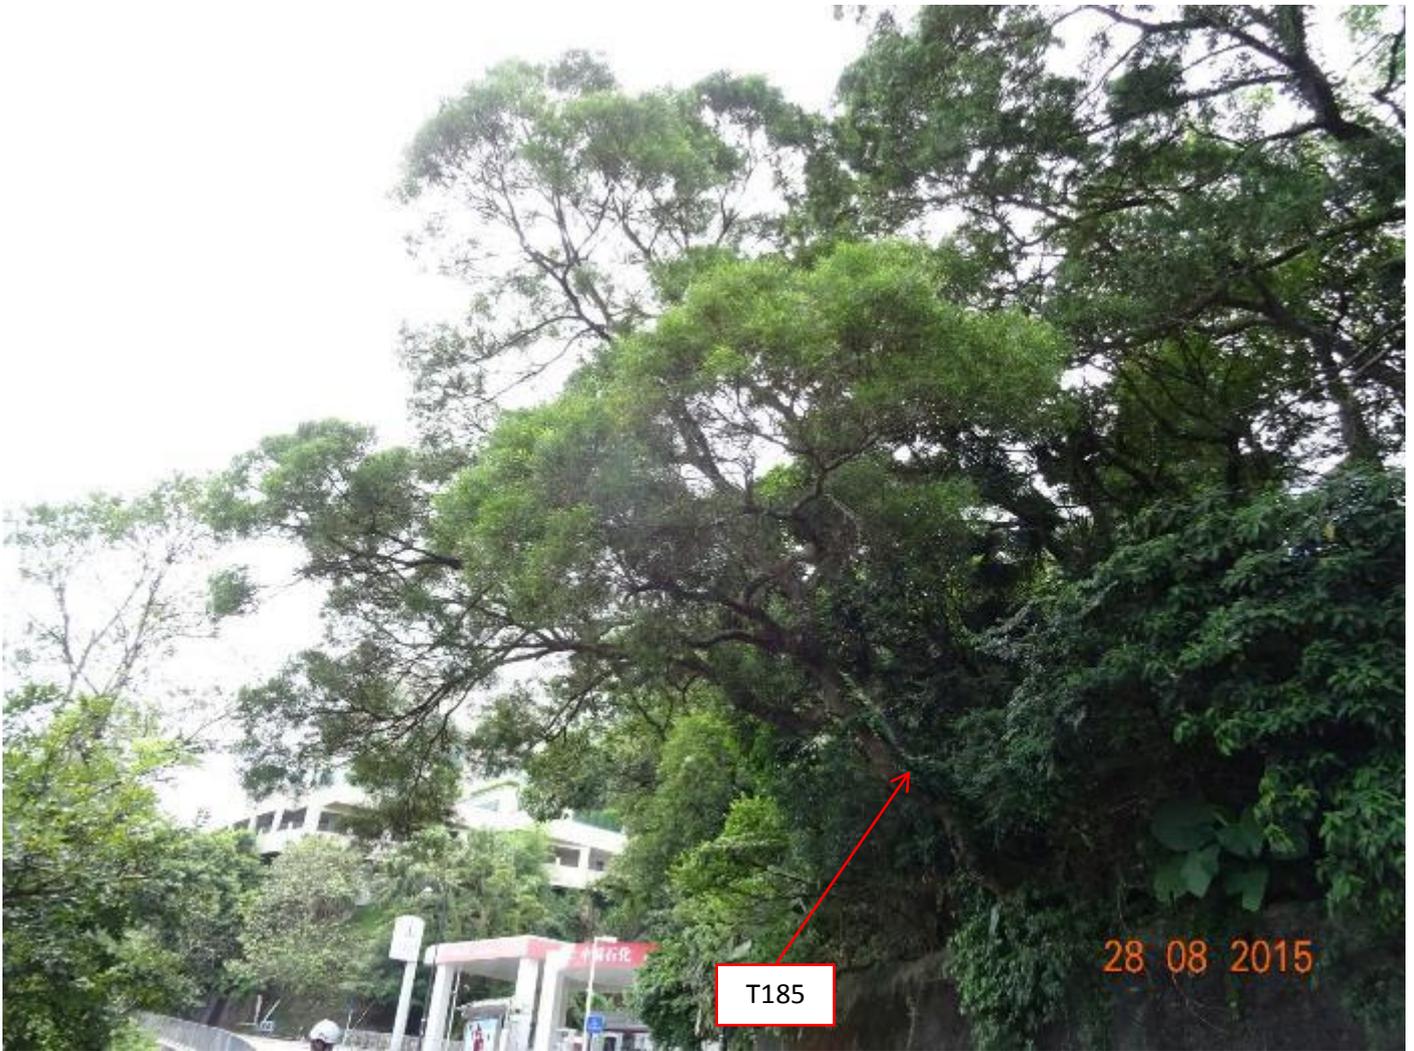
Overview of the subject tree T185. Due to the limited access on the slippery slope, carry out aerial inspection is recommended.

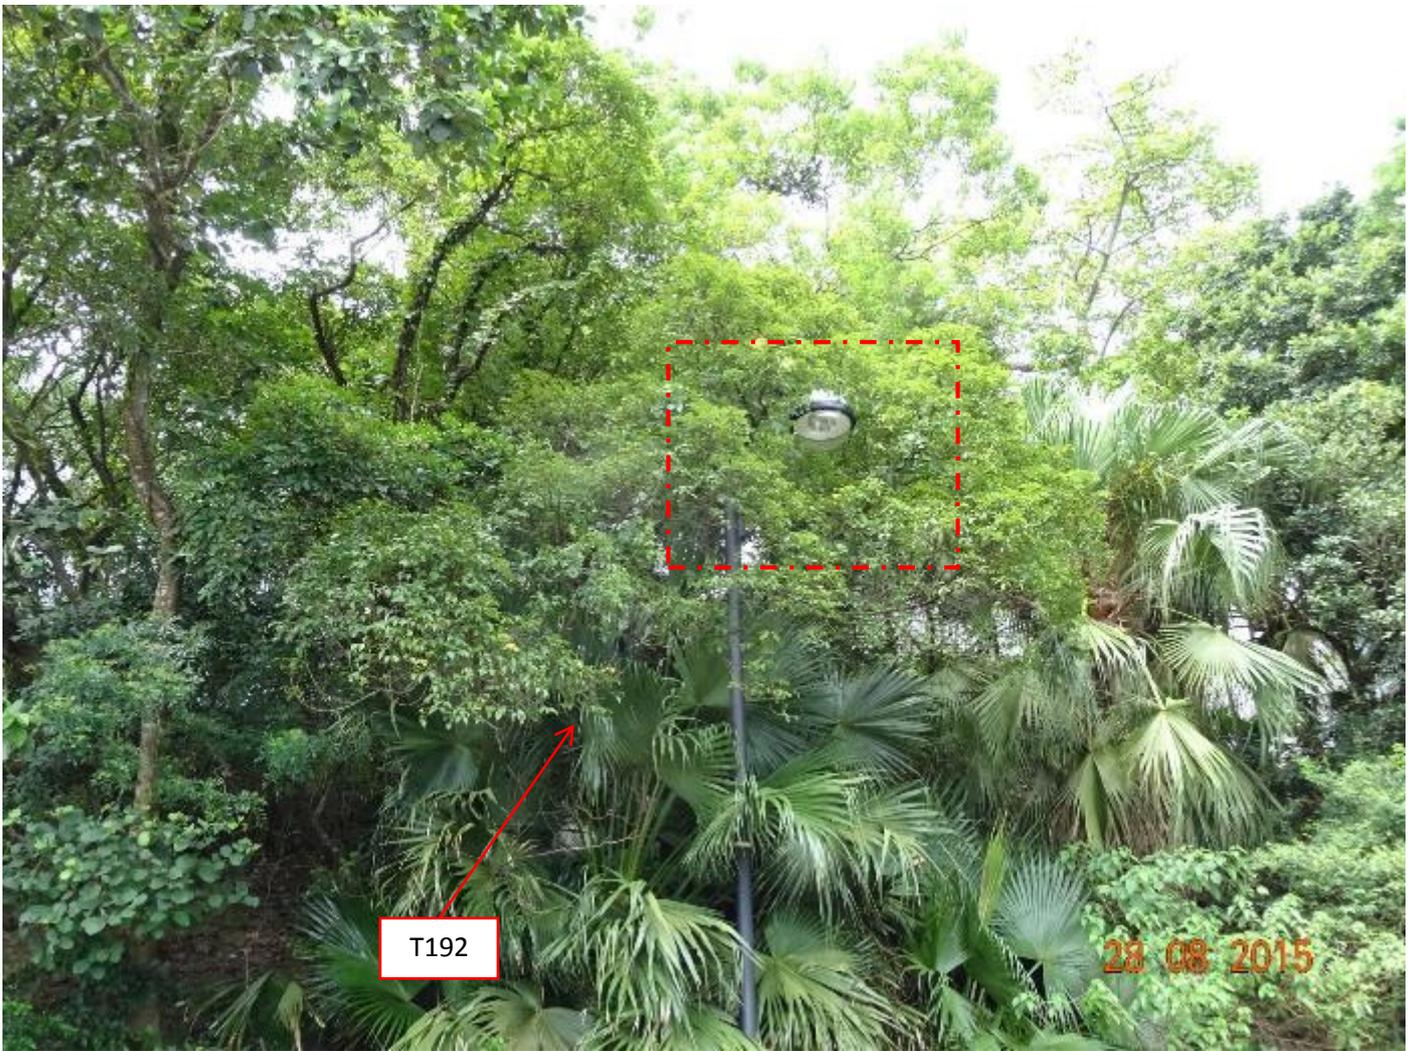
Overview of the subject tree T192. Lamppost clearance for LP#37489 is recommended.

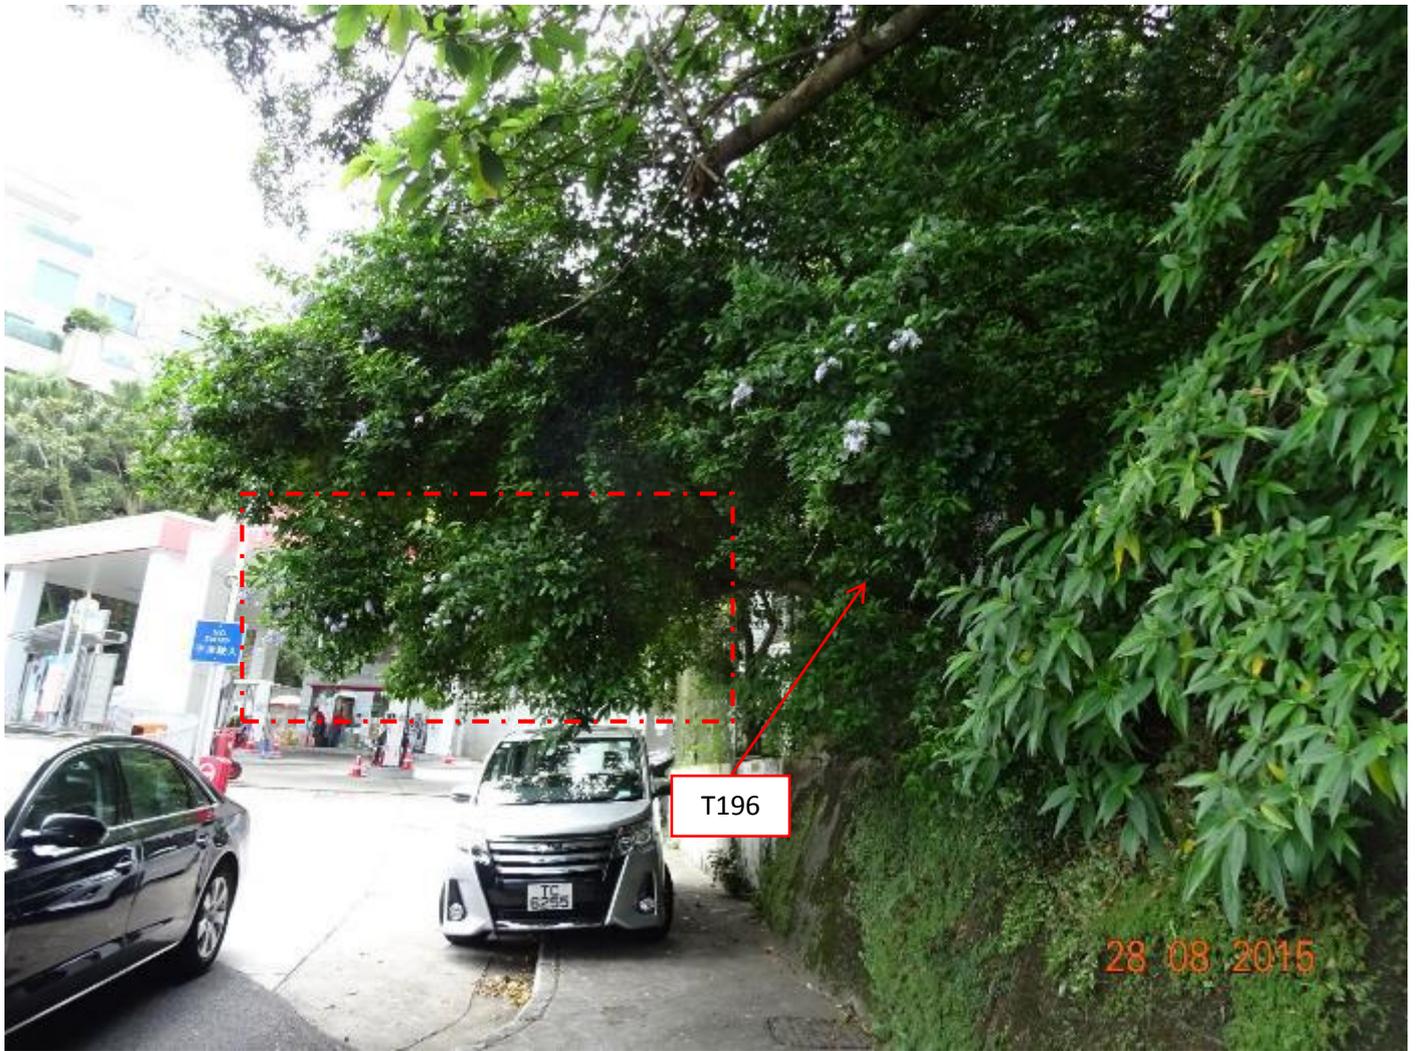
Overview of the subject tree T196. Crown raising to add 2-3 meters clearance is recommended.

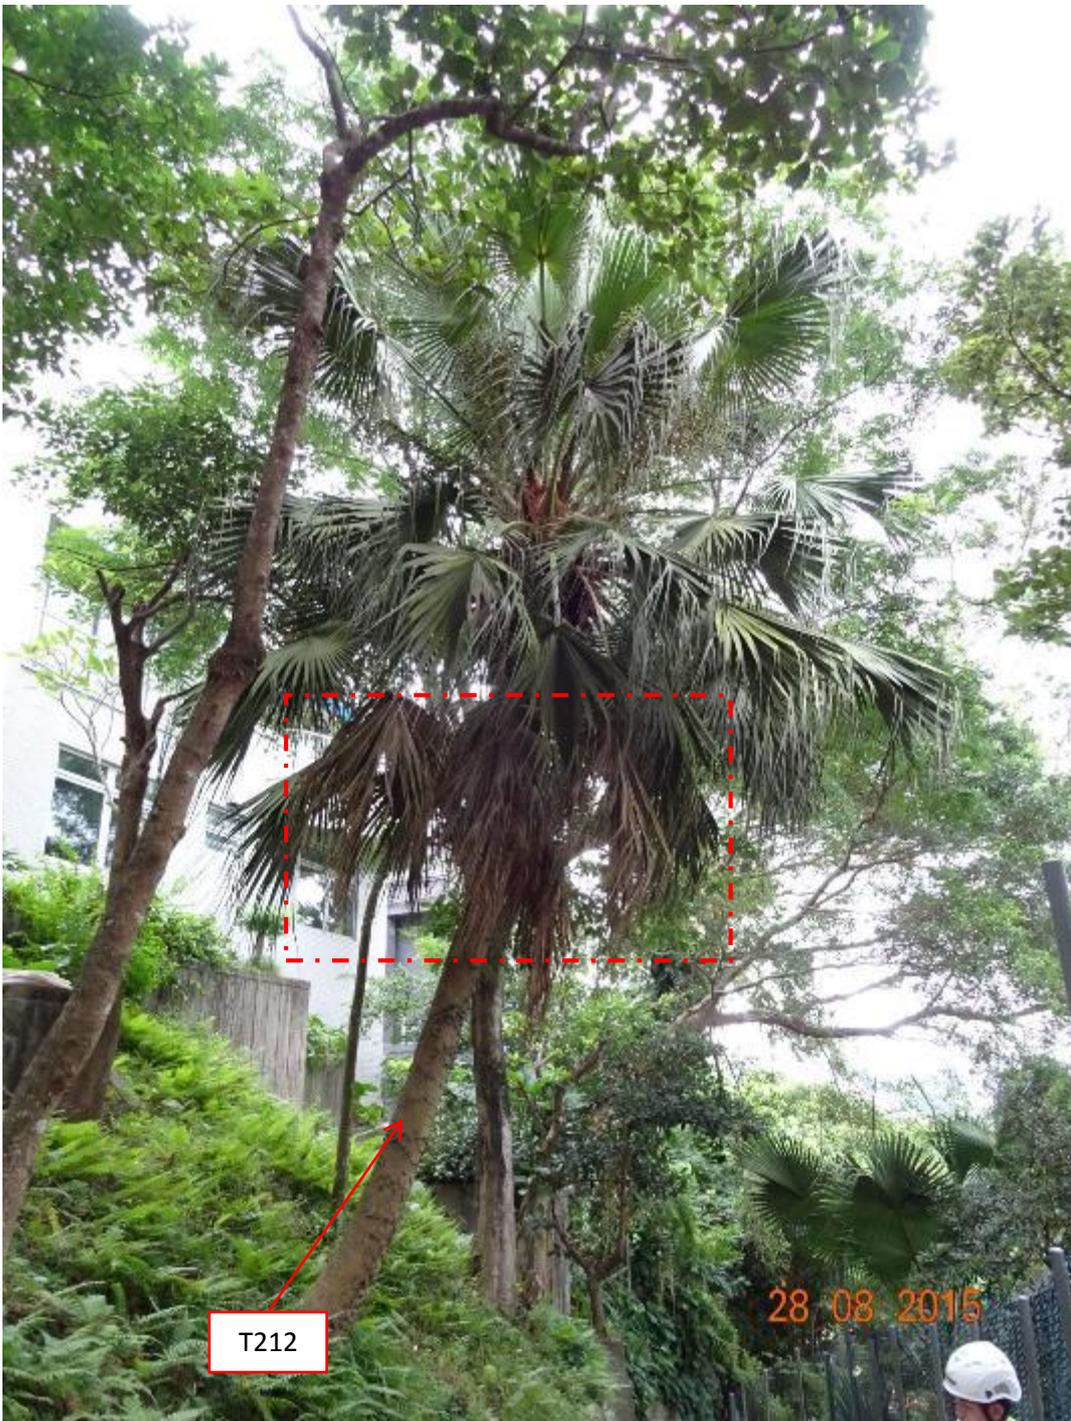
Overview of the subject tree T212. Crown cleaning is recommended.

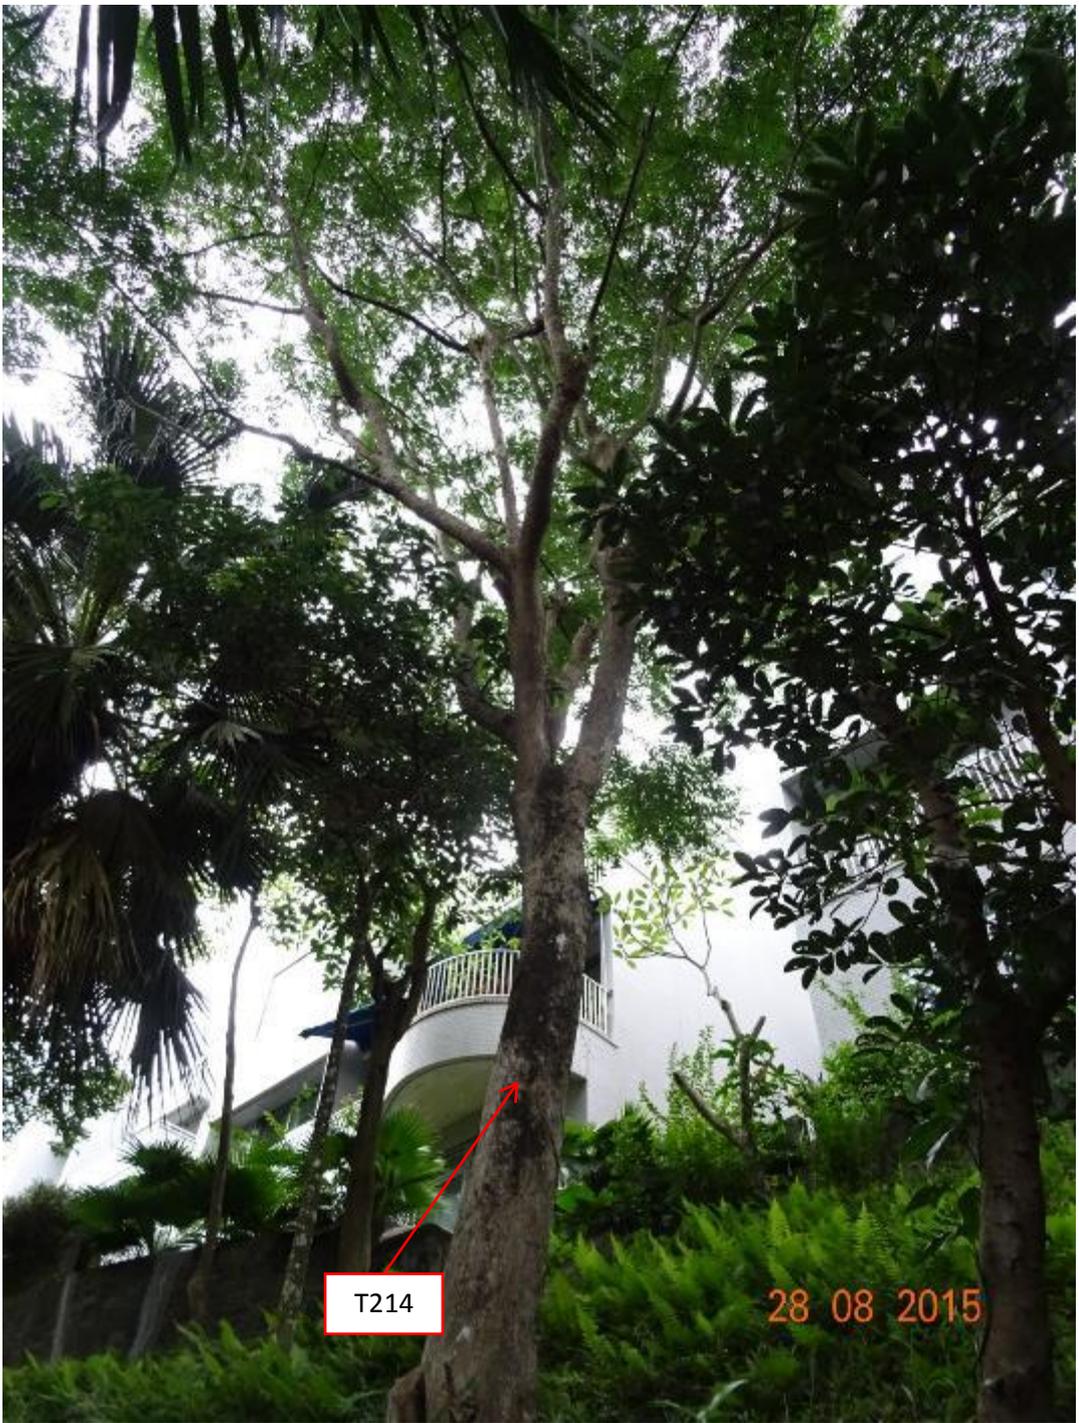
Overview of the subject tree T214. Crown cleaning is recommended.

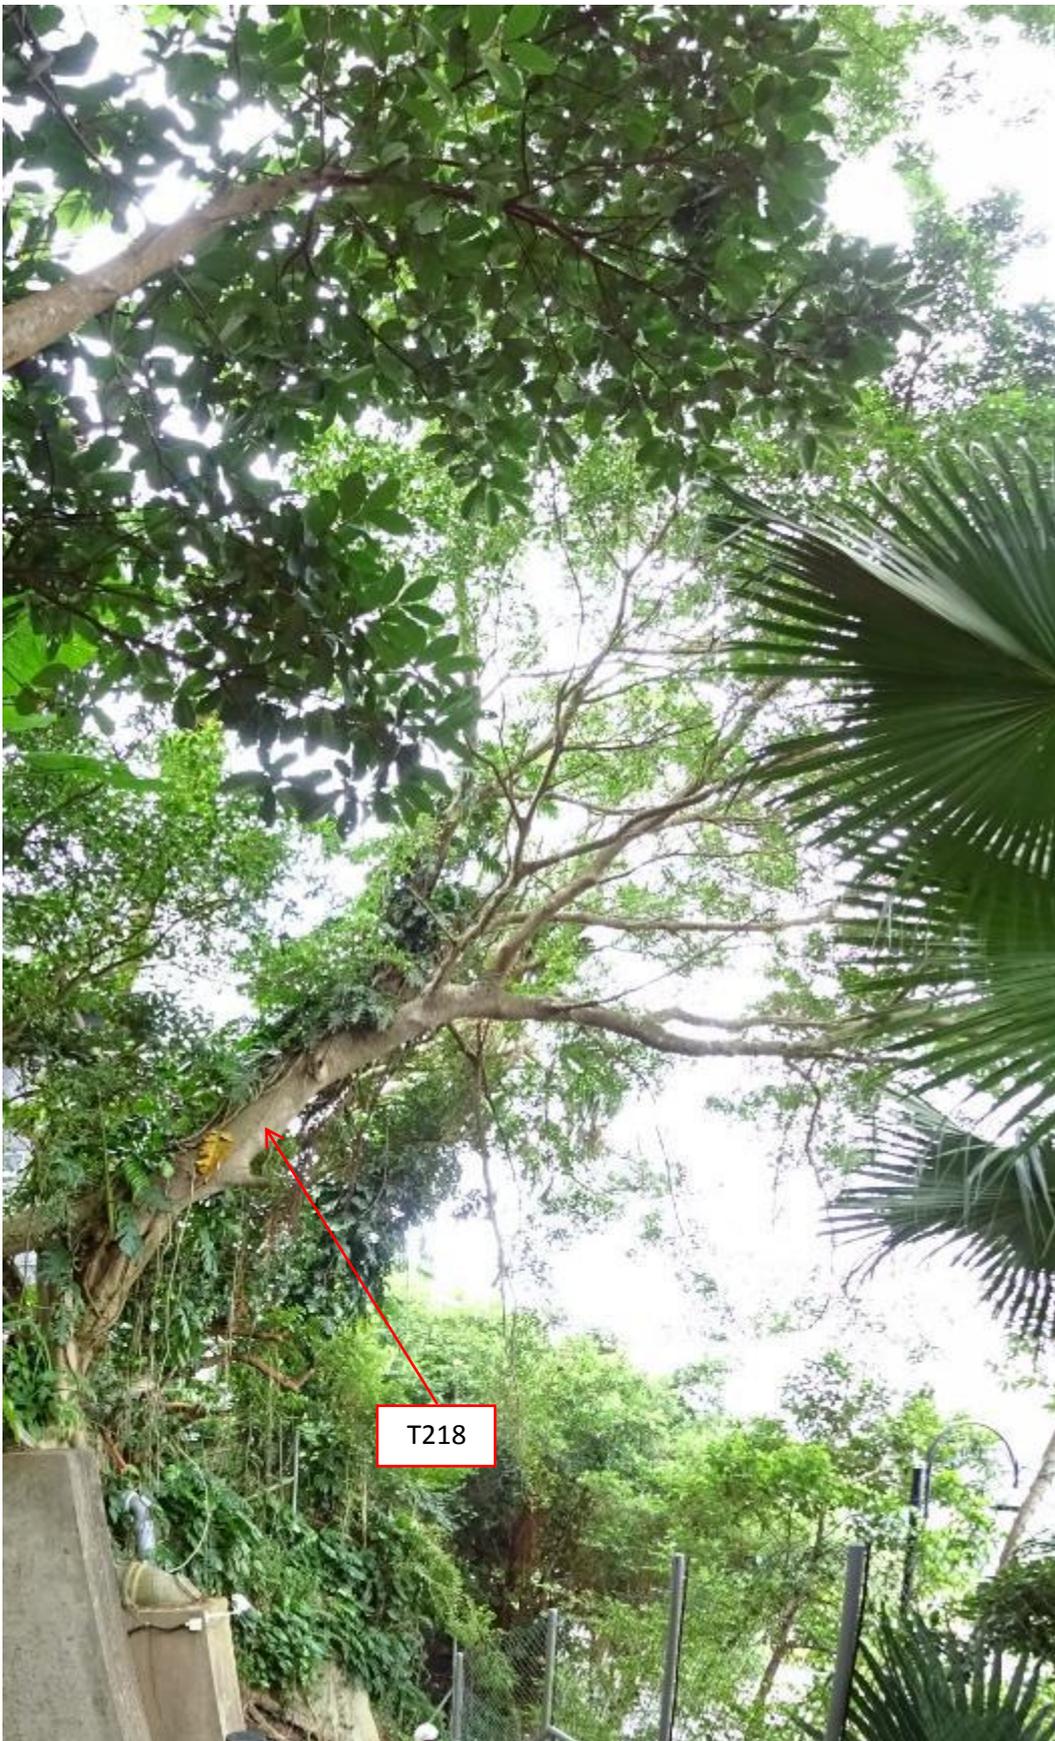
Overview of the subject tree T218. Crown cleaning is recommended.

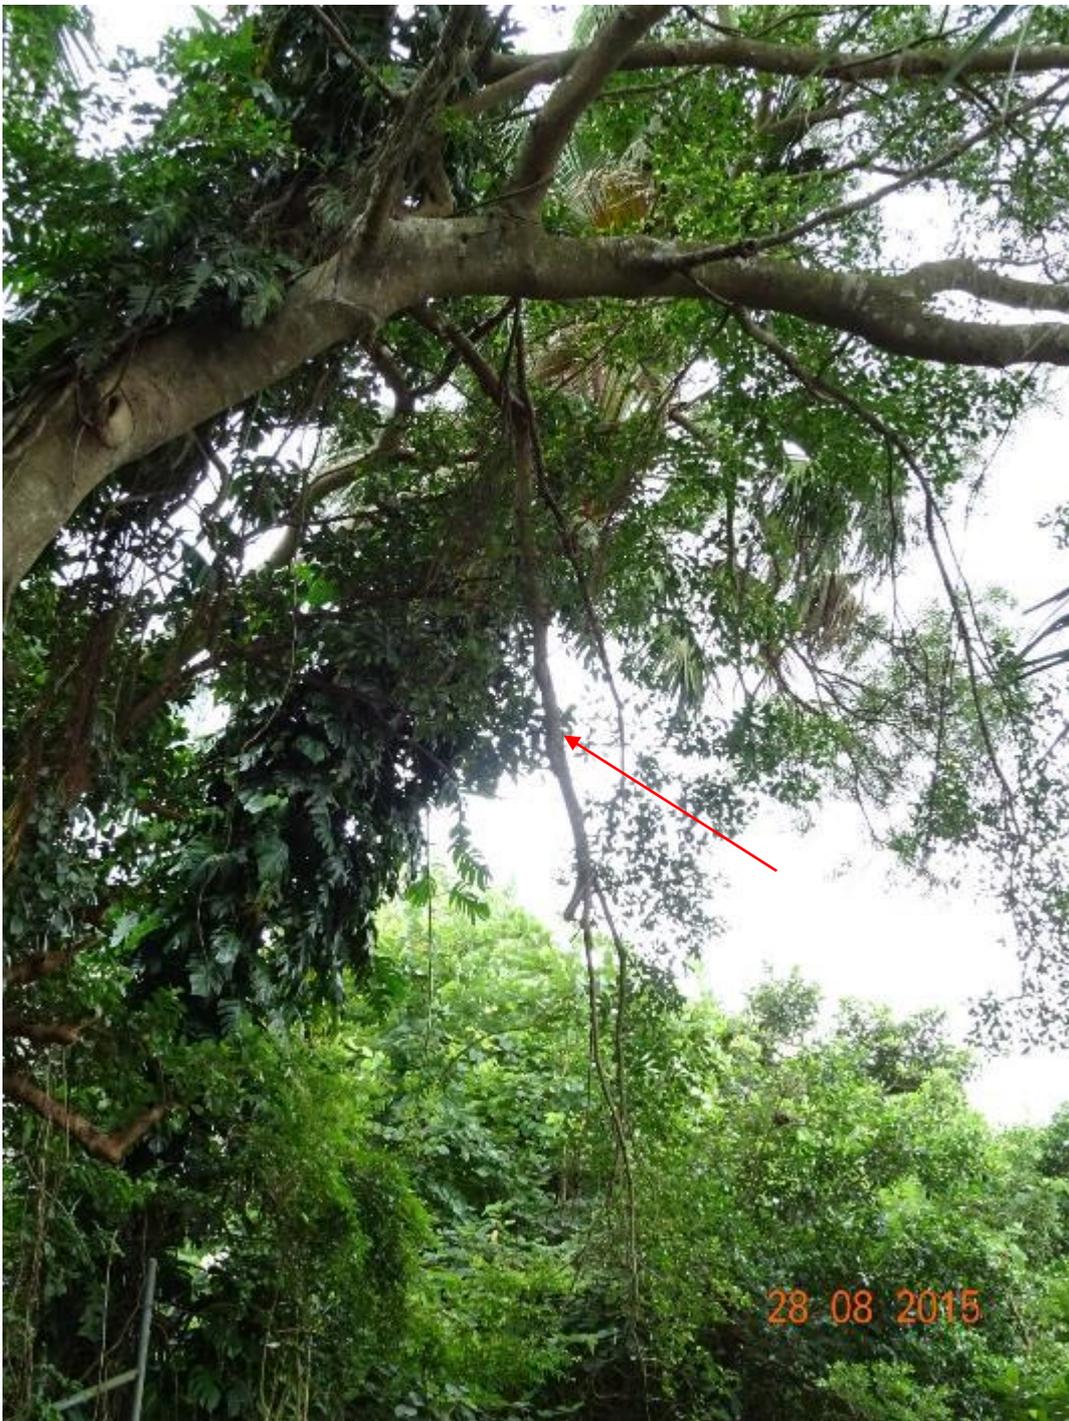
T218: Remove the dead branch is recommended.

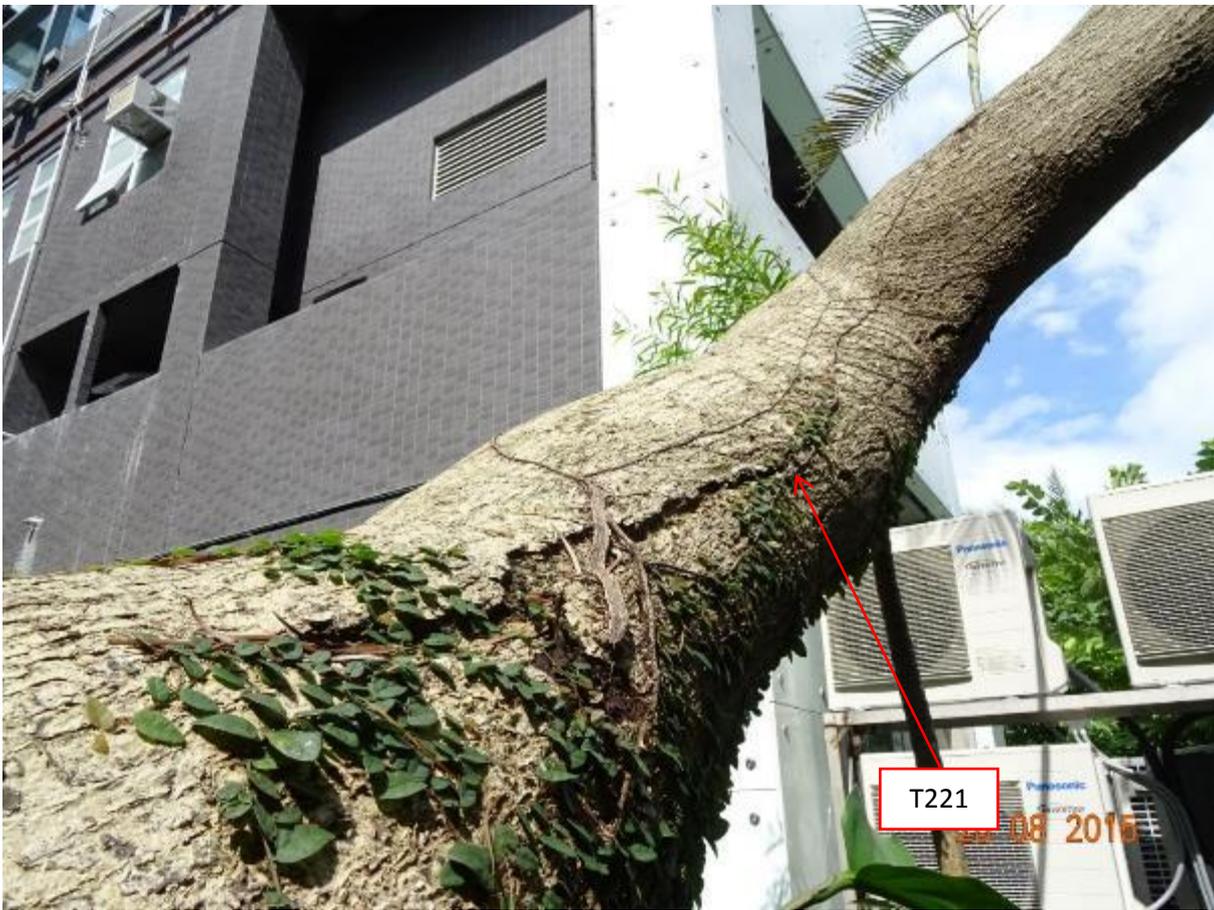
Overview of the subject tree T221.

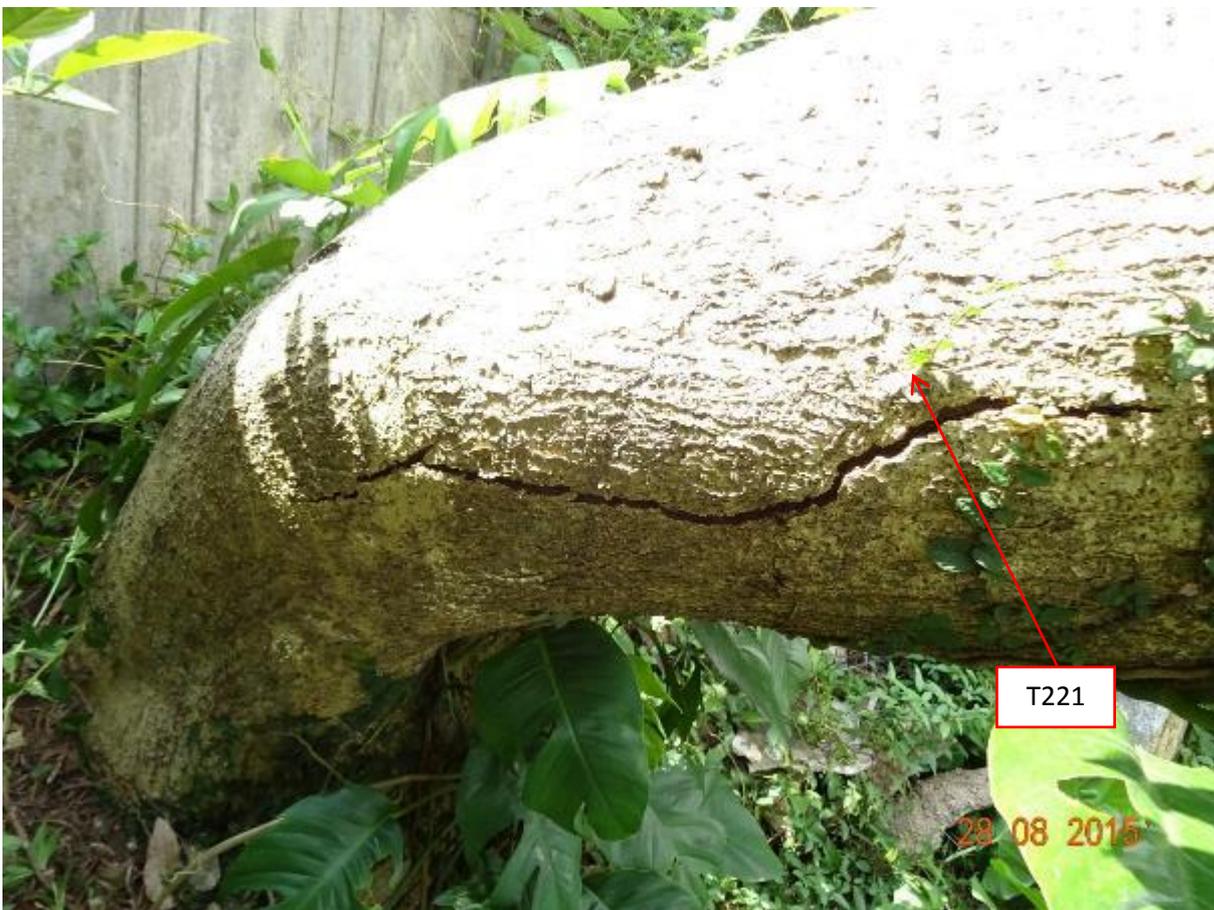
T221: A long crack is observed at the lower trunk. Further tree assessment is recommended.
