Bakheng Preservation Work - April 2009 Report

In March 2009, WMF's Phnom Bakheng Conservation Project focused on site mobilization, emergency stabilization, necessary archaeological excavation in preparation for site work, and condition surveys and documentation of the section of the temple currently under examination. WMF is studying the EFEO archives in

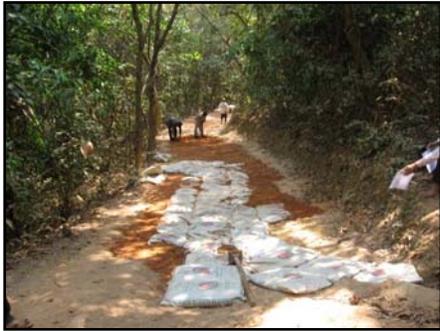
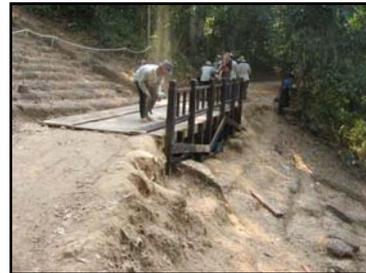
The mobilization of the site included the repair of the pathway to Phnom Bakheng and expansion of the existing workshop. These two images illustrate the repair work on the pathway that will allow it to be used efficiently for bringing materials and equipment to

the site. The team has reinforced the wooden bridge over the northern laterite stairs. APSARA has granted permission for a truck to be used for some work and this has accelerated the team's ability to mobilize the project. This bridge will be used to transport the tower crane, arriving at the end of May or beginning of June, up the hill to the site.

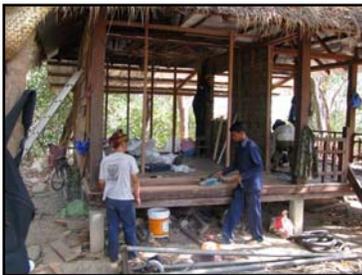
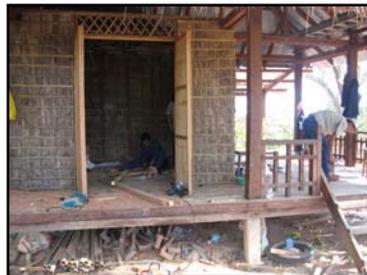
The existing site workshop was repaired and enlarged to store materials and technical equipment. These images below show the the workshop, which will be also used as a small field office.

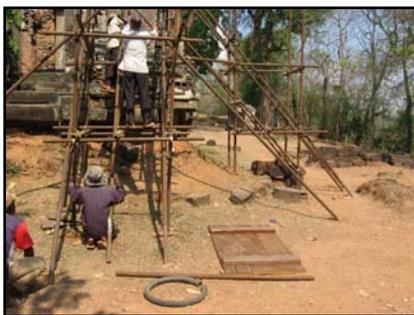
Two emergency stabilization structures were installed at Phnom Bakheng in

March 2009. A section of the first platform wall at the northwest corner was perilously leaning and was in need of emergency stabilization. Wooden shoring was installed to prevent collapse. The foundation of brick shrine G10 was heavily deteriorated, and scaffolding and wooden props, shown here, were installed in preparation of the repair of the foundation.

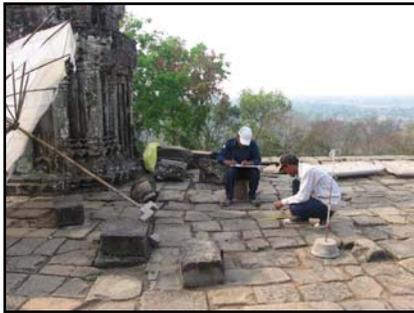
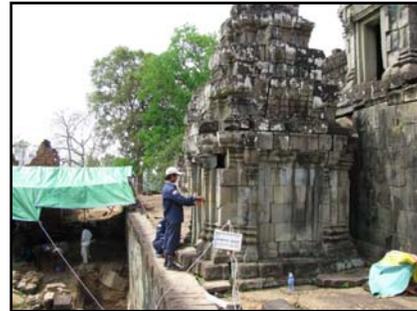
The team completed on-site documentation of the platform floor plans within the work area and has begun surveying and documenting the existing conditions of the 16 sandstone shrines. They have prepared Auto CAD drawings of all of the elevations and almost all of the floor plans based on on-site documentation.

These auto CAD drawings will be combined to create a coherent plan of the temple section under conservation. Total Station equipment is being utilized for the preparation of comprehensive digital documentation of the temple.

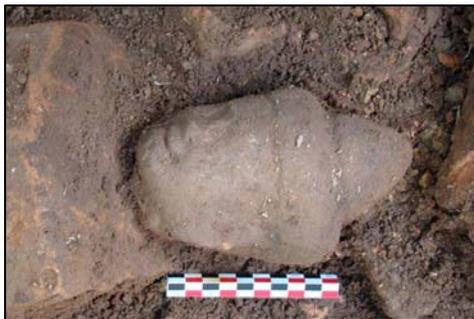
The archaeological excavations at Phnom Bakheng have led to the clearing of the passageway between the temple and the brick shrines, to the exposure of architectural elements, and to the discovery of artifacts. The team has opened trench number 4 to clear the passageway between the temple and the brick shrine. Porcelain archaeological material and the head of a statue were found in the debris. This work confirmed speculation that accumulated debris in this trench was due to a natural collapse. Sometime during the EFEO's restoration work at Phnom Bakheng between 1920 and 1949, they created the ramp by shaping and reinforcing the remains of the collapse to transport material up to higher levels.
