Phnom Bakheng Conservation Project Update

April 2014

In recent months work at Phnom Bakheng has focused on repairing the Northeast and Southeast corners of the structure. Terrace stabilization, waterproofing, and wall reassembly were all major concerns.

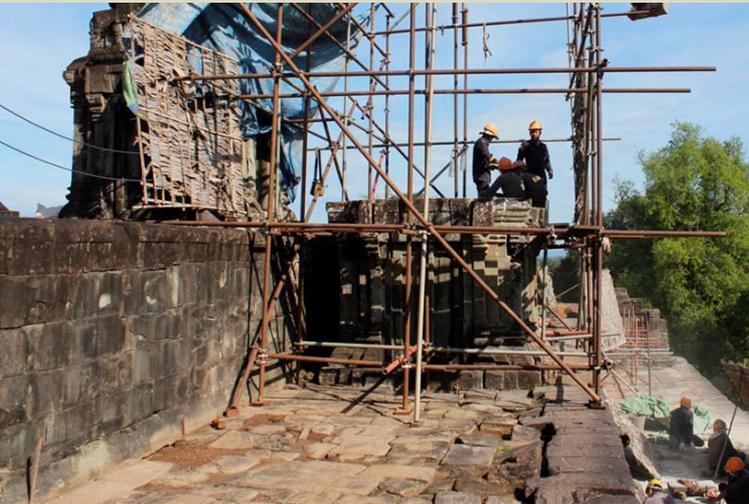
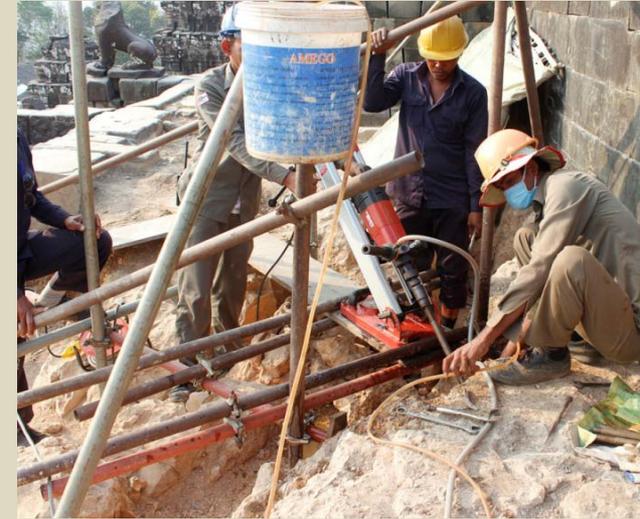
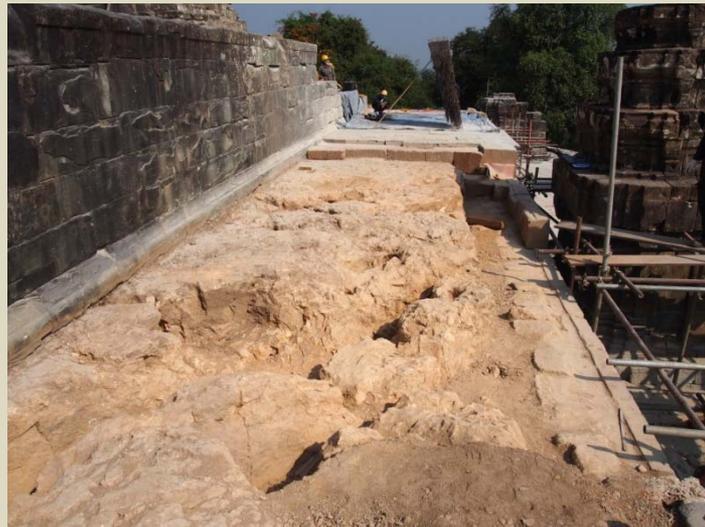
In another area of the temple, the WMF project team dismantled one of the shrines and discovered severely eroded bedrock in the foundation. Conservators removed parts of the bedrock and filled gullies in the surface with laterite. Side faces of the rock were connected using steel pins. Photos below show the shrine being dismantled (left), the condition of the bedrock underneath (middle), and the installation of supporting pins (right)

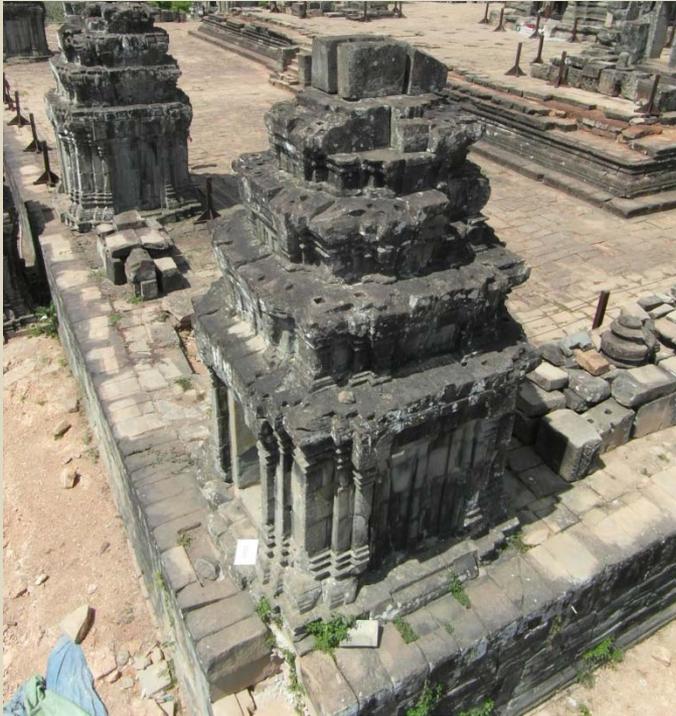
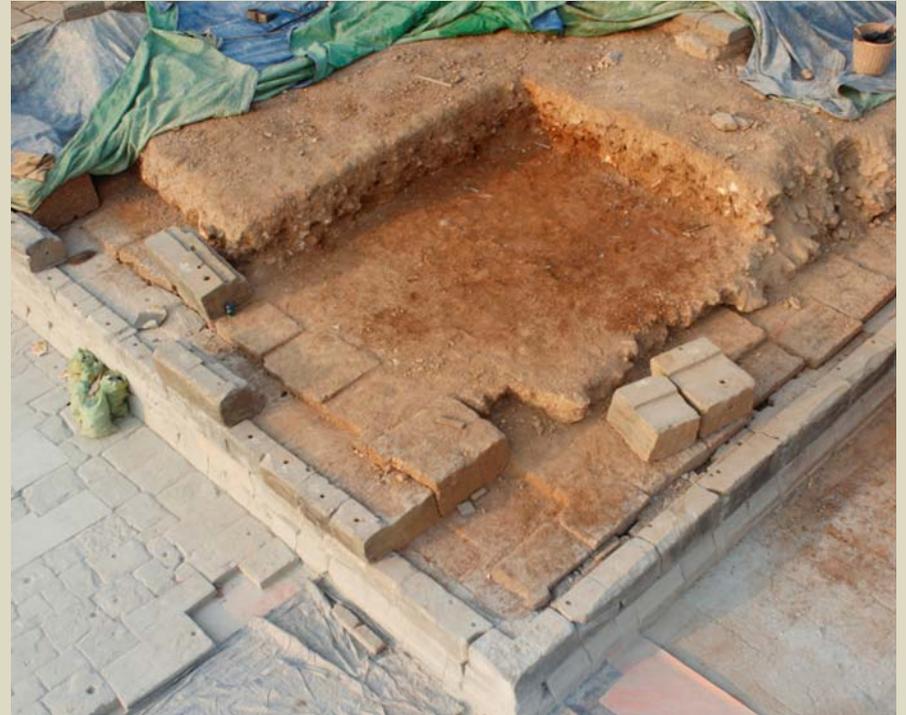
The final task on the Northeast corner of the temple was to reassemble a section of wall. The shrine visible in the photo on the left previously sat on a foundation of crushed laterite and bedrock. Structural analysis revealed that the front walls were incapable of providing necessary support.

After discussing multiple options, the conservation team chose to insert laterite blocks into the foundations underneath the front walls of the shrine (right) to assure proper stability.

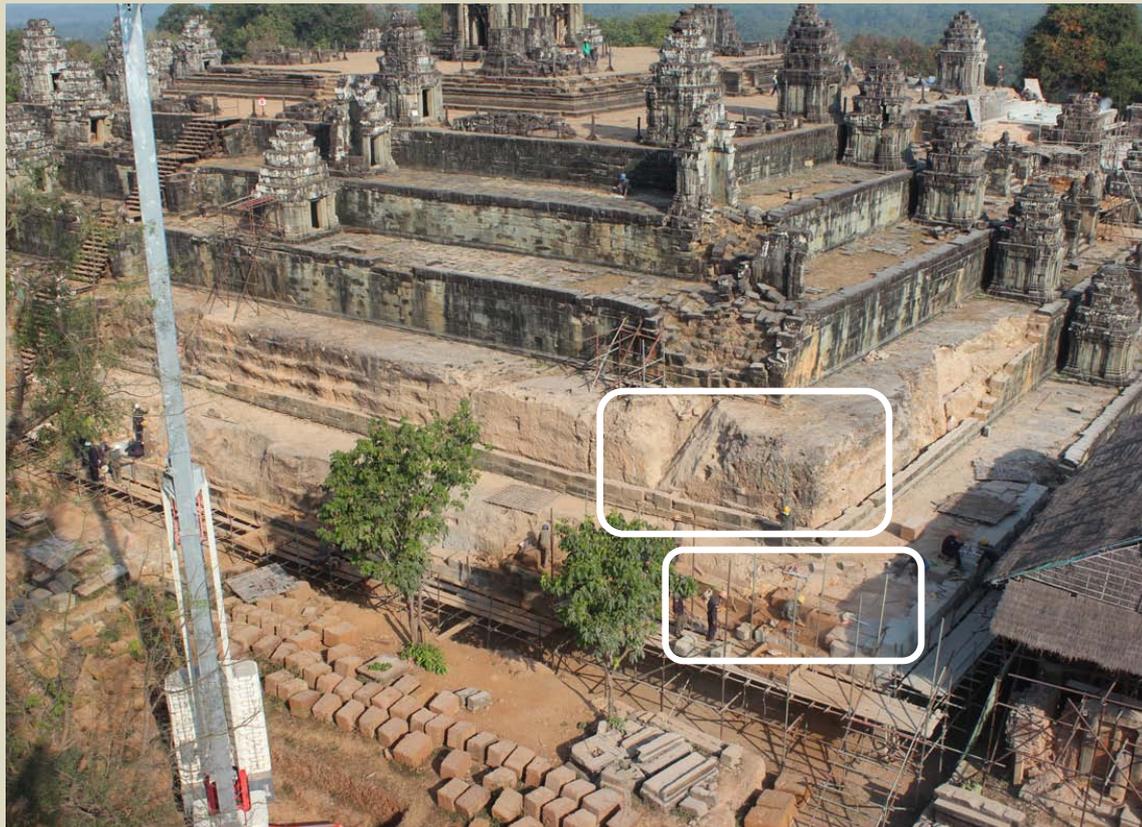
Work continued on the repair of the southeast corner at Phnom Bakheng. Recent efforts have focused on reassembling the two bottom layers of the temple. In total, the restoration effort will require 742 blocks, many of which have already been collected from historic blocks scattered on the site of the hill
