Phnom Bakheng Progress Report December 2010

1. Structural repair of the northeast corner

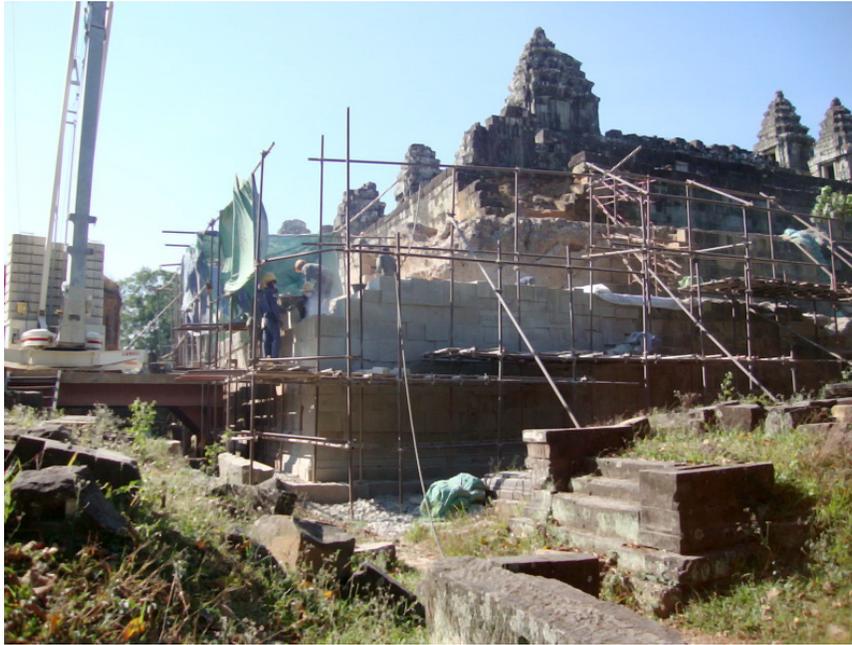
Figure 1: Work progressing at the northeast corner

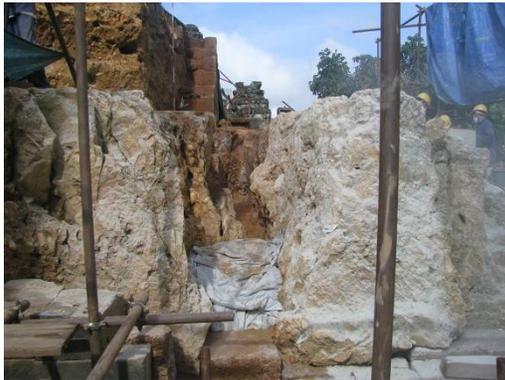
Reassembly of the lowest level at the northeast corner is reaching completion. Prior to reinstallation of the wall units and new pavers the bedrock has been cleaned and all deteriorated material was removed. The bedrock was found to be in very poor condition. To improve site conditions, stainless steel rock bolts and infill of new laterite blocks were installed. Sandstone was used as part of the fill to provide necessary load bearing stability. Gravel has been used to fill in areas where it can act as natural drainage. There are also weep holes hidden in the walls to facilitate drainage and improve the movement and evaporation of water to keep areas as dry as possible where moisture would erode the foundation and stability of the monument. In a humid environment such as Angkor and given the heavy seasonal rains, conduction of water and prevention of pooling and standing water are significant factors in long term protection of the condition of the monument. The bedrock surface has been leveled where needed and cracks and depressions were filled with laterite and small gravel to create a homogeneous slope to facilitate proper water flow. Where the wall does not bear directly on the bedrock, deteriorated laterite is replaced and the wall reassembled with the use of reinforced structural fiber pins.

Figure 2: Condition of bedrock at northeast corner level F

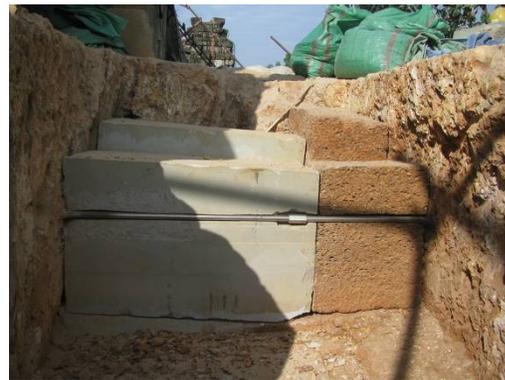
Figure 3: Detail of bedrock repair

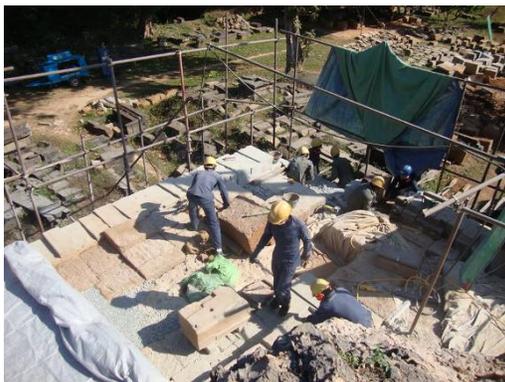
Fig 4: Reassembly of northeast corner level F - pavement

Original and new sandstone units were installed as part of the reassembly process. Thus far about 500 new laterite blocks and 300 new sandstone units have been prepared and installed at the lowest level at the northeast corner. The team is preparing new stone pavers to install at the lowest level. In February 2011, the waterproofing membrane will be laid and the crew will be trained to implement the technical details of this procedure. Reassembly of the lowest level with new pavement and water proofing membrane will be completed by the end of February 2011.

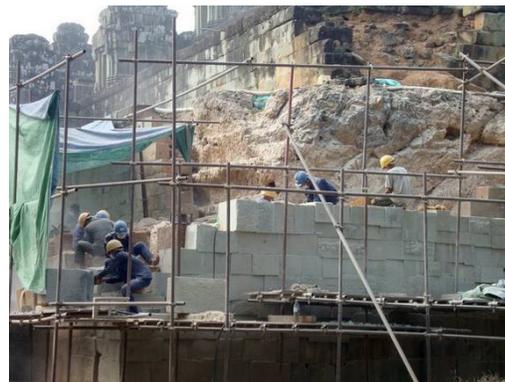
Fig 5: Reassembly of northeast corner – northern wall

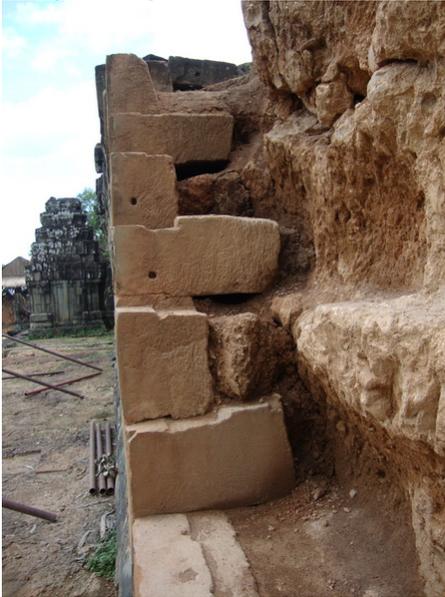
Figure 6: In-fill condition before repair

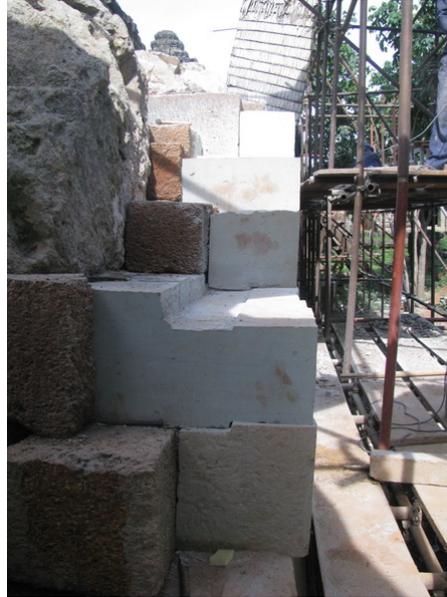
Figure 7: Condition after repair

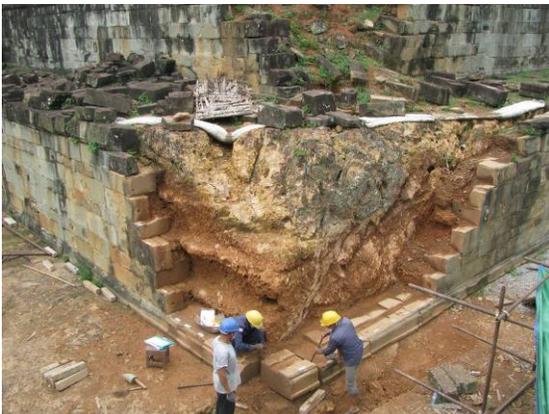
Figure 8: Northeast corner level E during disassembly

Disassembly of the second and third levels at the N\theast corner has begun. The wall has been dismantled to levels that were found to be in structurally sound condition. Stones that were originally in these locations but were scattered as a result of an earlier collapse have been moved to safe locations and the original stone pavers have been cleaned and moved to storage or the workshop for documentation and stone conservation. The bedrock at level E was found to be in similarly bad condition as the bedrock at the lowest level F. Thus, it will require structural repair by installation of rock bolts and replacement of deteriorated portions with new stone as described earlier in this report. Unstable areas of bedrock are currently being supported by scaffolding that WMF installed. The documentation team is conducting condition surveys of the bedrock in preparation for the repair of this section.

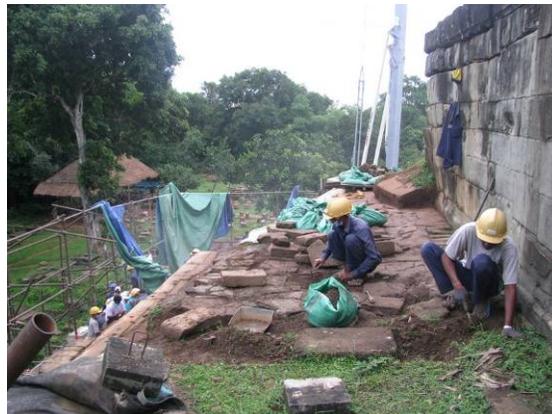
Figure 9: Northeast corner level E terrace cleaning of original pavement

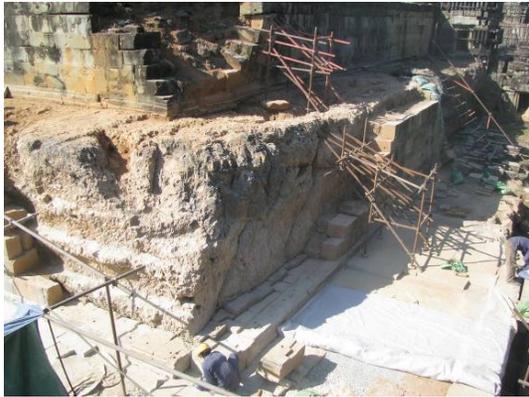
Figure 10: Northeast corner level E bedrock condition

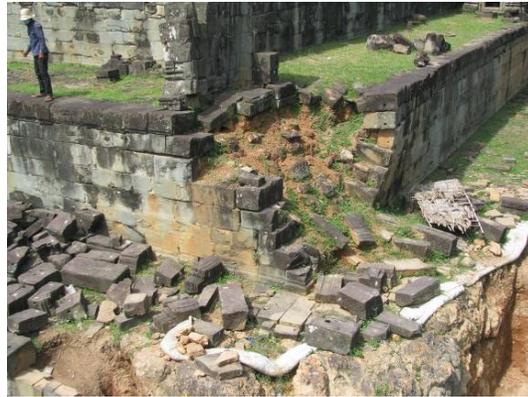
Figure 11: Northeast corner level D existing condition

To continue work at level E partial disassembly of the next upper level D will be required. This will include the disassembly of unstable wall sections and the remains of a sandstone shrine. There will be extensive documentation of this area prior to dismantling. Recording of conditions, dimensions, and other data will include wall sections, remains of a corner sandstone shrine on the terrace of level D, and existing original pavement. The documentation entails photographs of existing conditions of all sections of the wall and the existing stone pavers, graphic documentation and condition surveys, stone numbering, searching for fallen stone units to be returned to their original locations, and the design of new stone units for areas that require replacement.

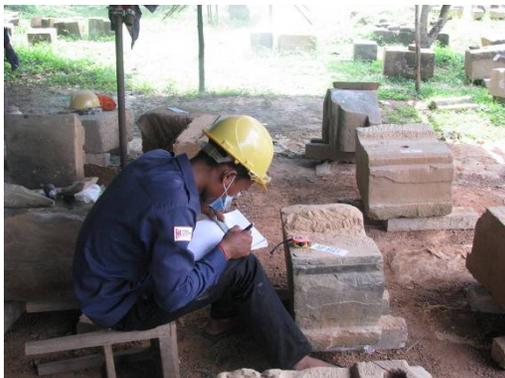
Figure 12: Documentation and condition assessment

Stone conservation measures include, documentation, cleaning, desalination, structural consolidation of broken blocks, and reattachment of fragments using adhesives. Work is progressing to repair original stone blocks to be returned to the temple structure. Final surface finishing of the stones including mortar repairs will be executed after the wall has been reassembled. The team continues to prepare new laterite and sandstone units for the repair of the walls and terrace pavers. WMF has installed a system of pneumatic stone carving chisels in order to increase production for the preparation of new stone units required for the repair of the temple and the preparation of the supporting bedrock. Training for this system has been completed and the team is effectively working on the stones.

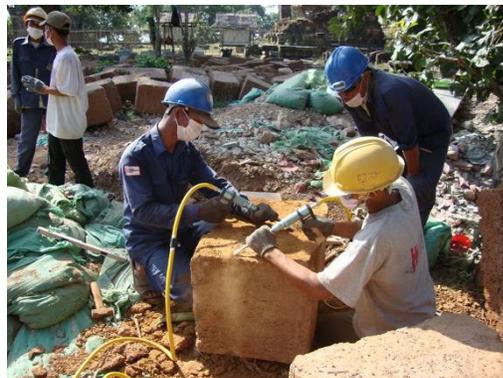
Fig 13: Preparation of laterite with pneumatic chisels
