Report submitted to the 23rd Plenary Session of ICC-Angkor (December 4, 2014)

Phnom Bakheng

Preah Khan

Angkor Wat

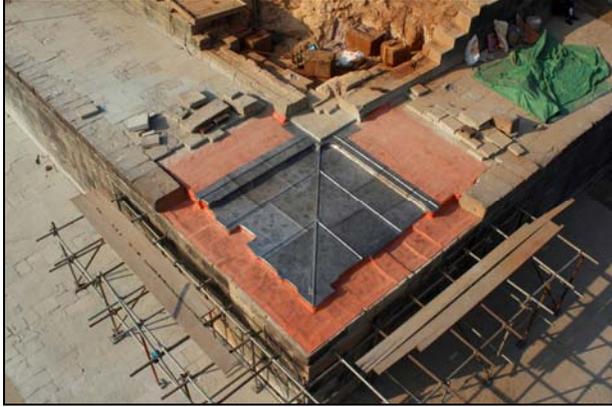
Fig. 1: The northeast corner of level D of Phnom Bakheng during restoration, prior to the reassembly of stone shrine D11, showing the waterproofing system used by WMF.

retrieved for this purpose from the side of the hill. At the northeast corner of level B, the WMF team worked with a structural engineer to determine whether the compacted soil and bedrock foundation could support the weight of stone shrine B11. To strengthen this area, a new laterite foundation was constructed for the shrine, and it was shaped and pitched so as to minimize water retention. Shrine B11 will be reassembled in 2015. Restoration at level C is currently focused on the area around stone shrine C12. The bedrock in this area was found to be in very poor condition, riven by deep gullies, and further decayed due to water infiltration over the centuries (**Fig. 2**). Sandstone blocks were inserted as infill material underneath stone shrine C12 and the abutting wall of level B. Laterite blocks were installed in the rest of the area under repair. This work will be accomplished by the end of the year, before shrine C12 is reassembled. In 2014, the restoration of level D was completed. Shrine D12 was disassembled in March 2013 and the bedrock underneath it was repaired, and reassembly of the structure was completed in February 2014. In prior years, WMF completed the restoration of levels E and F,

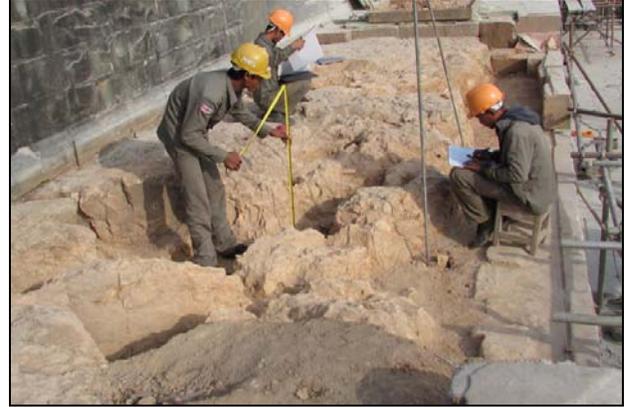
Fig. 2: The bedrock near the northeast corner of level C was found to be in very poor condition and was repaired using new sandstone blocks.

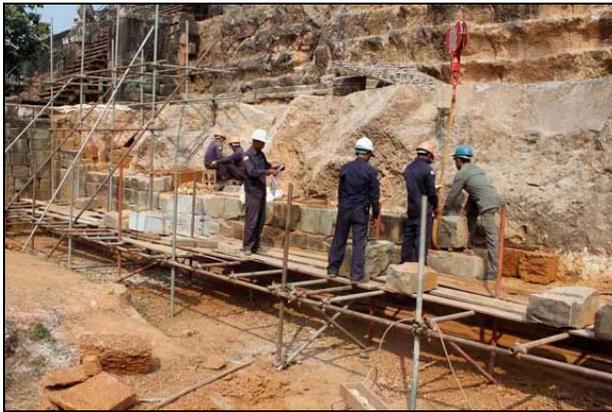
Fig. 3: Wall reassembly at the south side of level F of Phnom Bakheng.

Work on the southeast corner of Phnom Bakheng follows the same approach and applies the lessons learned from work on the northeast corner, as described above and in previous reports. The main restoration activity during 2014 has been wall reassembly at levels E and F (**Fig. 3**). The wall is being reassembled using both original blocks and stone blocks that have been retrieved from the wooded hillside. Laterite blocks are inserted between the wall and the bedrock to act as an interface between them. Fiber-Reinforced Polymer cables are used to tie the wall to the bedrock through the laterite. Where necessary, laterite is also used to repair the decayed or collapsed portions of the bedrock. At level E, the section of the terrace between shrines E1 and E2 is badly fractured. Given the sensitivity of this case, the WMF team has decided to wait until the next visit of the ad hoc expert group for conservation to Phnom Bakheng to present a suitable proposal for this location.

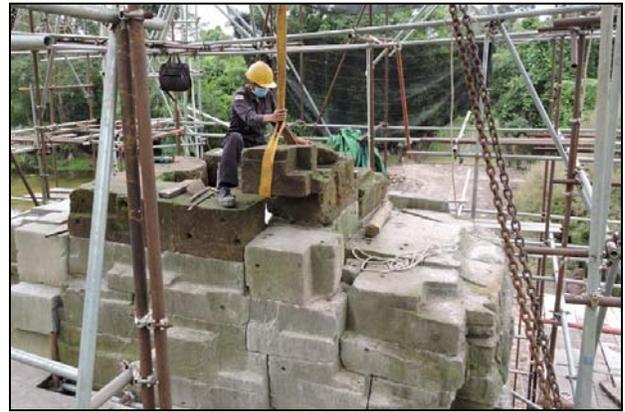
Fig. 4: Reassembly of the Central Tower of East Gopura IV at Preah Khan.

As has been previously reported, in 2014 work at Preah Khan has focused on East Gopura IV. Due to significant structural damage and the threat of collapse, as agreed with APSARA, in 2012 the superstructure of the Central Tower was dismantled to the springing of the arches. Restoration of the tower has been ongoing and is expected to be completed in November 2014 (**Fig. 4**). Some damaged or missing stones were replaced by new sandstone blocks. During the disassembly of the tower precious and semi-precious objects were recovered from holes in some of the blocks. Carefully documented, they

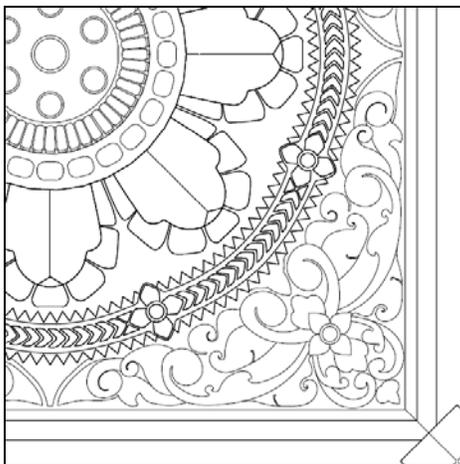
Fig. 5: Detail of proposed design for a new ceiling at the Churning of the Sea of Milk Gallery by Dr. Olivier Cunin.

In consultation with Dr. Cunin, WMF has now finalized a proposed design, consisting of rows of four lotus flowers carved onto wooden planks. The design most closely follows that of a ceiling fragment currently in the Guimet Museum (MG 23513), which was recommended by Dr. Cunin as the most appropriate model for the Churning of the Sea of Milk Gallery. According to Dr. Cunin's research, it is very likely that this fragment originated from one of the 3rd enclosure galleries, based on the location where it was discovered and on the dimensions of its carved decoration. Dr. Cunin has provided WMF with drawings and a 3D model of the proposed design (**Fig. 5**), which has been further refined in the process of carving (**Fig. 6**). A mock-up consisting of four planks will be installed at the gallery, and details about the installation of the ceiling will then be finalized. The installation will be designed so as to keep bats and other animals from entering while allowing for ventilation and for periodic removal to inspect the condition of the vault. The planks are being carved by a skilled wood carver based in Siem Reap, to a thickness of 10 cm, matching the dimensions of surviving ceiling fragments.

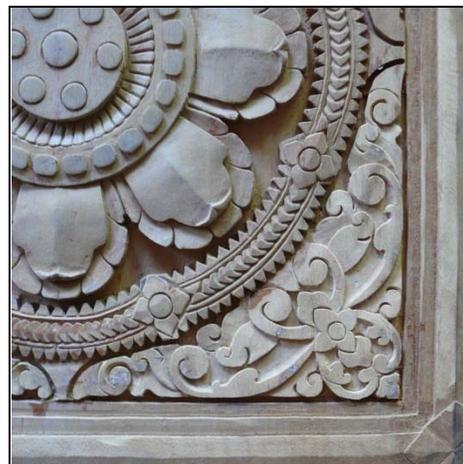
Fig. 6: Detail of plank carved according to the selected design by a carver in Siem Reap.
