Phnom Bakheng Progress Report July 2010

World Monument Fund - Conservation Program at Angkor

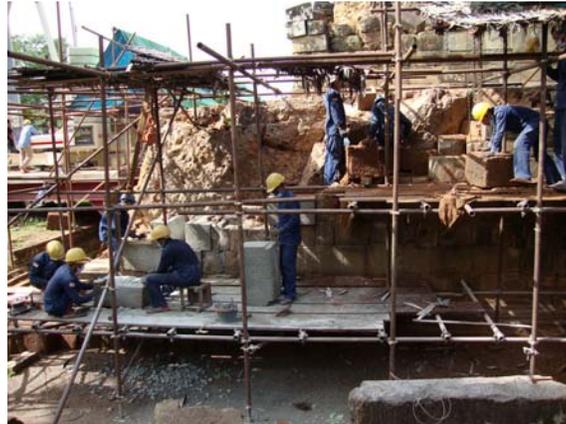
Fig 1: Reassembling NE corner level F

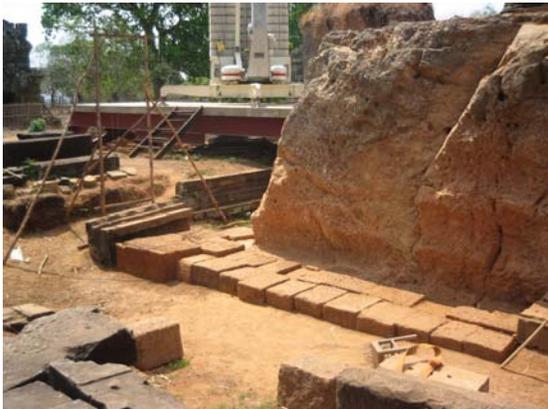
Fig 2: Repaired foundation

Following the approval of the mockup which presented the design of potential waterproofing, stabilization and material conservation options to address the present material decay threats to the central temple, the WMF team has begun to repair bedrock where necessary and to reassemble the wall. Activities include the set up of a reference wall, the in kind replacement of failed laterite foundations, and the resetting of repaired sandstone units and new sandstone replacements under provision of laterite blocks. The laterite is cut to fit exactly into the gap between sandstone wall and bedrock to provide structural stability. Smaller pockets are filled with gravel. In addition, fibre reinforced plastic rods are installed in selected locations to work against lateral pressure to the wall by potential water and soil infiltration.

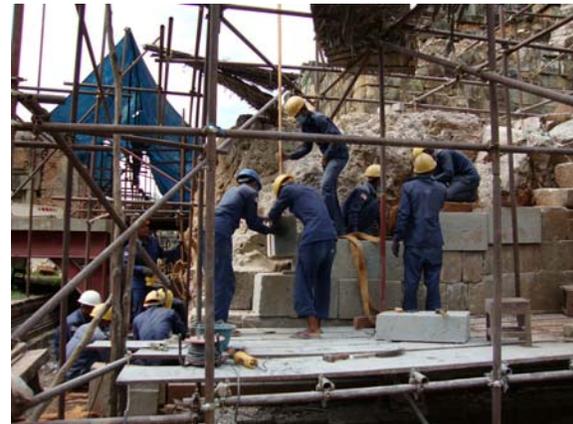
Fig 3: Reassembly of NE corner wall level F

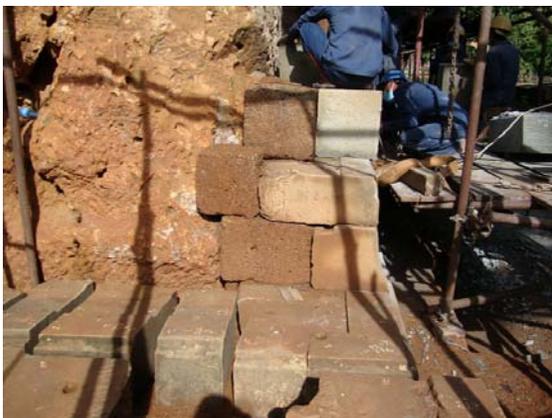
Fig 4: New laterite fills and sandstone units

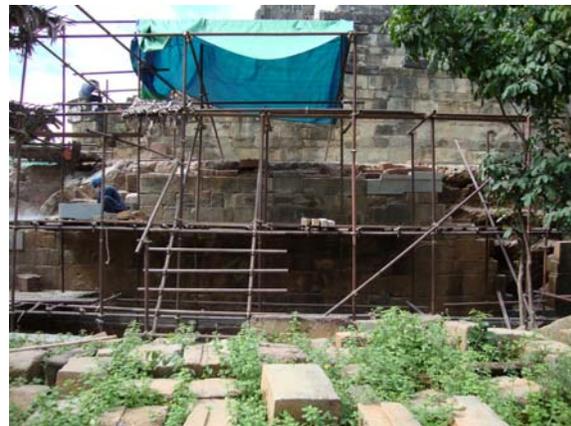
Fig 5: North elevation reference wall

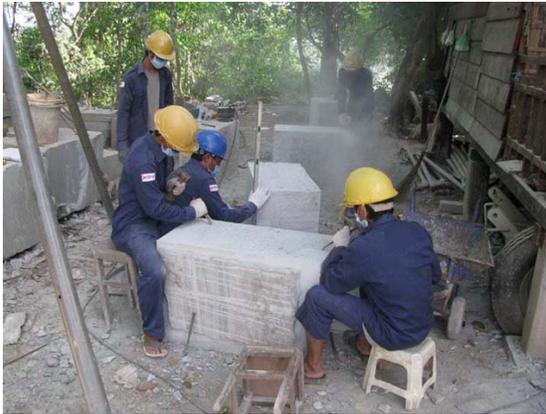
Fig 6: Preparation of new sandstone units

New sandstone blocks and pavers are prepared to be installed where original units are missing. Finally, the team has begun in-situ documentation of the next level in preparation of disassembly, and site logistic planning for extending the storage area.

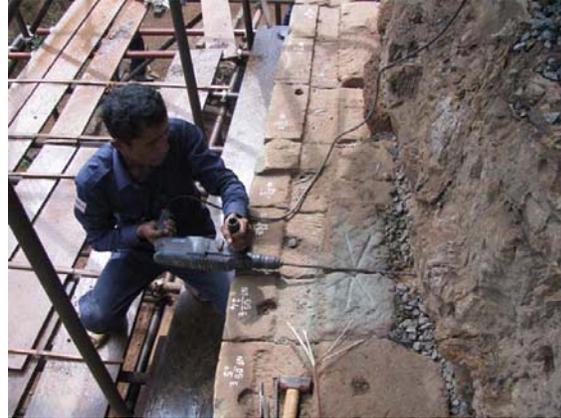
Fig 7: Installation of FRP cable

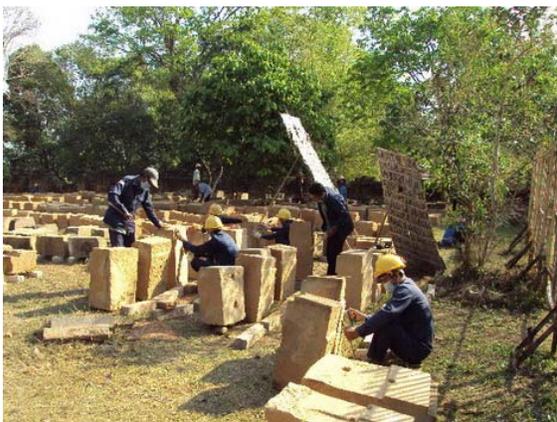
Fig 8 : Documentation and assessment

Stone conservation measures include, documentation, cleaning, desalination, structural consolidation of broken blocks, and reattachment of fragments using adhesives. WMF supported a testing program to develop an appropriate mortar repair system. The first portion of the on-site testing program has been completed and samples are currently being examined in the laboratory. Results are expected to direct the formulation of the best suited stone repair method and materials. The results will be presented to the Ad Hoc Experts of the ICC and the APSARA National Authority for their approval. Once this work is completed and the system is approved, it will be useful for our work at Phnom Bakheng as well as other sites within Angkor.

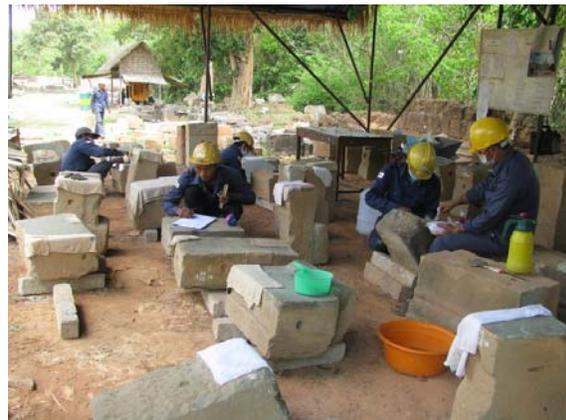
Fig 9: Stone conservation - Desalination

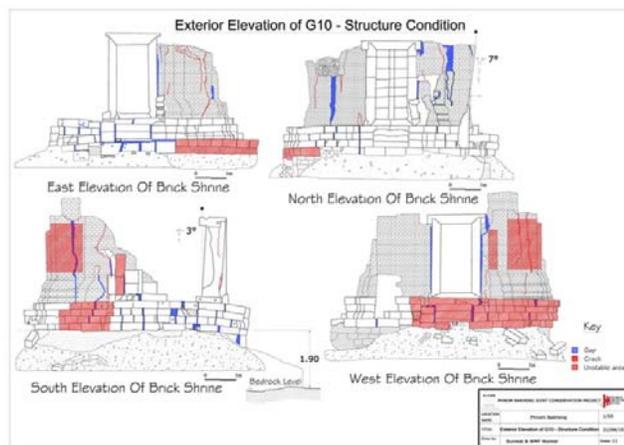
In addition, small scale samples of brick, stucco, mortar and pigmented washes were taken for testing and a weather station was installed. A detailed condition survey of the chosen shrines has been undertaken to complete documentation of existing conditions prior to the workshop. Information acquired in advance to the workshop is compiled in a booklet that will be made available to the public on the WMF website.

Fig 10: Structural Condition Survey of Brick shrine G 10

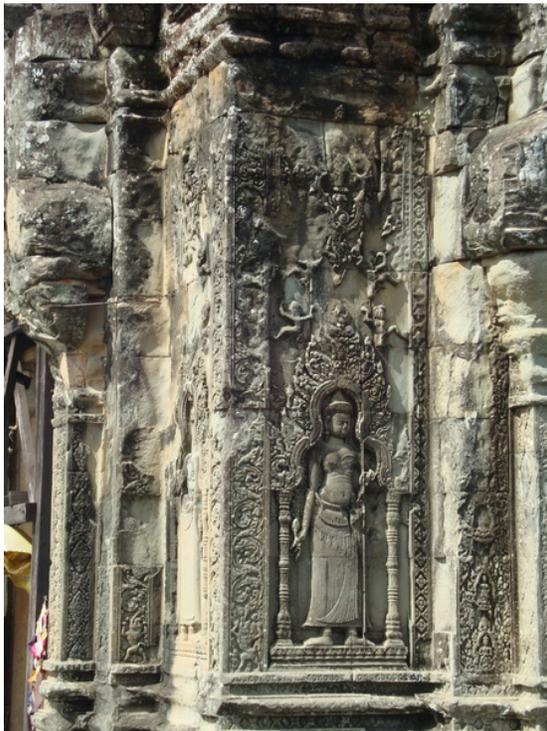
Fig 13: Central Shrine APSARA relief after Emergency Consolidation

Emergency consolidation and partial stone conservation of the Apsaras and figurative carvings at the central shrine have been completed in March 2010. The intervention included documentation of the existing condition, the structural reintegration of areas in advanced state of deterioration with the use of fiberglass pins, structural adhesives and fills, and the careful documentation of all interventions. The project has been executed successfully in collaboration with the APSARA National Authority Stone Conservation Unit and resulted in the stabilization of the figurative carvings and Apsara reliefs.

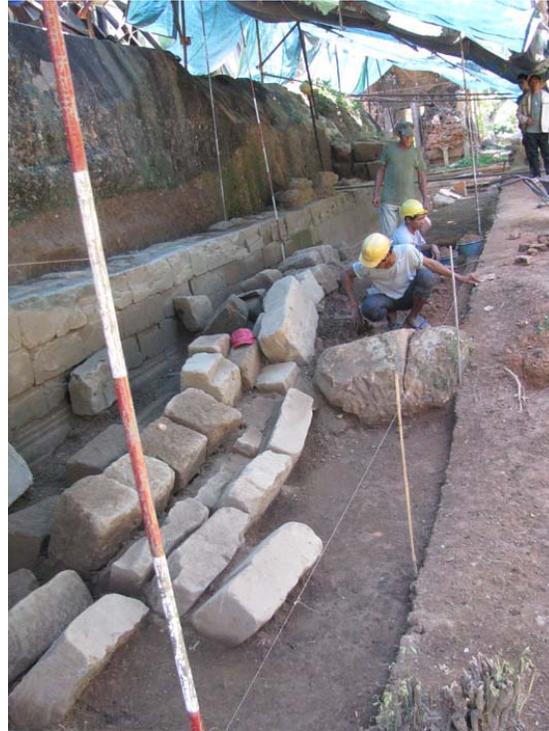
Fig 14: Fallen off stone blocks at the West Facade
