**Progress Report to the US Department of State for Phnom Bakheng
July 2011**

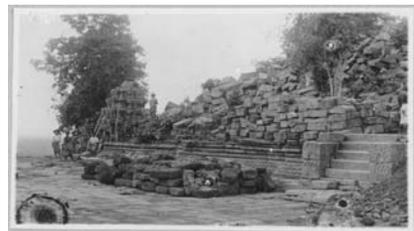
As has been reported previously, initial work focused on documentation and site preparation. An initial project was the rebuilding of the road to transport materials and equipment. WMF surveyed numerous stones scattered at the site to determine if they could be utilized for replacement of missing elements or if it could be discovered where they originally were on the temple. Experienced masons surveyed the stones to determine if any may have been from façade walls or pavers. This survey resulted in the discovery of 15 façade stones. The survey indicated that many original pavers were completely gone. This image of terrace level F clearly shows that very few pavers remain.

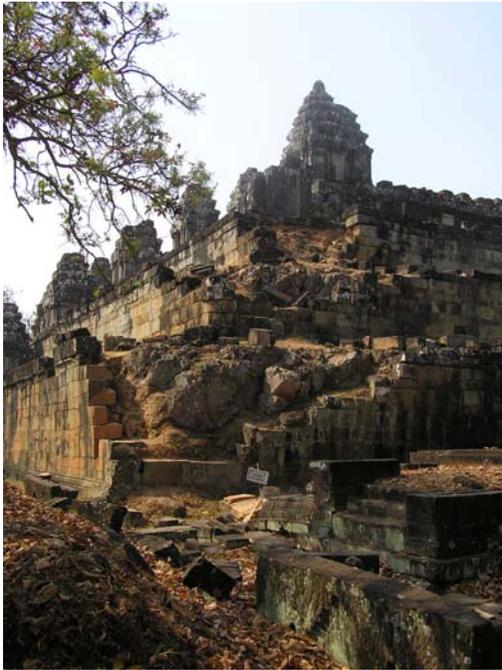
The south east corner at level F, as found at the beginning of the project

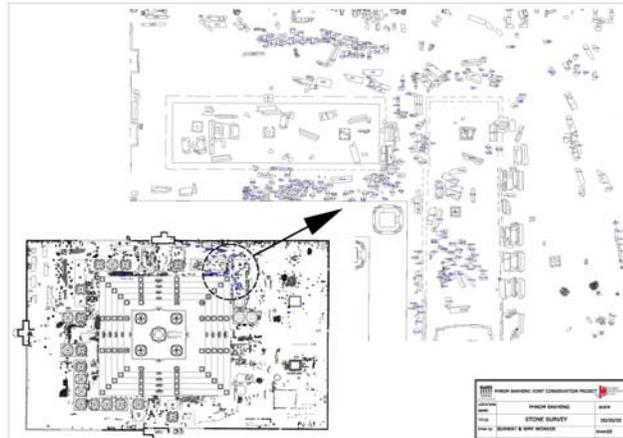
The image on the right shows mapping of the loose pieces around the upper sections of the site.

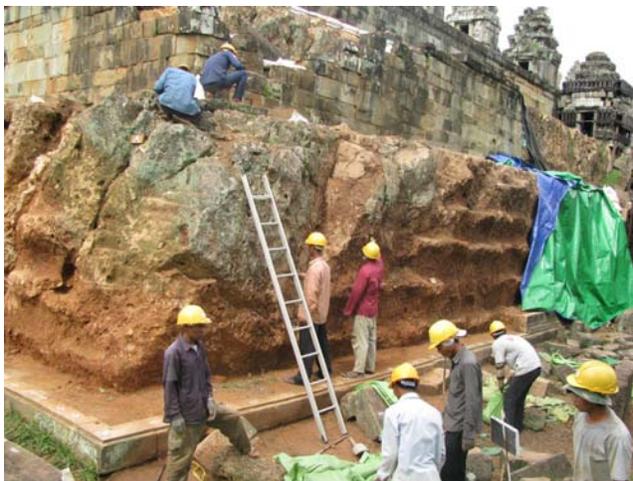
After the careful disassembly of the sections of level F that required resetting, the team exposed and cleaned bedrock.

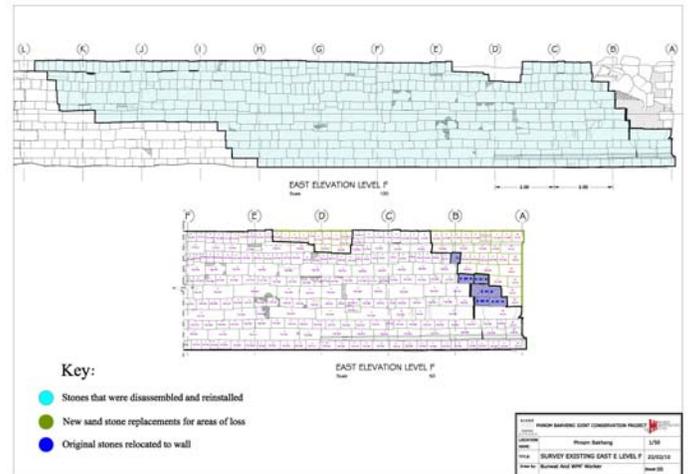
The image at right shows the required number of stone replacement units at the east corner of level F.

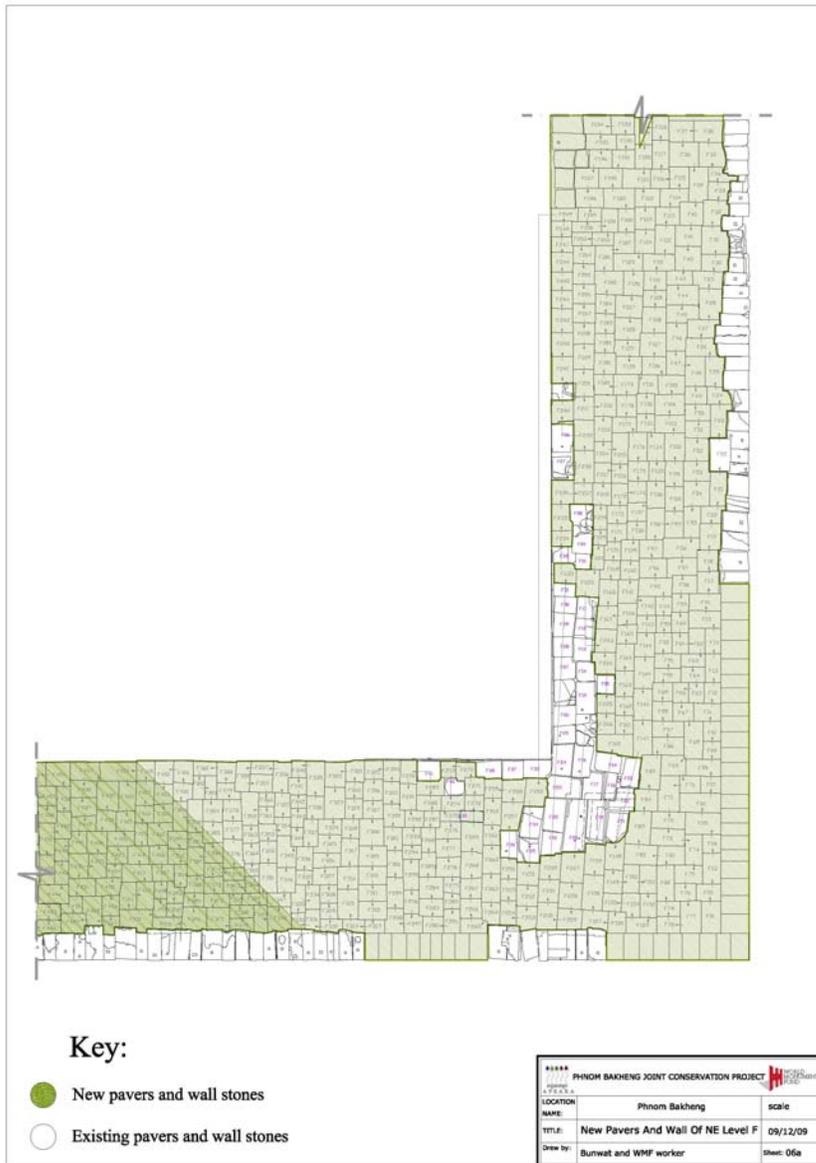
This plan drawing of level F terrace shows there are almost no original stone pavers left on this terrace. 25 original stones were remaining in place or found at the site. 630 new pavers were required to complete this corner of level F. During the course of work, a number of unforeseen conditions arose, forcing WMF to move slowly and work closely with APSARA to design appropriate solutions. In all cases so far these unforeseen circumstances were related to conditions that the ancient Khmers faced as well, which are related to the fact that the bedrock used to support the sandstone façade was not perfect. In many cases the bedrock does not extend out far enough to support the far reaching corners of the temple. WMF’s work has demonstrated that ancient Khmers used laterite to fill in these voids.

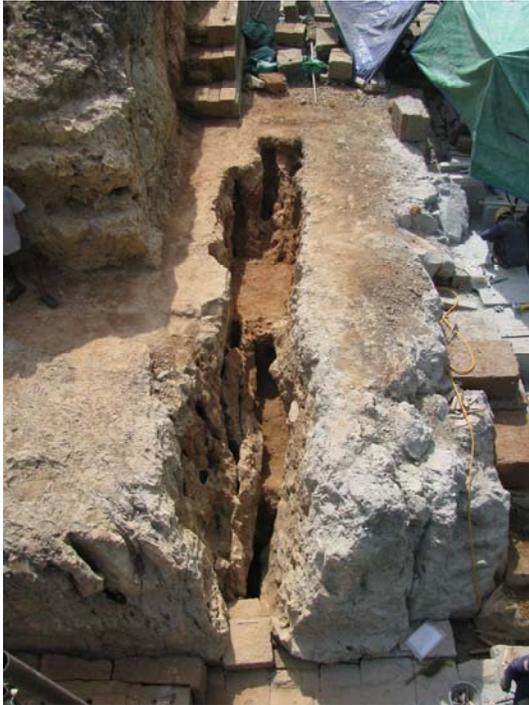
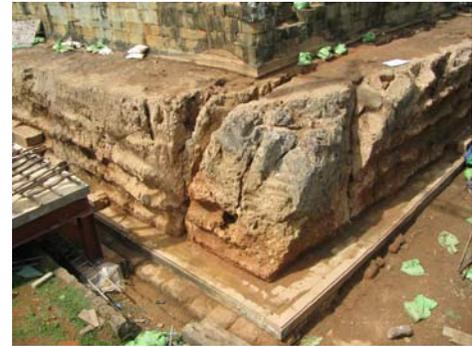
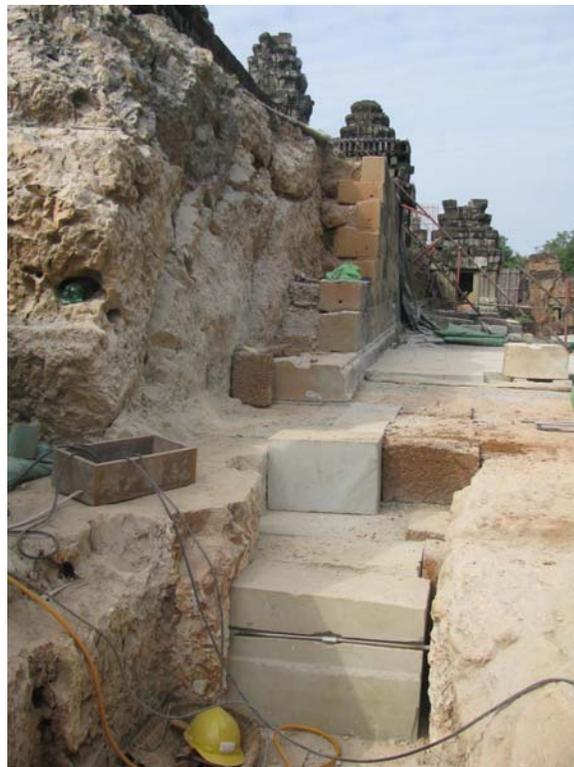
In some locations there were large geological inclusions that were weak and or missing that separated sound bedrock. In many sections the decay of this laterite, used as fill by ancient Khmer artisans, is one of the main causes of the erosion at the corners and the collapse of the stone façades and stone terrace shrines.

At left and below is a geologically weak section of the bedrock at level F.

After much discussion it was agreed that WMF would continue to dig out the soft material until sound material was found on all sides. Then the opening was squared up to receive stone infill.

It was decided that laterite would be placed where support of the terrace was required and sandstone would be placed where upper sections of façades were to be supported. Working with a structural engineer, the team determined how many rock bolts were required, their size and installation locations to secure this section of wall and serve as a sound substrate on which to place the façade and paving stones. Once the substrate is sound and ready to support the façade and upper level pavers the stone was reinstalled.

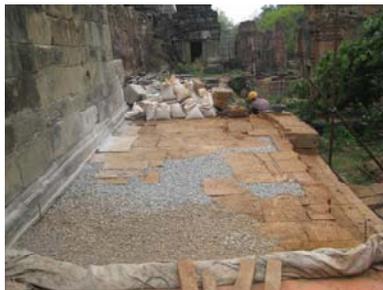
This image shows the installation of the paving system. First gravel is put down to insure the proper pitch of the terrace.

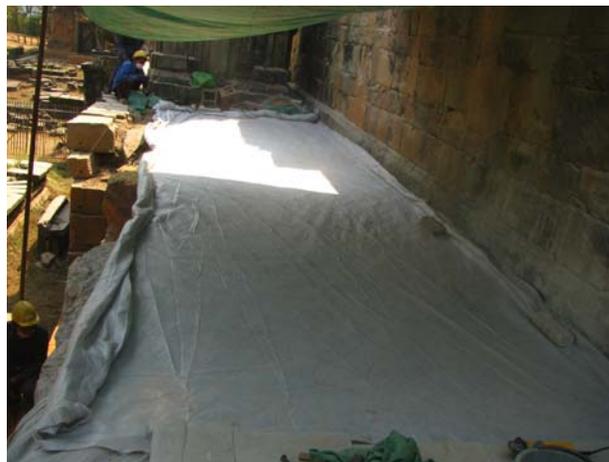
A geotextile fabric is inserted to prevent the gravel from being filled with debris and to act as a cushion to prevent the PVC membrane from coming into direct contact with the gravel. A great deal of research went into finding the correct membrane for this purpose and this was reviewed and approved by the Ad Hoc Experts.

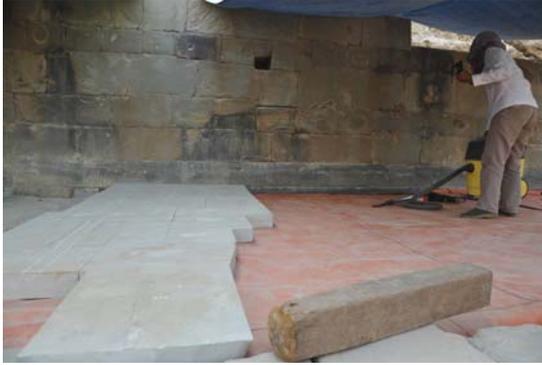
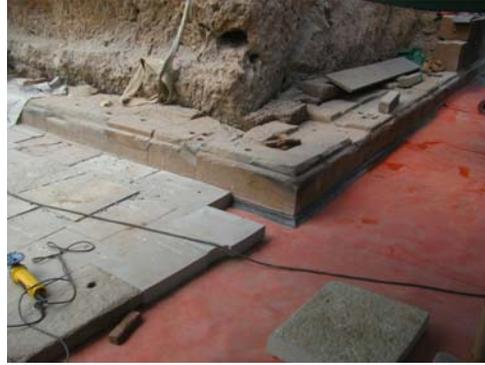
The material has been in use in the construction and engineering field for over 30 years and withstands exposure to the elements and UV light. The material has a very low expansion and contraction coefficient, allowing vast quantities of the material to be used at one time without the installation of expansion joints. In the case of WMF's work at Phnom Bakheng, it will be concealed by the installation of pavers. Thus it will serve as the barrier for which it is intended, but will not mar the visual experience at the site. Also, in the future, if the need arises, it can be removed.

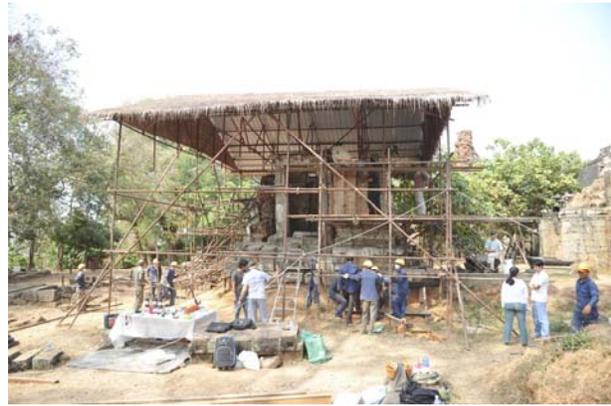
One of the most significant efforts was to reposition sections of threatened displaced brick walls without disassembly. Using a sophisticated series of hydraulic jacks that could be precisely controlled Professor Croci worked with the WMF team to move this large section of brick back into place, as show in the images below.
