**Conservation of Phnom Bakheng
Angkor Archaeological Park, Cambodia
June 2012**

Conservation of the northeast corner of Phnom Bakheng

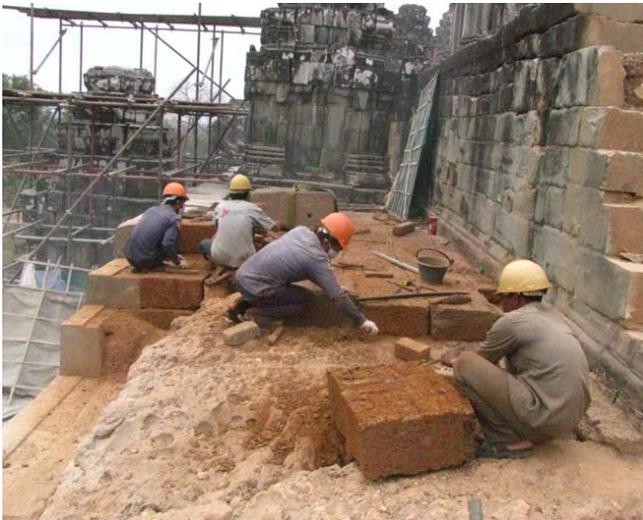
The repair of unstable and decayed bedrock is one of the core interventions that WMF is implementing at the temple. Since January, more than 120 new laterite blocks have been inserted in the foundation of level D to improve stability. To stabilize walls, both laterite and sandstone blocks were inserted where missing. Work included inserting new stones as well as utilizing older stones found at the site that were usable. This method provides a more harmonious look to the outer walls, as the stones have a more consistent patina from age.

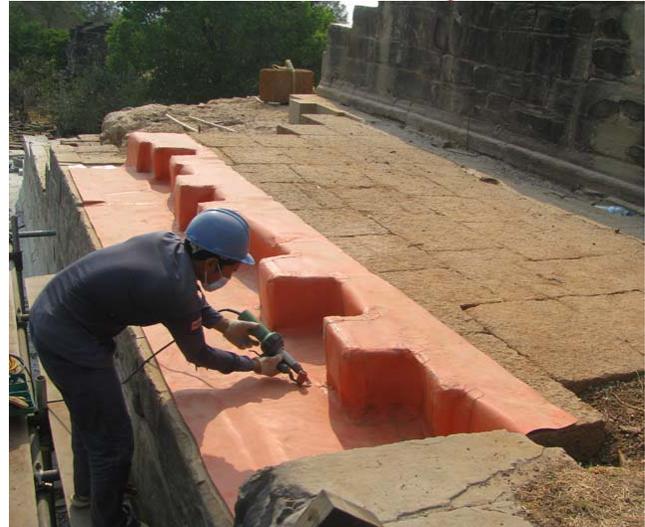
The waterproofing of the temple is the most critical intervention at Phnom Bakheng. To improve drainage, a waterproofing membrane has been installed at level F and E. The membrane was cut and fitted into each level in a way to conform to the irregular shapes of the stones, requiring significant skill and attention to detail. When Vincent Liot was on site, part of his work included extensive training sessions on methodology for installing the membrane with the Khmer workers.

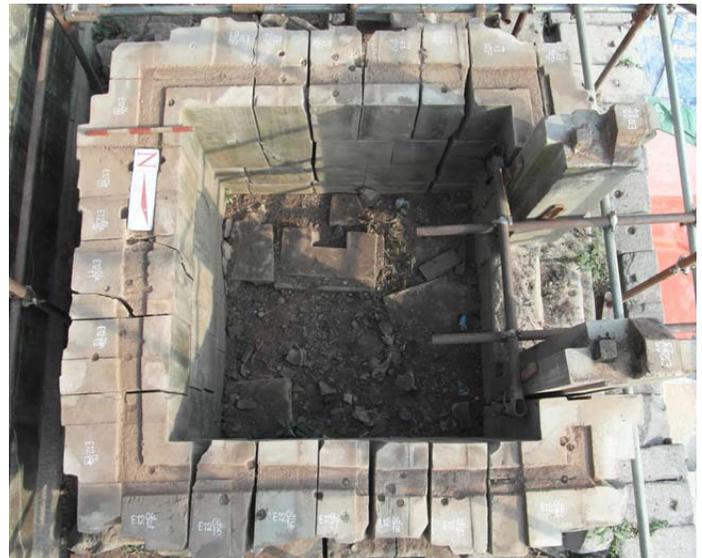
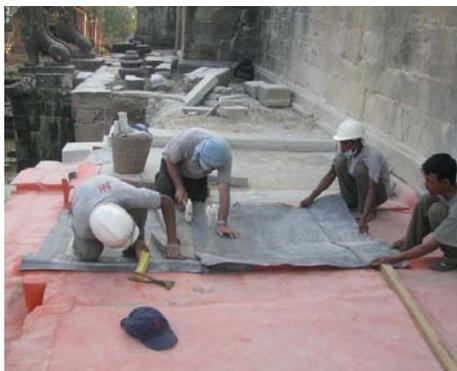
After the installation of the waterproof membrane and the lead sheet underneath stone shrine F12 (left), the reassembly of this sanctuary started in February (right).

The waterproofing intervention at level E included the complete dismantling of stone shrine E12, which will enable specialized waterproofing where the shrine and central temple intersect. The procedure for dismantling is the same as the one previously used with stone shrine F12 at level F, which is considered the prototype intervention for all stone shrines at the temple. The position of each sandstone block has been measured and after meticulous documentation, each block was properly numbered to allow the correct reassembly of the sanctuary. With the use of the crane, the stones have been moved to the conservation workshop or storage area depending on the condition and treatment needs.

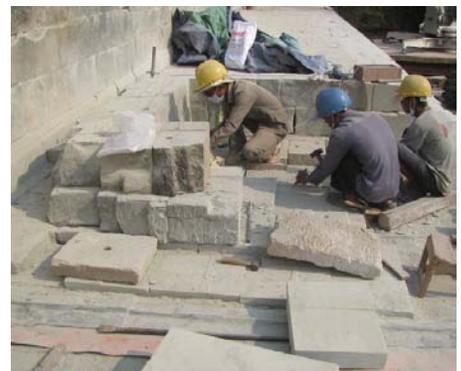
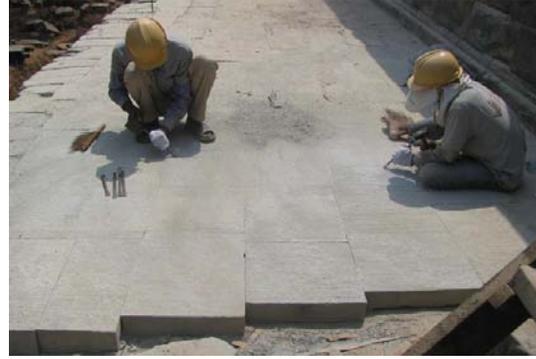
The reassembly of the pavers of level F has been completed and 120 pavers were installed. For the blocks used for the wall of the same terrace, the surface has been tooled to blend the look of the stones for a more harmonious presentation.

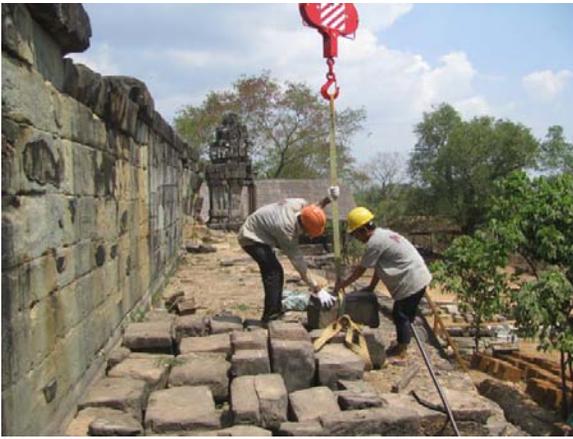
To increase worker safety and advance the work a second crane was erected at the south east corner. Today two crews are implementing the approved conservation, stabilization and waterproofing plan. To insure long term waterproofing of the terraces, if membrane maintenance is required under the pavers little effort is need to address the work. If maintenance is required under a stone terrace shrine the effort will be significant. After careful consideration, World Monuments Fund has added an extra measure of waterproofing in strategic areas by inserting a thin lead sheet under the stone shrines. This lead panel system that sits between the stone terrace shrine and the approved membrane will extend the life of the waterproofing program significantly. The work at the southeast corner included the removal of sandstone blocks at level E and F, through the use of the second crane, installed in January to accelerate the work at the temple. Cleaning of the bedrock was a major focus in winter 2012, which involved primarily the removal of accumulated soil and vegetation so that condition surveys, measurement, analysis and treatments could be carried out on clean surfaces. This work began in April 2012 and continued through June. .

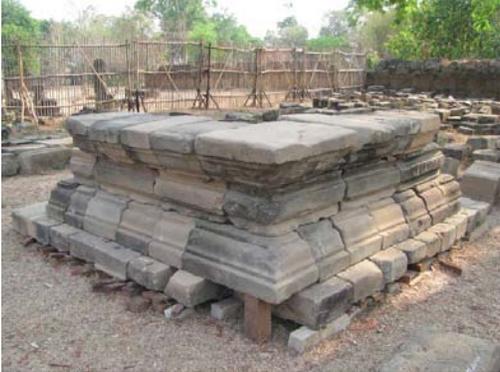
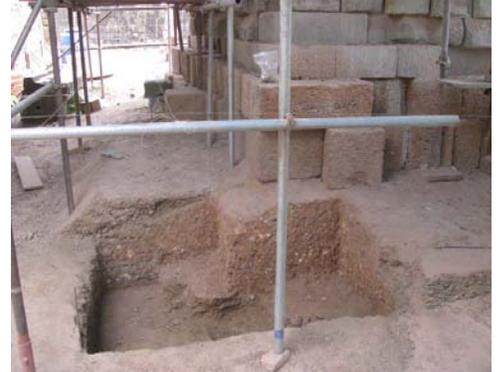
A detailed study was carried out to design a mock-up for the original configuration of the platform around the brick shrine. It will be put in place after the excavation of the foundation (right).

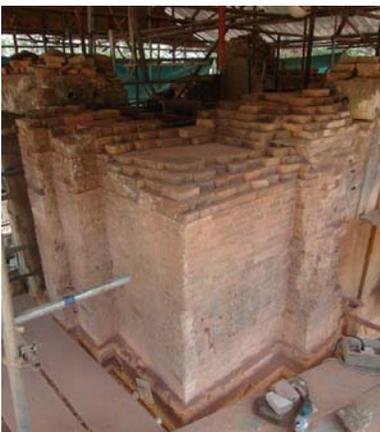
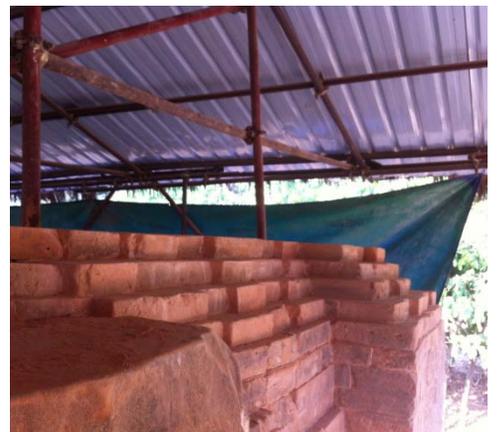
The brick consolidation at the northeast corner of the brick shrine (left) included the insertion of new bricks and the resetting of the original bricks in the masonry. Brick masonry consolidation has progressed in 2012. Once this work is completed, waterproofing of the shrine will be carried out through the insertion of lead at the top of G10 and capping the masonry. The pitch is also important to shed water properly. Work in progress on G10's northwest corner is seen at right

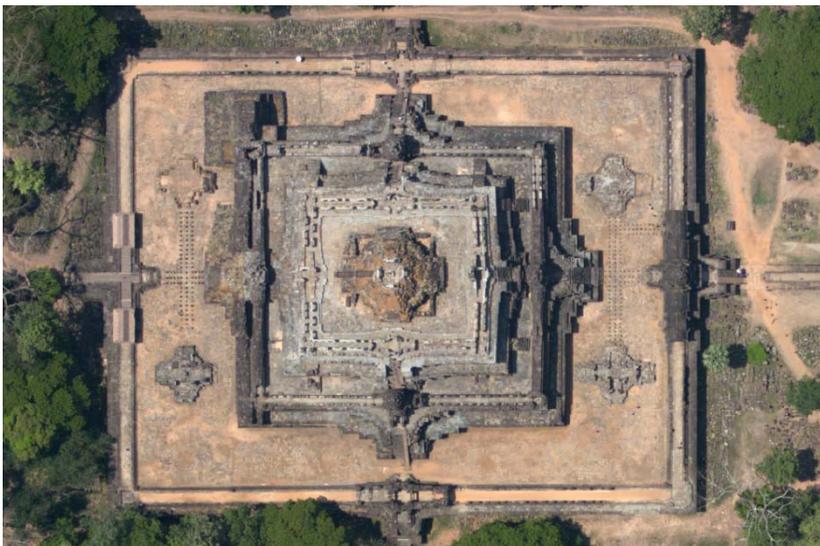
Damian Evans of the University of Sydney carried out an extensive LIDAR survey at Angkor in 2012. WMF contributed to this project and in return will receive detailed LIDAR for the Phnom Bakheng precinct in Angkor Archaeological Park. This section of the report contains representative preliminary screen shots of the data collected. An aerial

view of Phnom Bakheng with high resolution photography layered onto the LIDAR is at left.

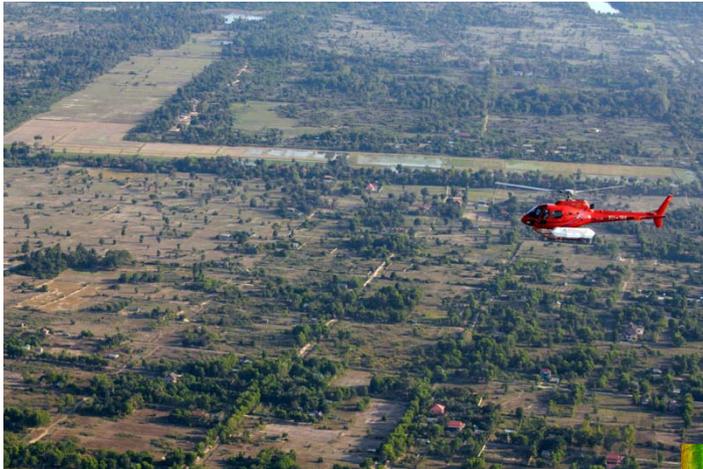
At left is a photograph of the helicopter flying over Angkor on capturing LIDAR as part of the collaborative project between several international teams. The project was organized by the University of Sydney. APSARA National Authority will be given all the data collected. Each international team that participated in the project will receive approximately one terabyte of data for its site.

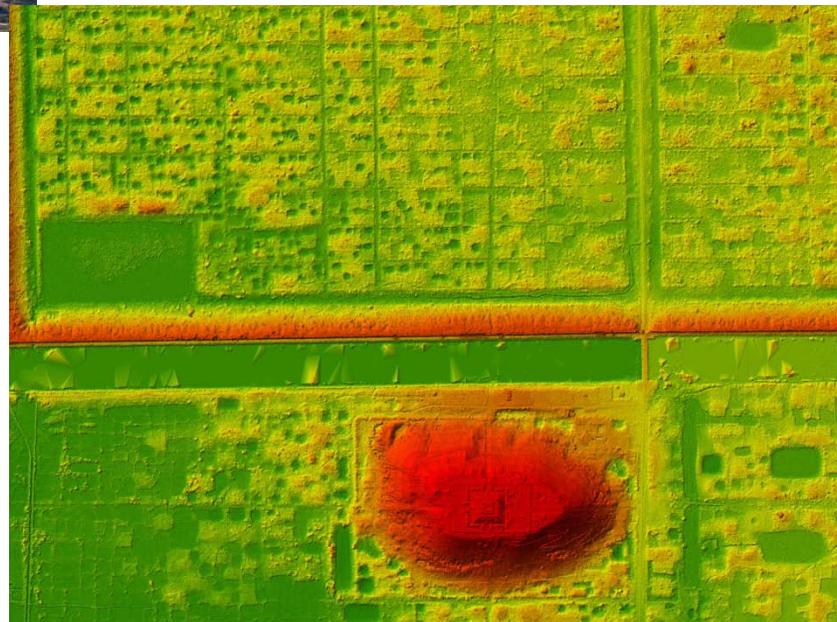
At right is a screen shot of LIDAR of Phnom Bakheng. As this raw data is processed, it will provide a wealth of information about the topography of the site. Preliminary analysis has already shown that ancient paths no longer seen when walking up the hill show up on the aerial photography and LIDAR. This will be very valuable for addressing water run off issues at the site and erosion of the hill that is causing conservation challenges.
