Appendix 4: Errata Sheet and Environmental Impact Assessment 2007

**Airport Road Realignment at
Amata Kabua International Airport
Majuro, Republic of the Marshall Islands**

**DRAFT
ENVIRONMENTAL IMPACT ASSESSMENT**

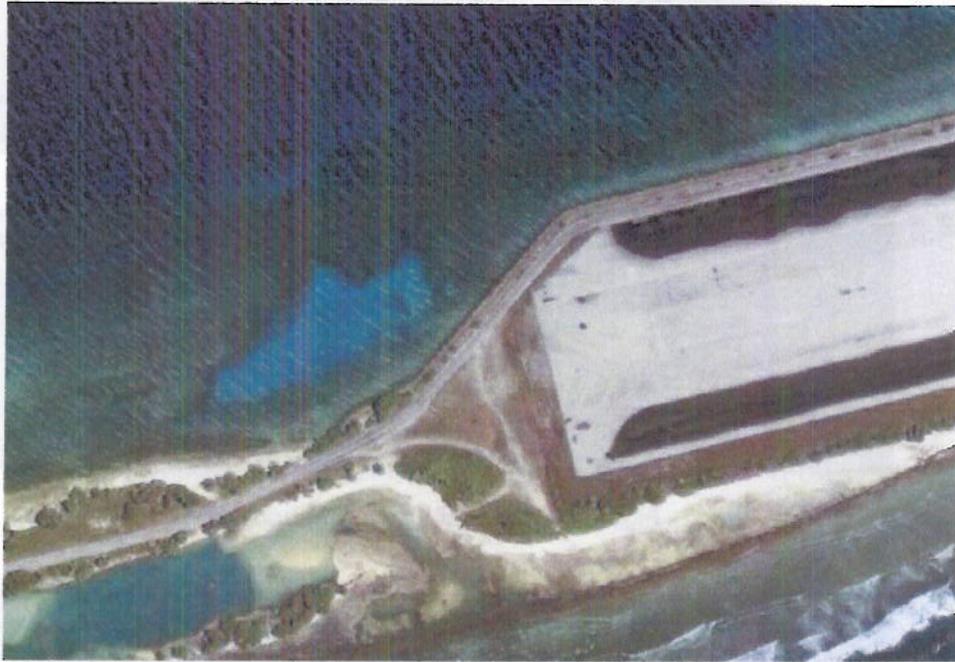
Figure 3 West End of Runway 7 (Project Site)

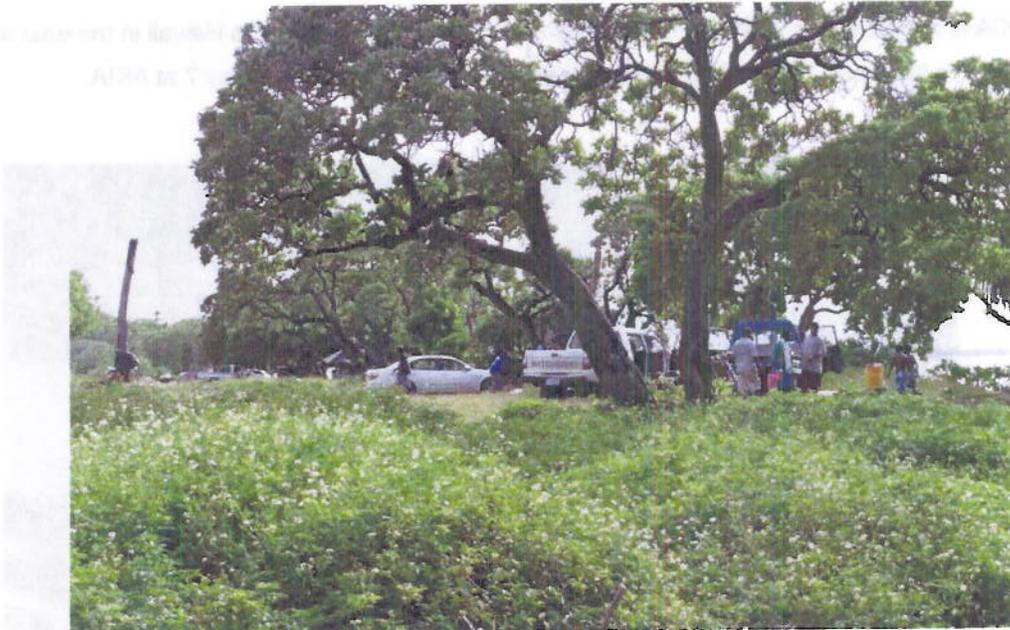
Figure 4 Recreation Area (Lagoon Side)

There are no homes or businesses in the area. The site itself includes a grassy area in front of the runway, a man-made ocean pool used for swimming, and a grassy area with some garbage cans, creating a recreation area on the lagoon side, and approximately 11 acres of lagoon.

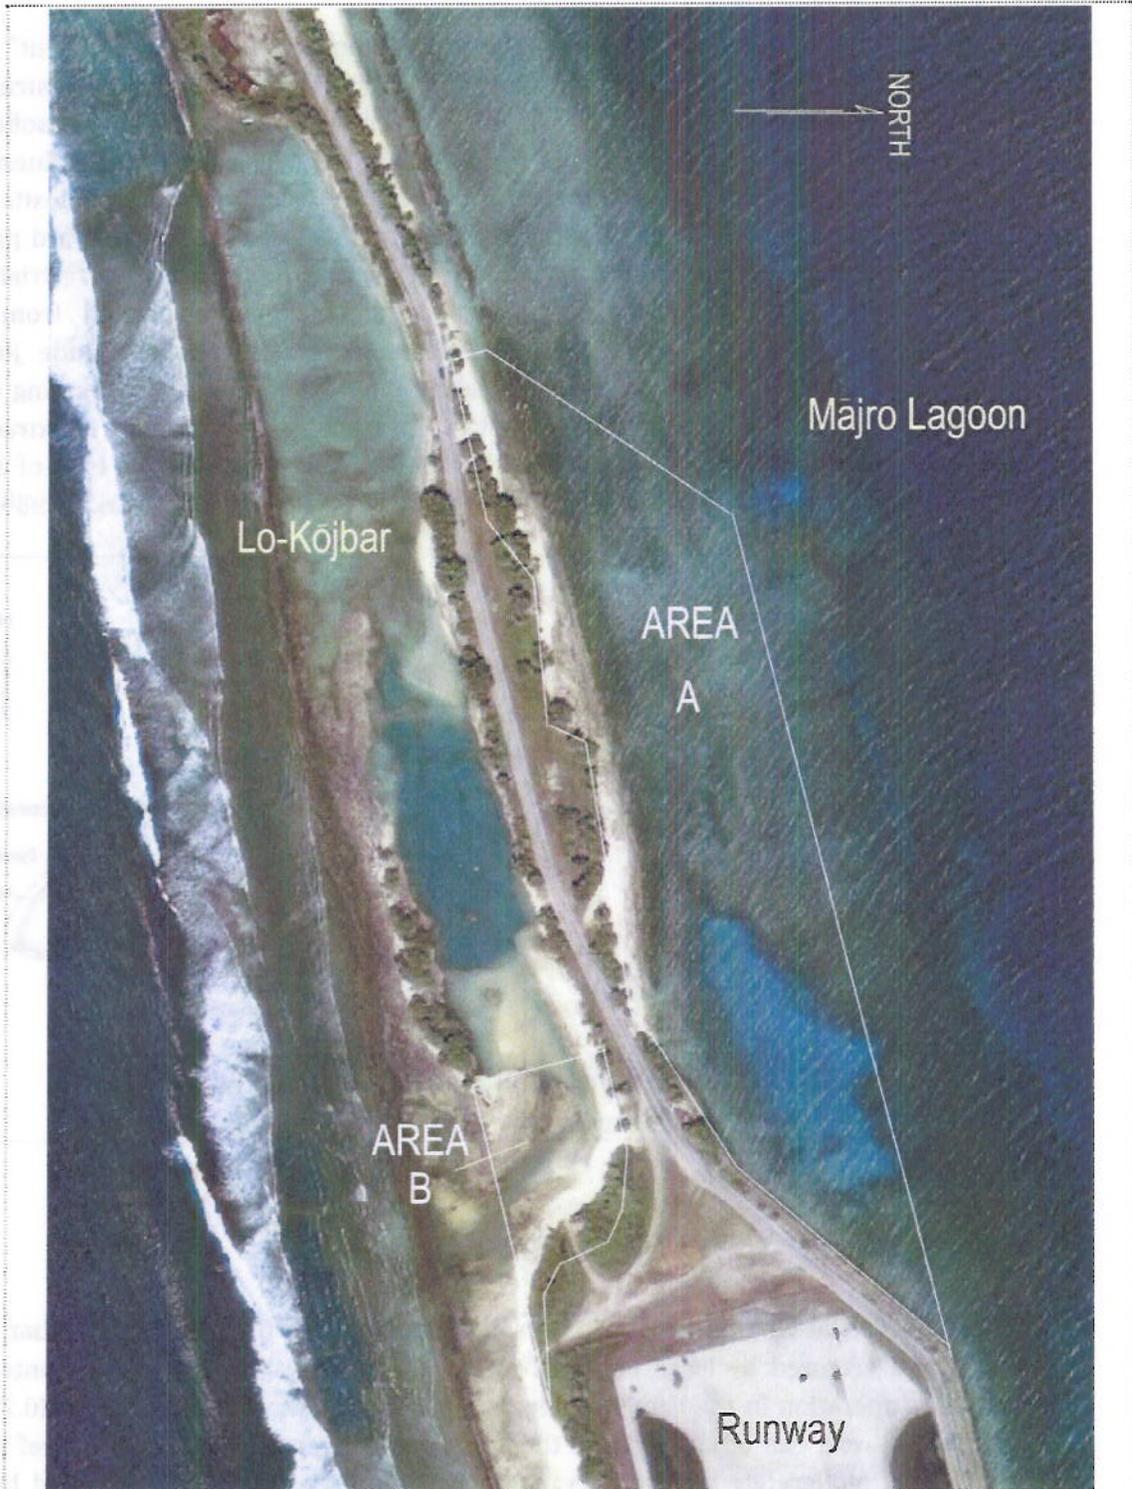
Figure 2. Satellite image showing features in the project area at the west end of the airport runway. Areas "A" and "B" are proposed fill areas.

As noted, the proposed project involves extending fill land out onto a portion of the lagoon reef and across a shallow (man-made) channel on the ocean reef (Fig. 2). The lagoon fill would extend out to a new reveted shore as required to realign the coastal roadway out of the runway safety zone. The reef area that would be directly impacted by the proposed fill is shown in Fig. 2 ("Area A").

Fill "Area B" is proposed for an area that is technically part of the seaward reef of the atoll. However, this area is presently a shallow channel containing water only at high tide (see Fig. 3, above) and was once part of the islet of Lo-kōjbar that appears to have been scraped off during development of the mid-islet borrow. The ocean reef in this area incorporates a sea level reef flat and an older somewhat elevated platform perhaps representing an earlier stand of the sea or material consolidated beneath an old islet and similar in origin to the beachrock on the lagoon shore. The sloping seaward face of this platform appears as a dark zone running the full length of the back reef shown in Fig. 2. In the aerial photo, the wave break marks

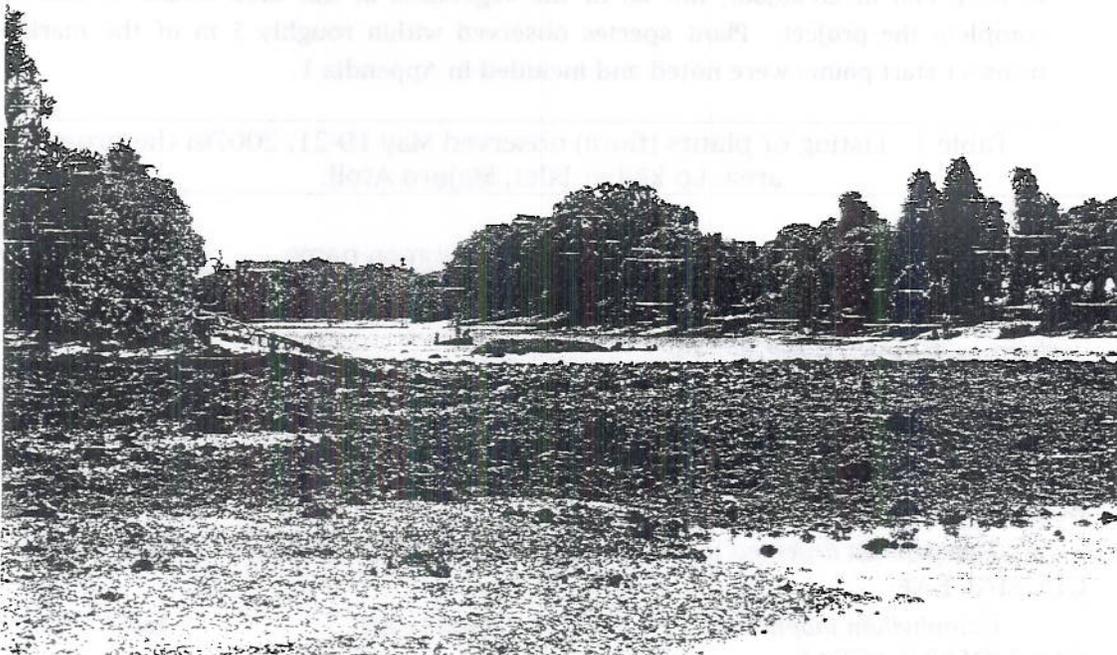
Figure 3. The central part of the islet of Lo-kōjbar has been dredged, creating a protected pool now popular as a recreational feature.

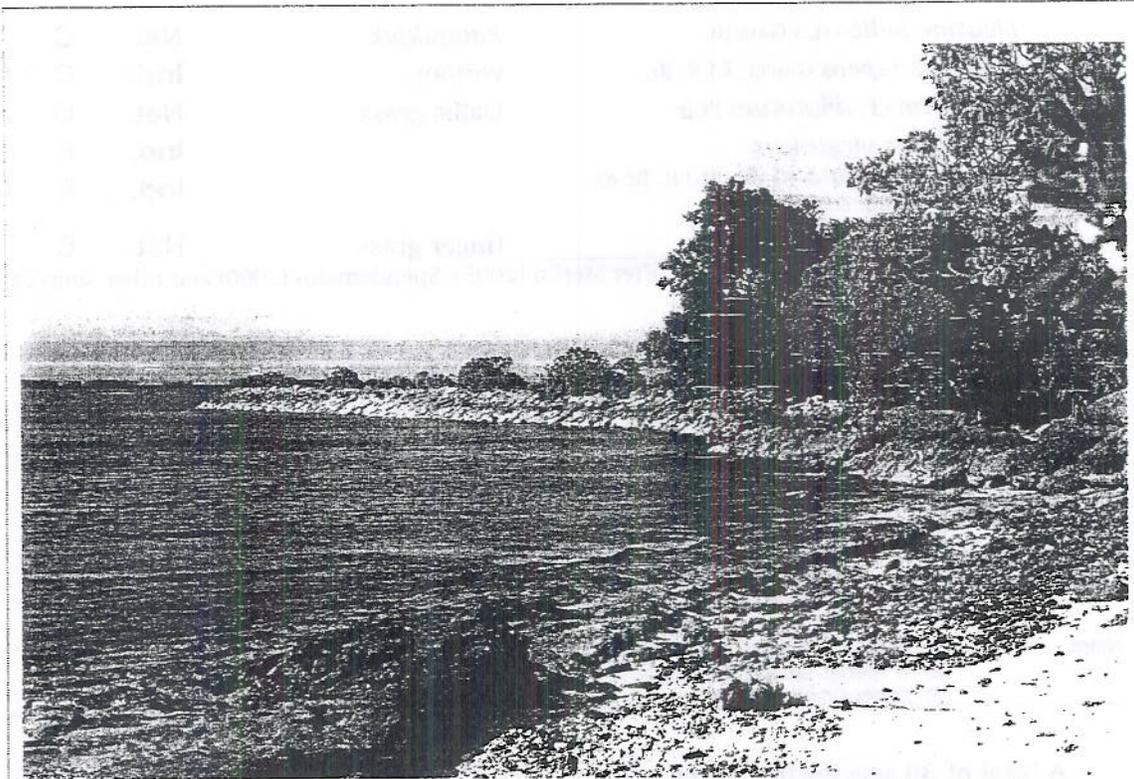
Figure 4. Massive beachrock formations (foreground) typify the islet shore, inland of which are deposits of sand or rubble. Here, at the east end of the natural islet, a revetment protects the coast road on fill (background).

At the east end, adjacent to the lagoon reef, the land is protected by relatively massive armoring to protect the coast road and adjacent runway from erosion (see Fig. 4). All of the lagoon shore of the islet of Lo-kōjbar is marked by massive beachrock formations, inland of which occur beach deposits of sand and/or rubble reached only by high tides (Fig. 4). Some armoring is present along the ocean side of the road where, for example, the causeway leading off to the west is exposed to ocean waves.
