Phnom Bakheng Progress Report August 2009

Since the last progress report submitted in May 2009 site mobilization measures have been completed, the tower crane has been successfully installed, and the first phase of restoration work has commenced at the lower terrace of the northern half of the East Elevation. Archaeological excavation in front of the East Elevation –South side and detailed condition surveys have continued. Some additional emergency stabilization and protection measures for surrounding brick shrine structures are being planned and will be executed in due course.

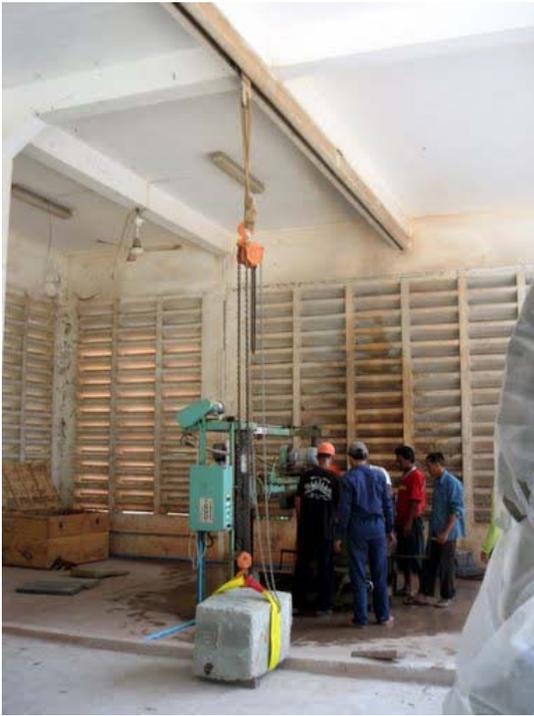
Fig 18: stone saw at Conservation d' Angkor

In order to facilitate sizing of the new sandstone blocks for replacement of broken and missing pavers and wall units, an existing stone saw in the compound of the Conservation d' Angkor was repaired and the crew has begun cutting stones with this device.

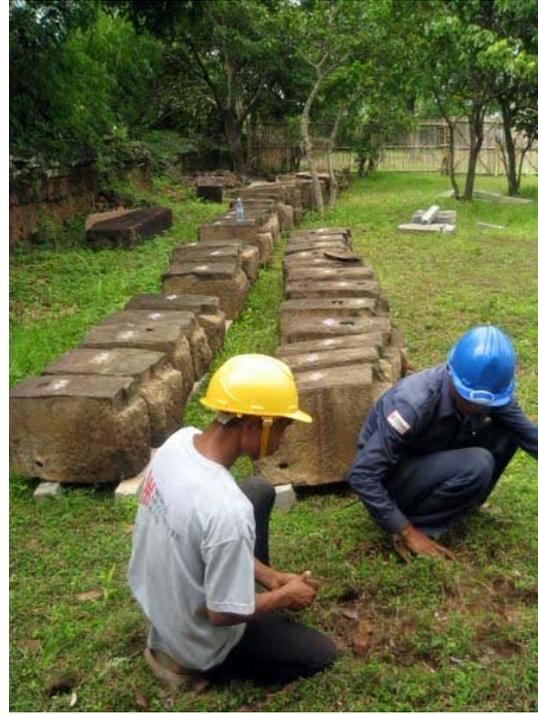
Fig 23: stone blocks in storage

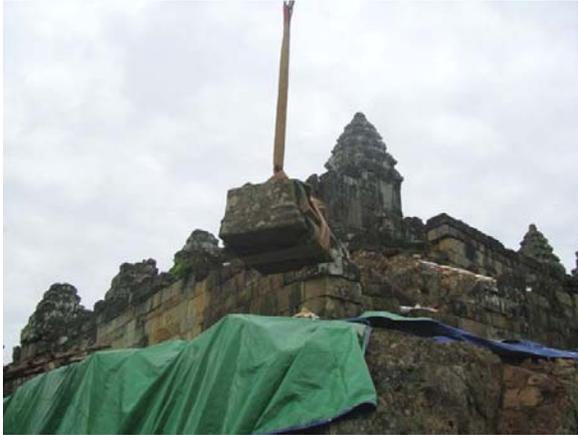
Fig 26: removal of stone blocks

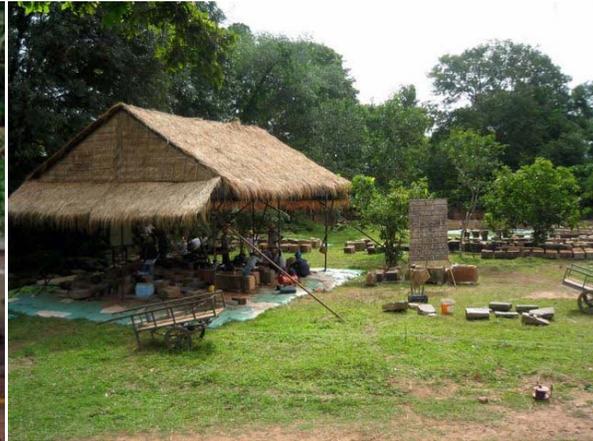
Fig 31: conservation workshop

The conservation of damaged stone blocks has commenced. The team is using stainless steel pins and fiber glass dowels of different sizes, and an epoxy based adhesive, to reattach broken stone fragments. This measure serves to stabilize stone blocks to be reused in the repaired wall section.

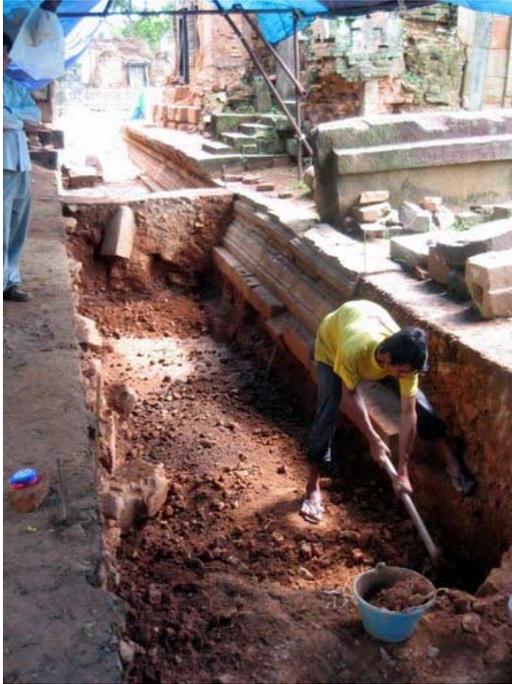
Fig 35: opened trench between brick shrine and lowest wall of temple pyramid

The excavation in front of the East Elevation South side is progressing well. Up to now 11 of the anticipated 16 trenches have been opened. Soil between the brick shrine structure and the lower wall of the temple pyramid has been removed.
