Akhaldaba Landslide (Photo courtesy of GeoGraphics GIS and Remote Sensing Consulting Center)

Tbilisi Flood 2015

Initial Findings and Response Actions

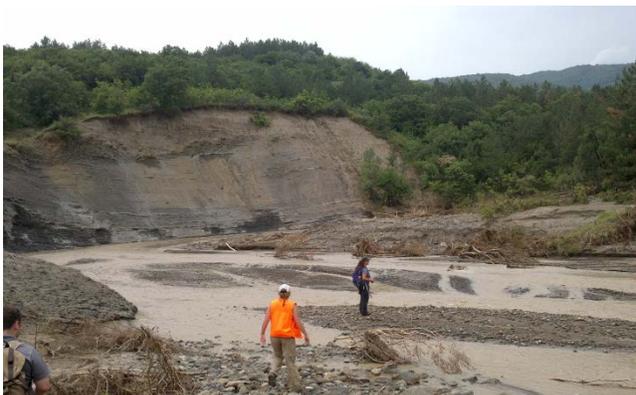
Figure 6: Vere River displaying a braided channel indicating log gradient and high sediment loads

channels consist of multiple small, shallow channels with many mid-channel bars that divide and recombine numerous times (Figure 6). Braided streams form where the sediment load is so heavy that some of the sediments are deposited as shifting islands or bars between the channels¹. The Vere River upstream of Tbilisi is braided. Multiple active landslides and canyon wall erosion at the outer bends of the highly sinuous river within the Vere watershed are continuously supplying sediment and bedload material which exceeds the streams natural capacity to transport the load. Within

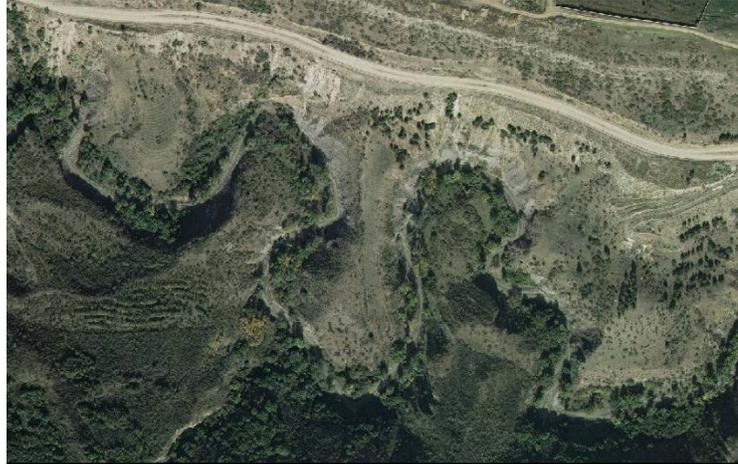
Figure 7: The Vere River is highly sinuous. The stream wanders back and forth through the landscape. This greatly increases the stream length as it heads down valley and is a natural stream energy dissipater.

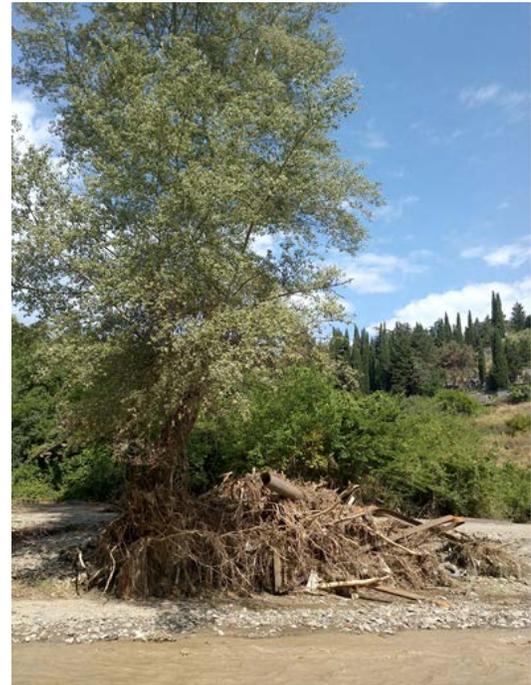
Figure 8: Riparian vegetation maintains stream bank stability and serves as a natural trash rack storing and slowly routing debris through the stream

Reestablish Native forests adjacent to streams and in unstable areas: Field observations found multiple locations where cottonwood trees on the terraces adjacent to the Vere River captured woody and other debris including steel beams (Figure 8). The magnitude of the June 13 floods mobilized and transported extensive quantities of woody debris. It is recommended that reforestation of cottonwoods on stream terraces throughout the mainstem of the Vere River be initiated to grow cottonwood trees that would act to capture debris during flood flow events. Field reconnaissance also revealed that young cottonwoods were not part of the riparian vegetation probably due to grazing pressure which removes young riparian trees and shrubs from the system. Any planting sites should be protected from livestock. The effectiveness of this treatment will be delayed until the cottonwood trees mature, but once mature, the cottonwoods would be self-maintaining debris racks with low potential for failure during flood flow events.

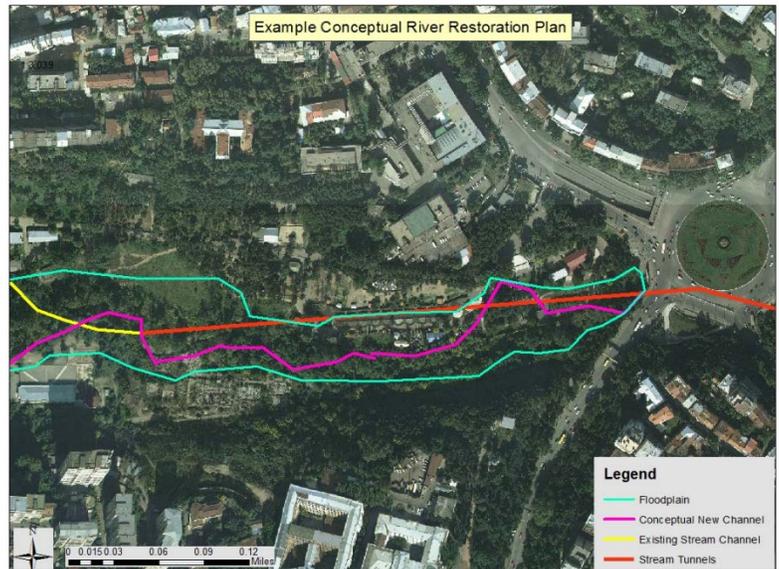
Figure 18: A very crude drawing of potential restoration of one small portion of the Vere River by the zoo. The teal color represents the maximum floodplain area while the pink shows a potential sinuous stream channel meandering within the floodplain. The red line depicts the approximate current location of the VERE River placed under ground in a tunnel and the yellow is a currently channelized portion of the Vere

Vere River Restoration through Tbilisi should be considered in phases from immediate to long-term (Tables 2-5). The first phase of this project is for the leadership within the City of Tbilisi to determine their support for restoring stream function within the city limits. No designs should be developed until that commitment is in place. Completion of the SMZ identification would also help to define the area available for stream restoration. Once commitment to restore the Vere River through Tbilisi is in place, all actions that would eliminate future options, like the revetment below the first tunnel should be placed on hold. An initial design concept (figure 18) that allows both highway access, stream function and a useable greenway through the city would then be completed in partnership with the Tbilisi Open Space committee. This would be used to garnish further discussion and support for the project. A collaborative charrette process would follow where multiple groups have the opportunity to envision the future of this corridor. Iterative meetings and planning sessions will be held until a consensus plan is reached and a final concept is developed. The final concept would be supplied to a qualified engineering design firm for an engineered design and implementation. .

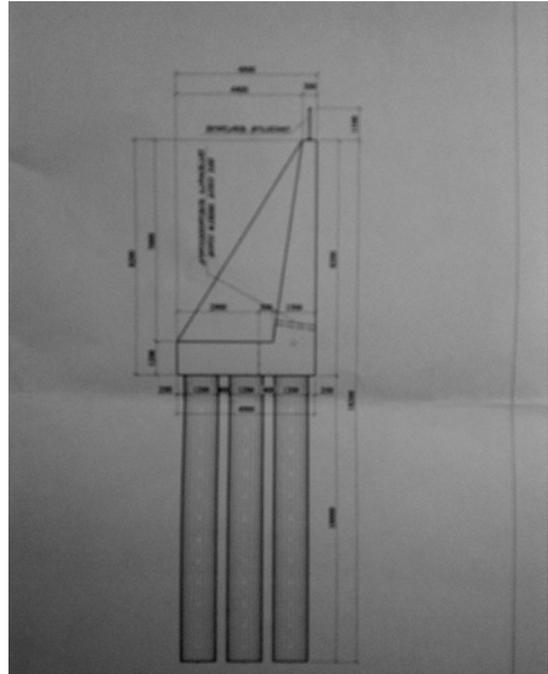
The current retaining wall being constructed to stabilize the populated hillside along the Vere just below tunnel #1, has continual anchored piles both along the bend as well as intermittent piles perpendicular to the wall face to act as a vane, thereby adding strength (Figure 19). It appears to be a well thought out design and should provide long term stability. However, this is also an example of a structure that may

Figure 19: Designs for a well constructed retaining wall at the site of the outlet of the first tunnel. Rapid implementation of this project may limit options for stream restoration in the future.

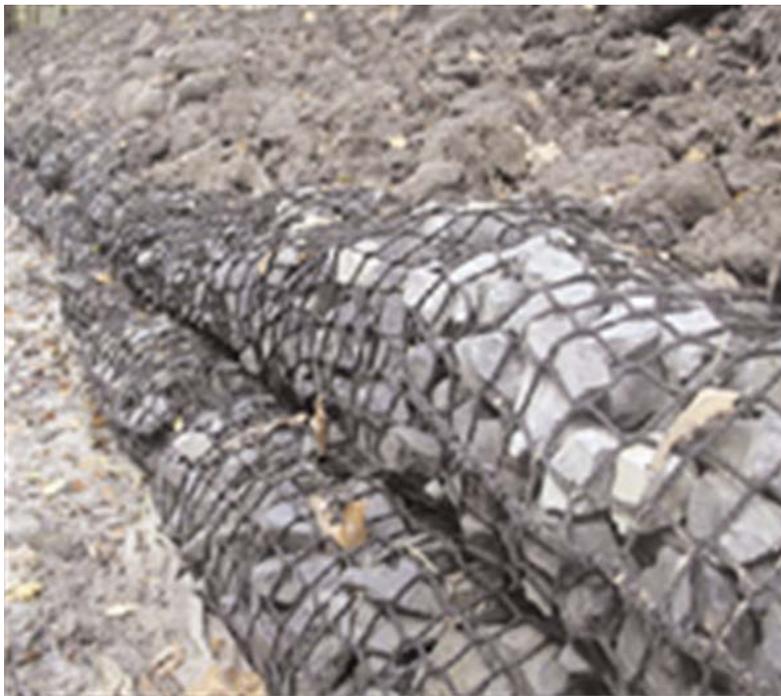
The slide area just upstream of the Electrical Plant poses another very difficult problem due to the narrow ravine for access. Evaluate the engineering feasibility of removing the rock slide and building a buttress at the toe with rock. It appears to be feasible to bring a road in from the top by the power lines to first topple and then remove the rock slide material until the bankfull width of the stream channel is attained and the slide is buttressed and stable. A stable storage area for the rock that is removed will need to be found. If the rock is suitable for construction projects, it could be sold.

Figure 21: A simple rock filled buttress to increase slope stability using gabion or a rock roll which are flexible 'sausages' of crushed rock that are place embedded into the bank toe to prevent undercutting and fluvial scour.

We recommend removal of the slide top by excavation to the depth of the fissures and building a buttress at the toe with rock. The purpose is to remove weight from the top and add weight to the toe. It is also recommended that the top area be graded to eliminate water penetration. The toe buttress can be constructed with large diameter rock blanketed together or with a gabion type structure (Figure 21).

Although removing the head of the slide reduces the driving force and thereby improves stability in some situations, removing the slide mass is not recommended because it can destabilize the already unstable slope. Excavation is not always effective in deeper soils, especially soft clays, where there are two potential failure surfaces, one deep and one shallow. Excavating down to the first failure surface might trigger a sudden slippage on the deeper failure surface. Therefore a stability analysis using soil strength data is advised.

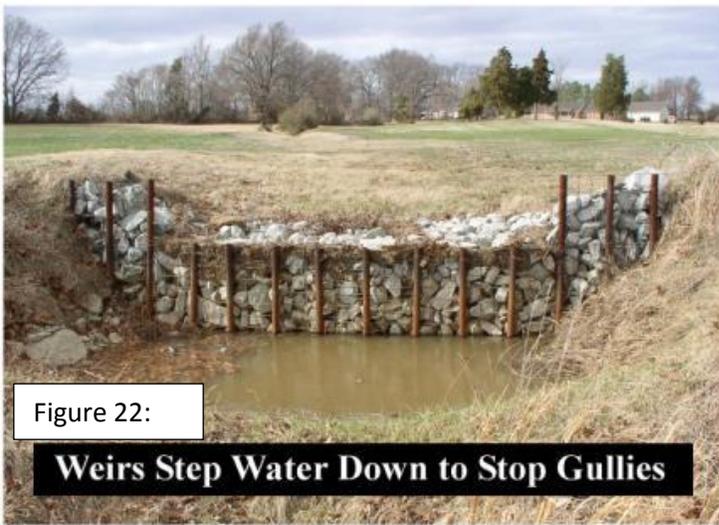
Grade Control Structure in Electrical watershed: It is recommended that a grade control structure be constructed at or near the site of the culvert failure to prevent headcutting of the stream. The headwaters of this stream are in a high landslide hazard area. Headcutting of the now lowered stream grade would undercut this unstable area causing debris torrents to flow all the way to the electricity sub-station. A hardened low-flow crossing should be constructed to replace the culvert as this sediment

rich stream will continue to block future culverts placed at stream crossings. The crossing can potentially be tied in with the grade control structure. Placement of a grade control structure (Figure 22) can help reduce erosion and head cutting. Tying the structure into the stream banks in a way that it will not be eroded around and constructing a footing where the water flows over the structure to eliminate erosion and undercutting of the structure are both critical design elements.

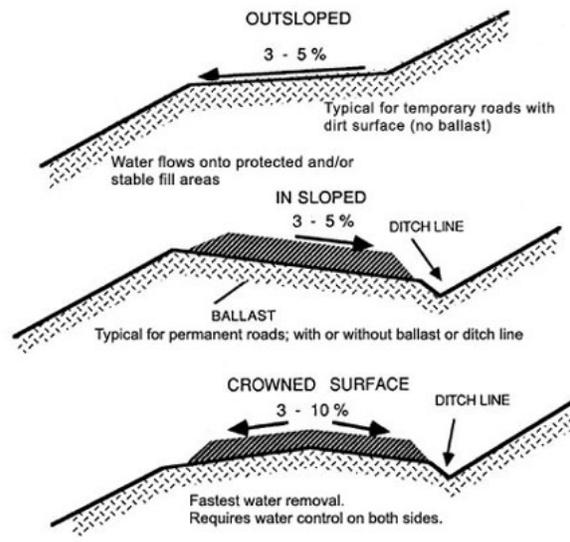
Figure 23: Schematic of various road surface shapes that shed water.

Designing roads systems with proper drainage is one of the most critical best management practices to both protect the integrity of the road system and to protect from soil erosion and landslides. It is much less expensive to incorporate drainage during initial construction than to retrofit existing systems. No functioning road drainage systems were observed during our field visit. Even the newly constructed Chabua Amirejibi motorway has no storm drain control. There are many components to road drainage, including determining the shape of the road (Figure 23), incorporating cross drains, determining appropriate spacing and sizing the drainage features based on anticipated storm and flow events. Although the watershed get just over 500mm of rain a year, storm drainage should be designed for the typical high intensity short duration storm that is likely to cause driving hazards and environmental damage.
