Scope of Work
Trim and removal of trees
away from security fence and
alongside Barker Road

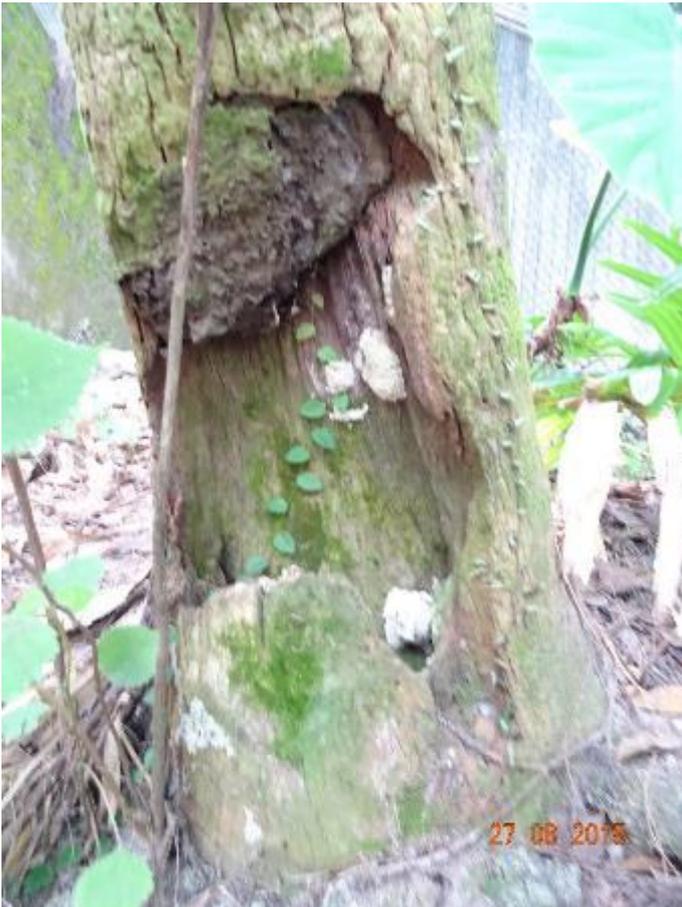
Overview of the subject tree T24.

T24: A cavity is noted at the lower trunk. Due to the high target rating and large cavity, for the sake of the public safety, removal can be considered.

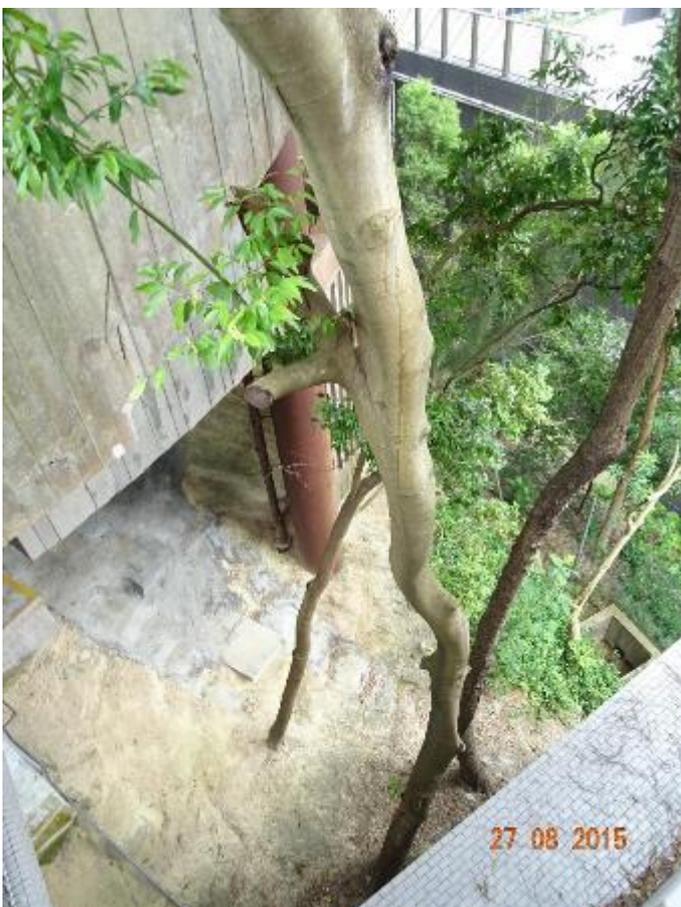
Overview of the subject tree T60. Crown reduction to reduce the lever arm (expose to the wind) is recommended.

T60: Poor taper form to withstand the wind.

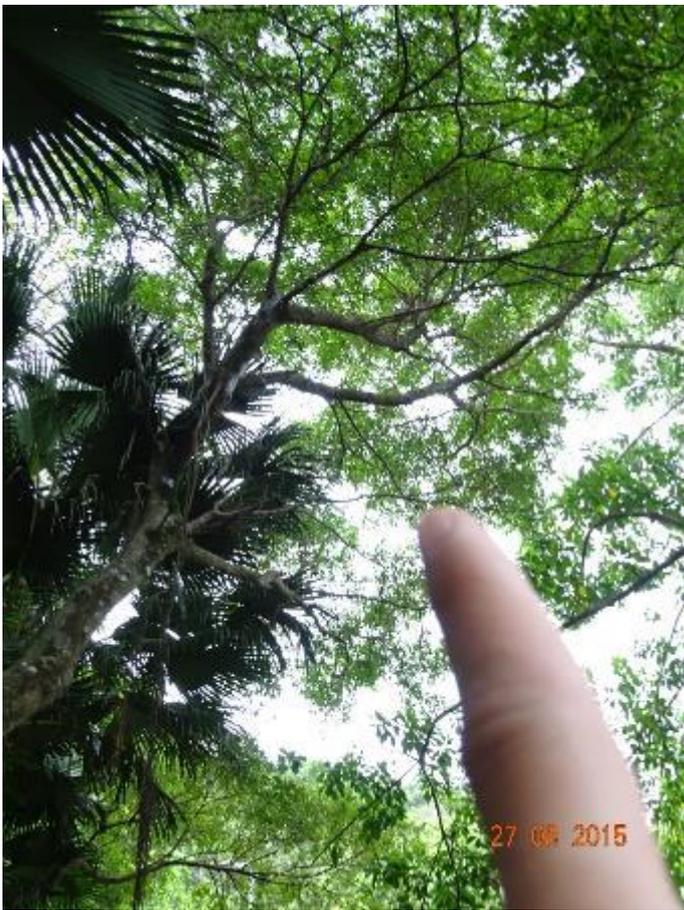
Overview of the subject tree T92. Crown cleaning is recommended.

T92: Remove the dead branches above the walkway is recommended.

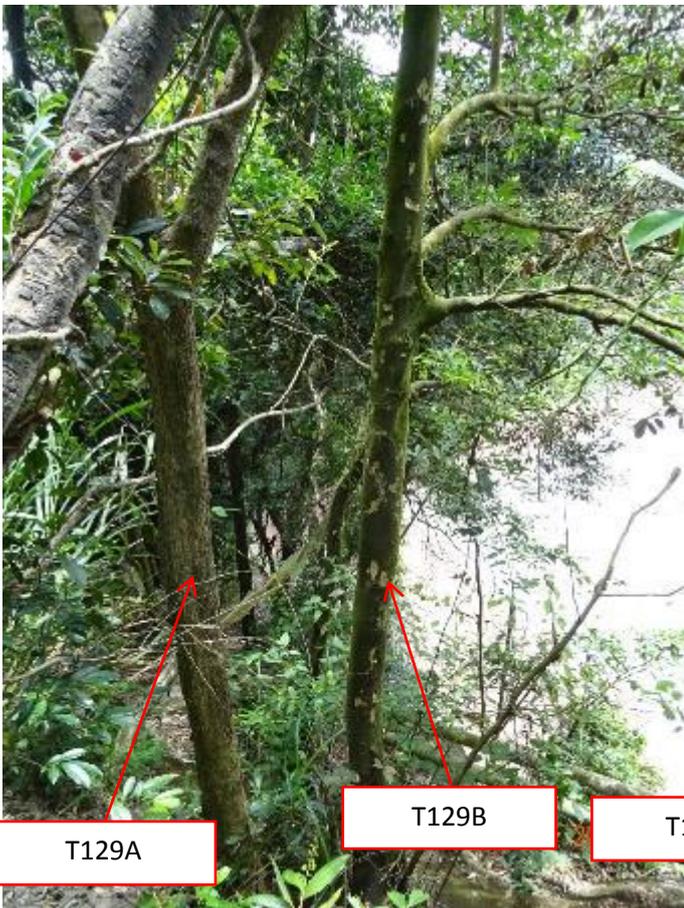
T129A, B are dead. Removal is recommended.

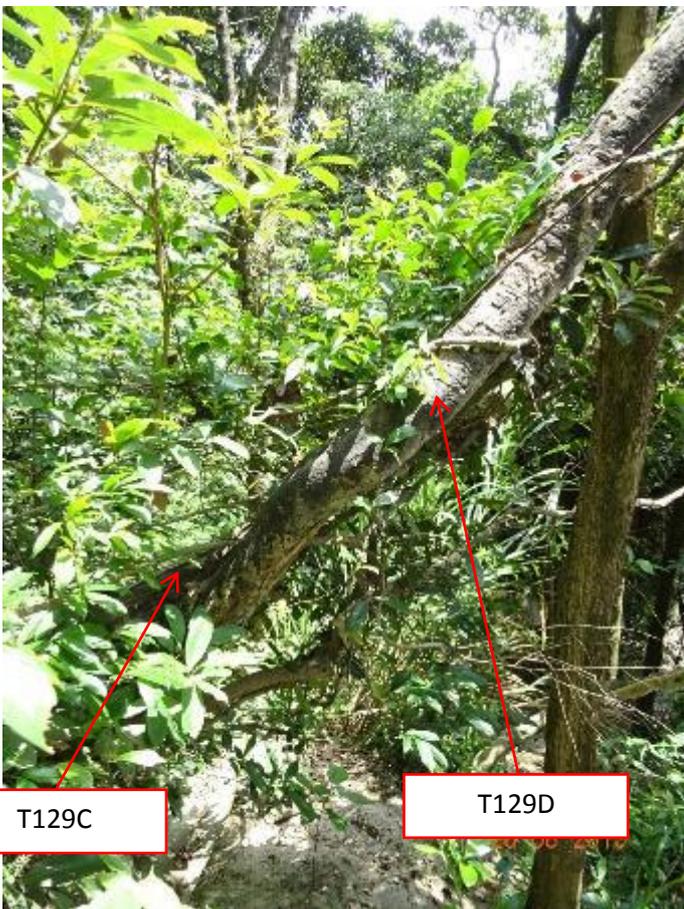
T129C, D are dead. Removal is recommended.

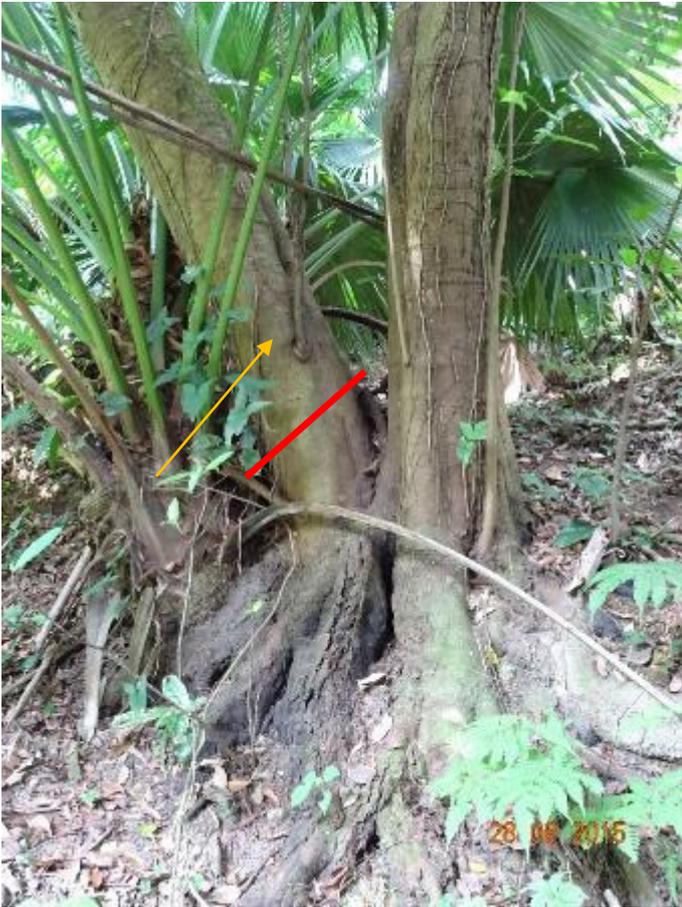
T163: The tree has developed 2 co-dominant trunk. One of the trunk has longitudinal crack, Remove the stem is recommended.

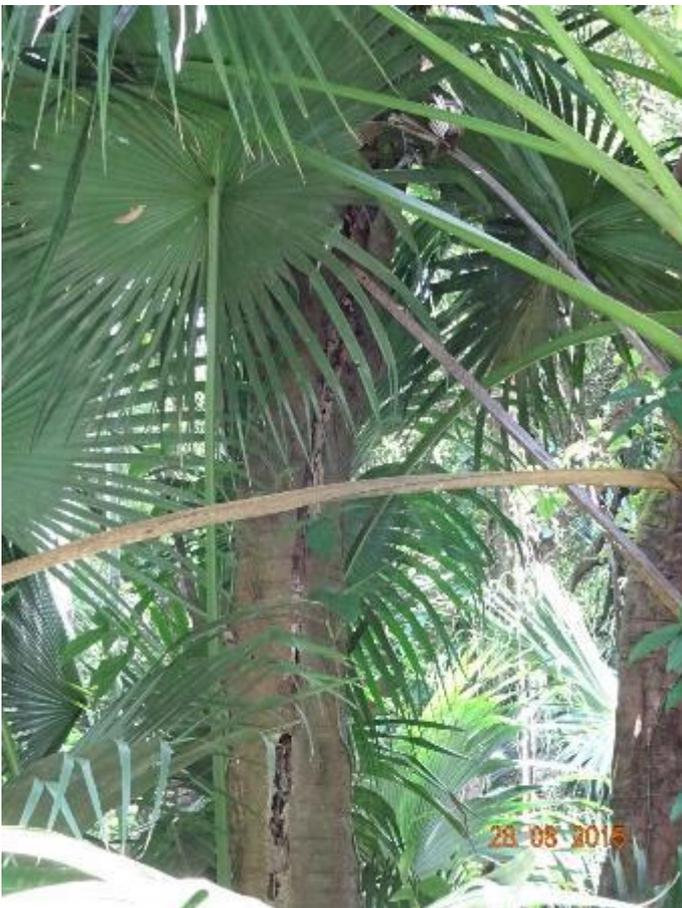
T163: A long crack is noted at the stem.

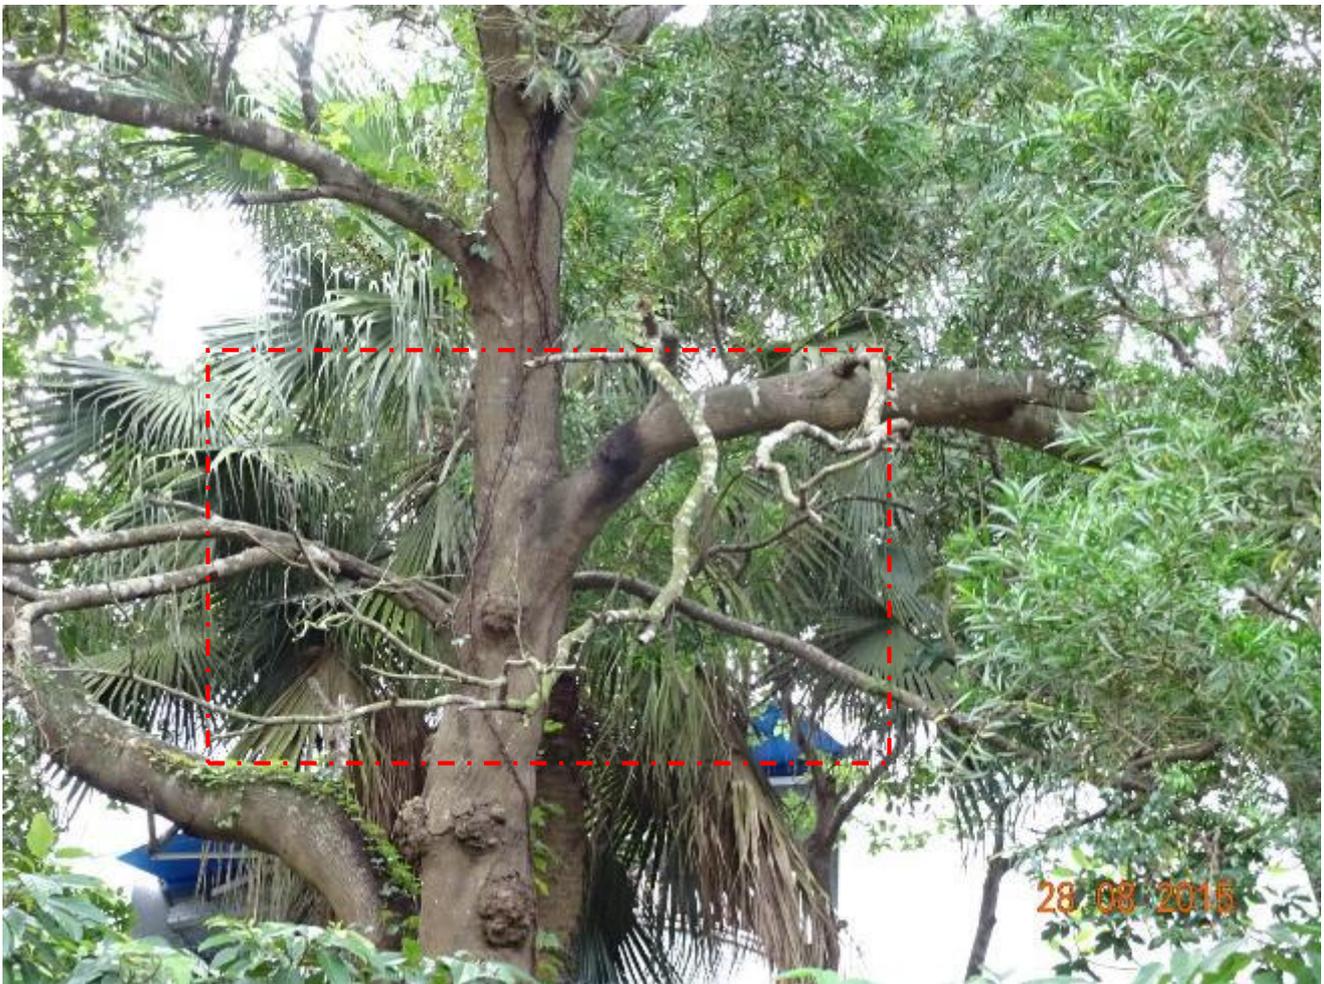
T184

Overview of the subject tree T184. Crown cleaning is recommended.
